**RE: Investigation and Characterization Plan Report
Rice Operating Company – EME SWD System
L-15-1 Vent (UL L Sec 15 T 20S R 37E)
OCD Case No.: 1R427-173**

EME L-15-1 Vent

**RE: Investigation and Characterization Plan
Rice Operating Company – EME SWD System
L-15-1 Vent (UL L Sec 15 T 20S R 37E)**

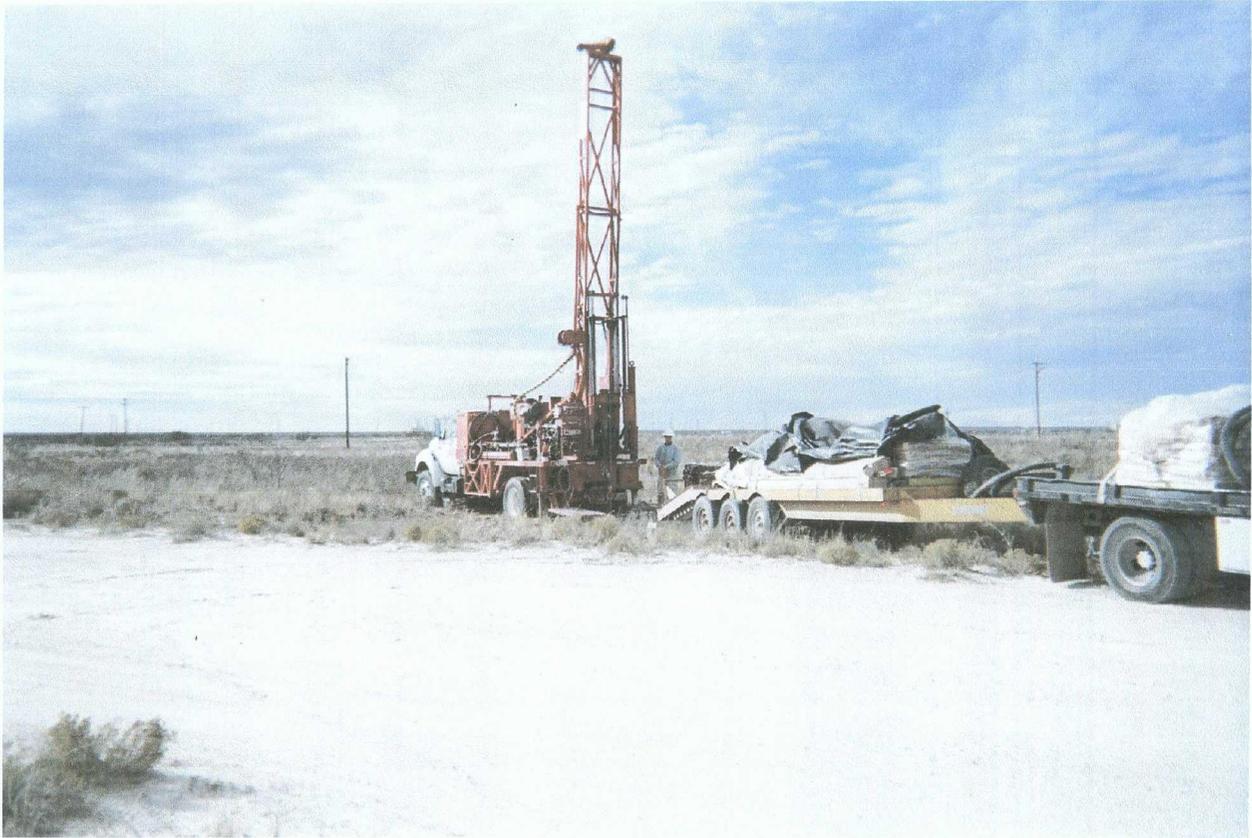
Figure 1 – Atkins Engineering Associates drill rig at EME L-15-1 on November 29th, 2007.

A soil boring was advanced at the former junction box location using a rotary auger drill on November 29th of last year (Figure 1). Samples were analyzed at five foot increments and field titrated for chlorides and tested for organics using a portable PID instrument (Table 1). Two sub-samples were sent to Cardinal Laboratories for a quality-check of the field results (Figures 2a & 2b).

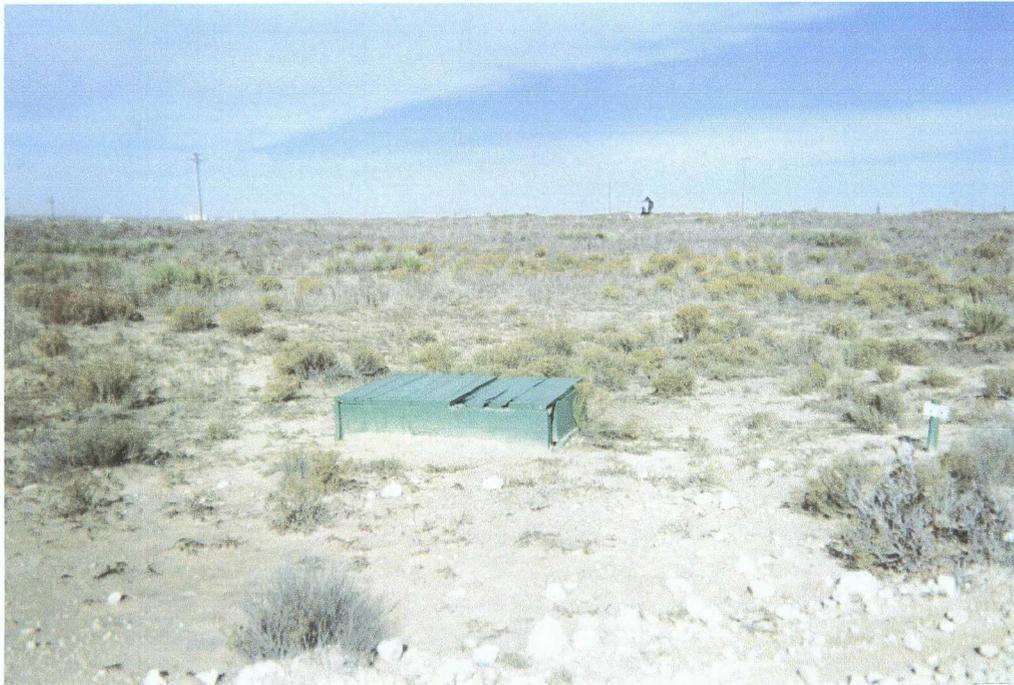
Photograph 1 – Junction box at EME L-15-1 before removal.

The surface (ecological) impact of this junction box was limited, as visual observation indicated that vegetation was not affected beyond approximately 15 ft from the former junction box; (Photograph 1). However, as some potential for groundwater contamination may exist, further evaluation is warranted for petroleum hydrocarbons and chlorides, the constituents of concern. Therefore, ROC proposes additional investigative work, as outlined below, to determine if groundwater was impacted by the former junction box.

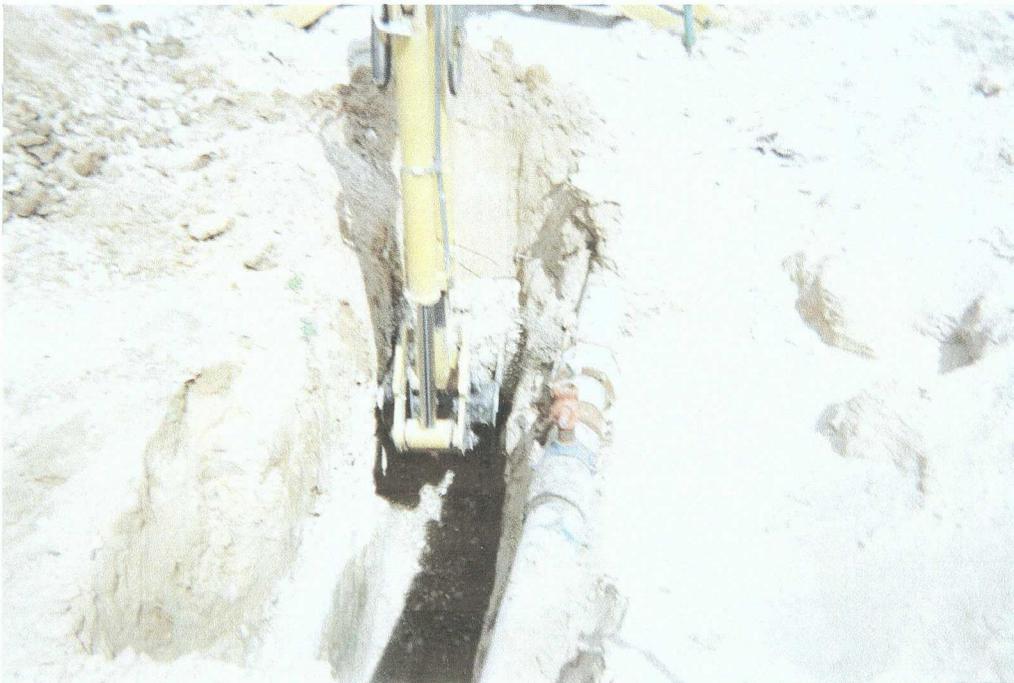
Photograph 2 – Soils evaluation at vent adjacent to former junction box.

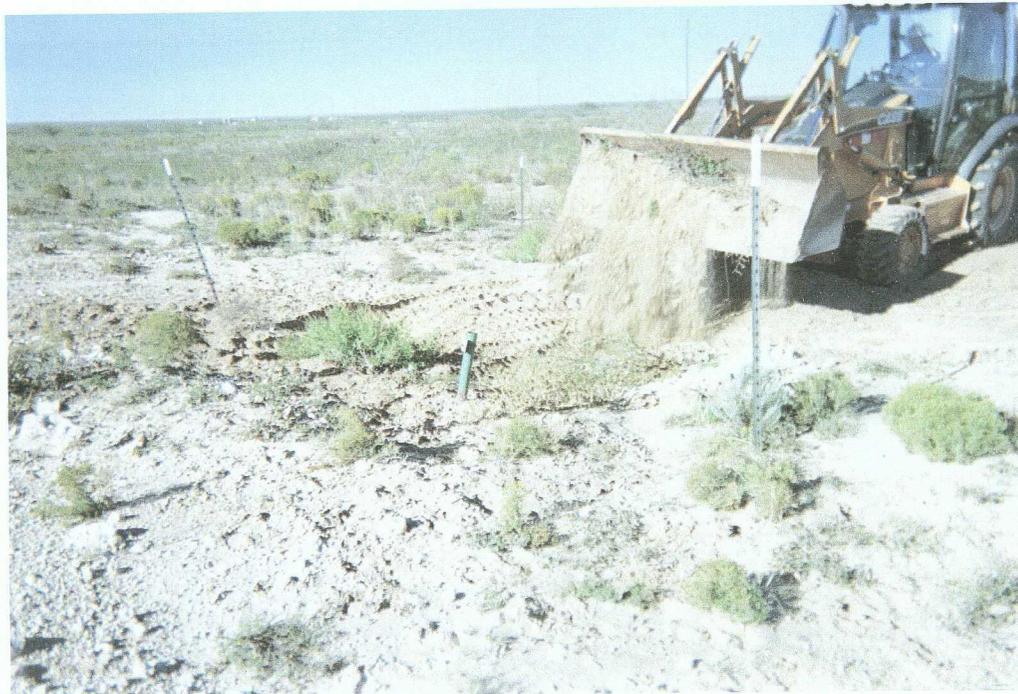
Photograph 3 – Backfilling of excavation.

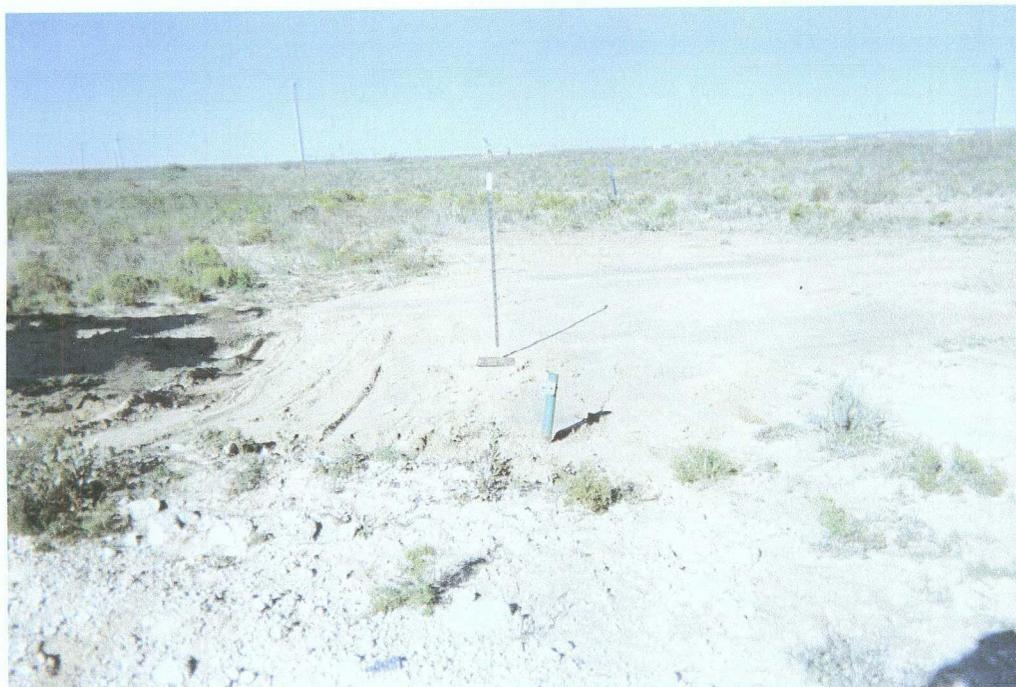
Photograph 4 – View of site following junction box removal. Note that a steel marker plat has been installed at the ground surface for future reference.

The junction was eliminated and the pipeline was lain straight through this location.
The box lumber was removed and the site was delineated using a backhoe while PID screenings and chloride field tests were conducted every 2 feet of depth. Chloride impact was consistently elevated to the reach of the backhoe (12 ft bgs). A grab sample at 12 ft was collected for lab analysis. NMOCD TPH guidelines were not met. The excavated soil was blended on site and then backfilled into the delineation trench and contoured to the surrounding surface. An identification plate has been placed on the surface to mark the site of the former junction box for future environmental consideration. NMOCD has been notified of potential groundwater impact at this site.
