**STAGE 1 & 2
WORKPLAN**

RE: Samson Livestock "30" Reserve Pit, T21S, R35E, Section 30, Unit P;
NMOCD Case: Abatement Plan 62

**Stage 1/Stage 2
Abatement Plan
Samson Livestock 30
T21S-R35E-Section 30**

**Prepared for:
Samson Resources Inc**

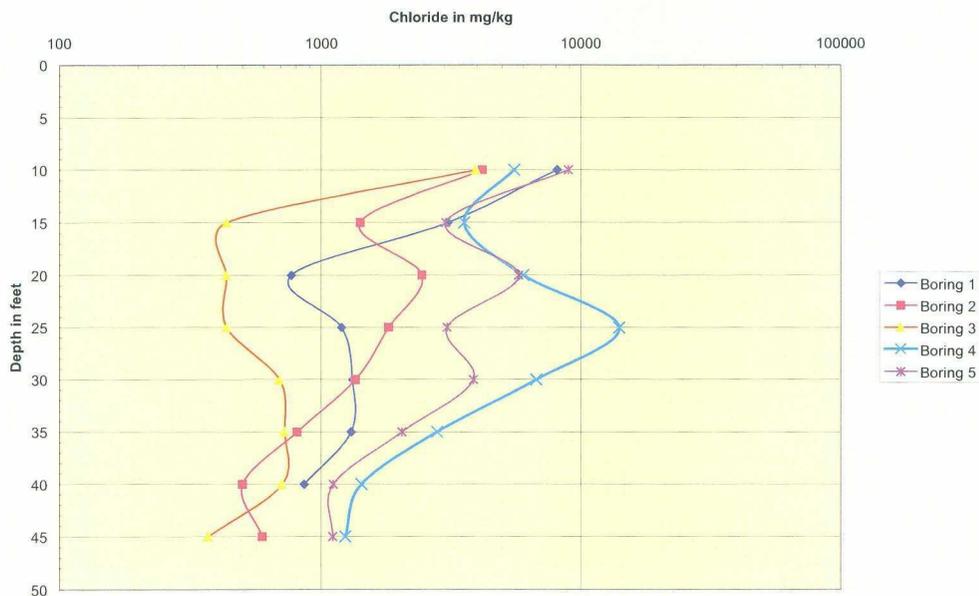
Figure 3: Chloride Concentration in Soil at the Livestock Site

Figure 3 shows the chloride concentrations v. depth for the boreholes within the excavation associated with the former reserve pit. The maximum field chloride concentration of 14,080 mg/kg is from B-4 at a depth of 25 feet bgs. The deepest samples above the capillary fringe (about 35 feet bgs) suggest that chloride did not materially impact the lower vadose zone in the northern portion of the former pit (borings 2 and 3). In the central and southern portion of the former pit, chloride concentrations above the capillary fringe are 1,298 mg/kg (B-1), 2,799 mg/kg (B-4) and 2,031 mg/kg (B-5). The fact that borehole #4 exhibits the highest chloride concentrations may not be surprising, given the fact that this borehole characterizes the area of the former reserve pit where accumulated cuttings would not restrict any loss from a lack of liner integrity. Figure 3 presents two schematic cross sections showing chloride concentrations from north to south and from east to west.

Rocks exposed at the surface along the ridges are alluvial deposits and petrocalcic soils of the Tertiary Ogallala formation (see Plate 5). They are covered by Quaternary age eolian deposits in the valleys, which consist of less than 10 feet of brown to reddish brown silt and very fine grain sand. The contact between the Quaternary and Tertiary formations in the reserve pit is shown in Figure 3.
