SAMSON RESOURCES
LIVESTOCK 30 STATE #1 LEASE
GROUNDWATER INVESTIGATION
REPORT
SEC 30 T21S-R35E
API #30-025-35200
LEA COUNTY, NEW MEXICO

NOVEMBER 8, 2005

Reference:
Site Delineation Plan-Samson Resources
Livestock 30 State # 1
Sec. 30, T21S-R35E
Lea County, NM

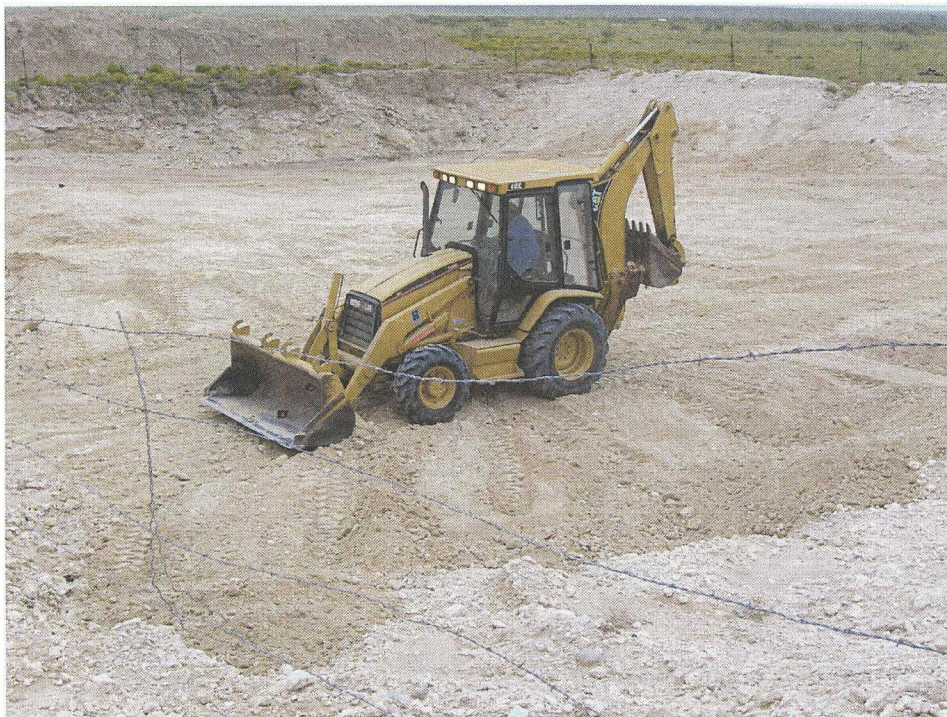
SMOOTHING EXCAVATED BOTTOM – PREPARING TO DRILL

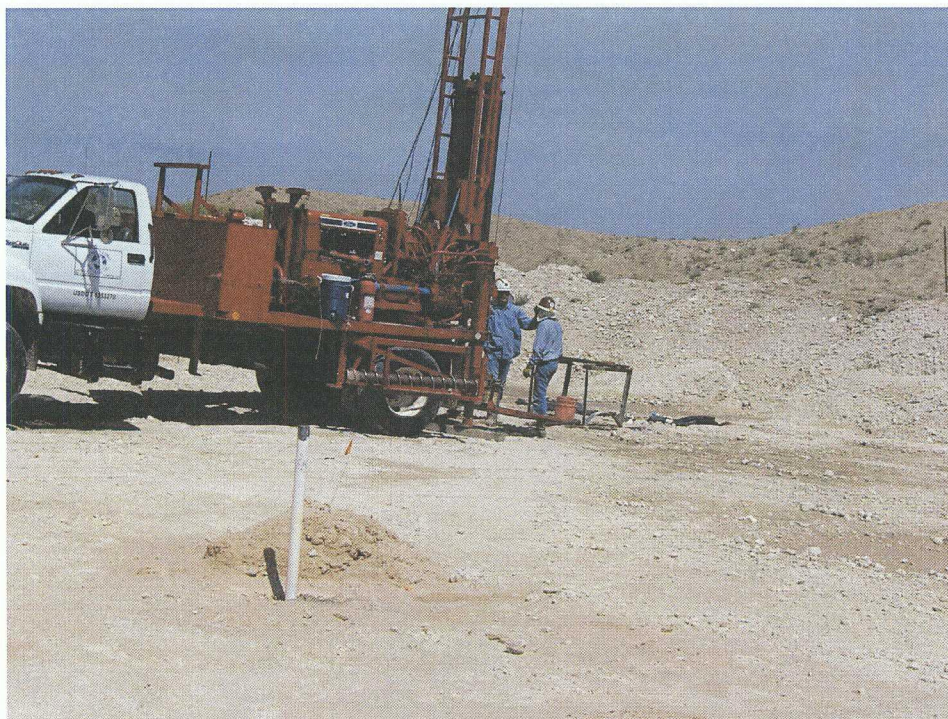
COMPLETED MW (BH #1) – LOOKING NE TOWARDS BH#3
