Vac Oxy Permian 'N' EOL

RICE OPERATING COMPANY
JUNCTION BOX FINAL REPORT

Vacuum Oxy Permian 'N' EOL

Unit B, Section 28, T17S, R35E

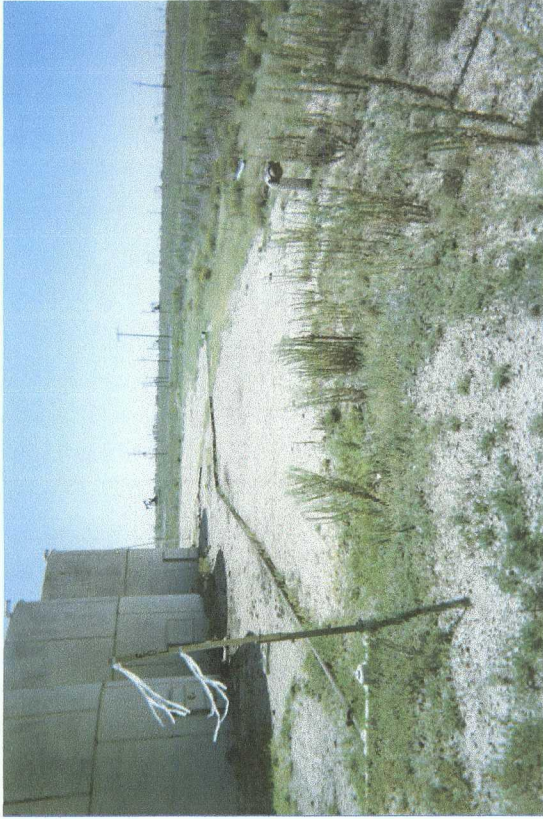
8/7/2007

Stake at former box location

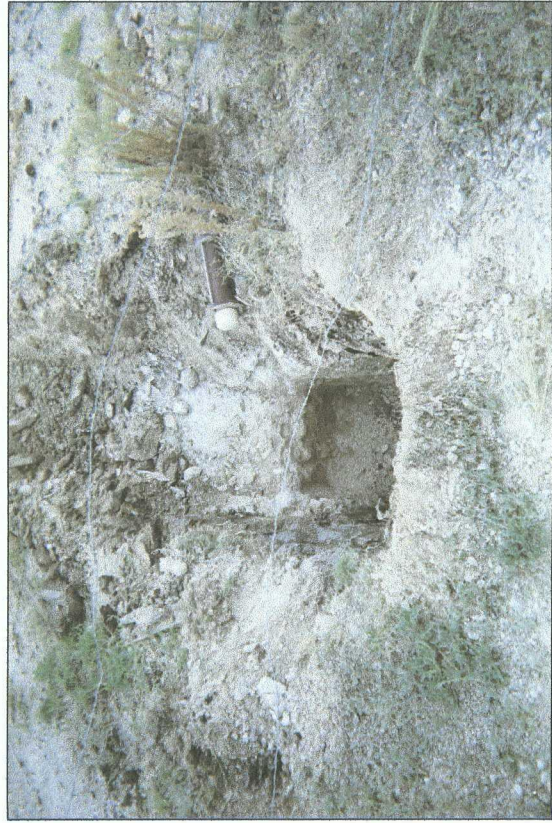
8/24/2007

delineation trench 6 ft deep

Vacuum SWD System abandonment. After the box was removed and the site was cleared of NORM contamination, a delineation trench was made at the former junction site using a backhoe to collect samples to 6 ft BGS. Chloride field tests performed on the samples yielded very low concentrations. Organic vapors were measured using a PID and also yielded very low concentrations in each sample. The deepest (6 ft) sample was sent to a certified laboratory for confirmation. TPH levels were not present within the laboratory's detection limits, meeting NMOCD guidelines. The trench was backfilled and the remaining hole from the box was filled with clean, imported soil and contoured to the surrounding terrain.

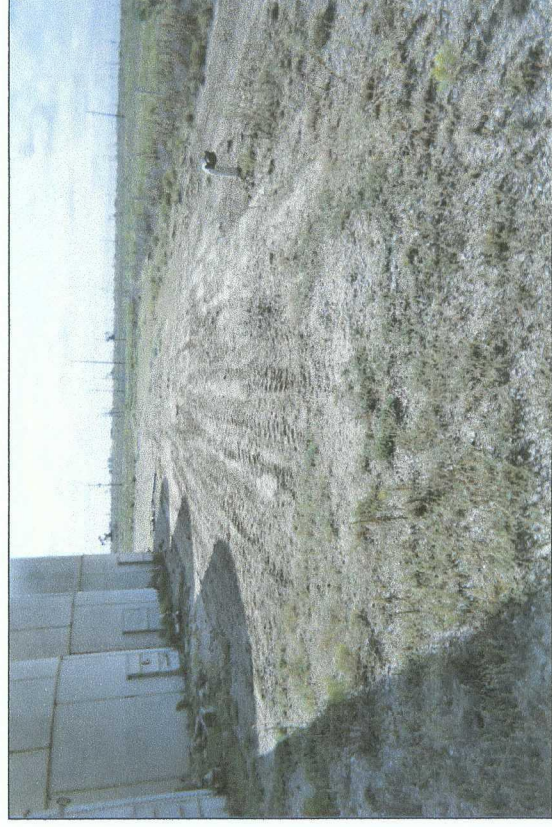
8/31/2007

site backfilled with 12 yds³ imported fill
