Vacuum C-33 Boot

RICE OPERATING COMPANY
JUNCTION BOX **DISCLOSURE*** REPORT

unit C, Section 33, T17S, R35E

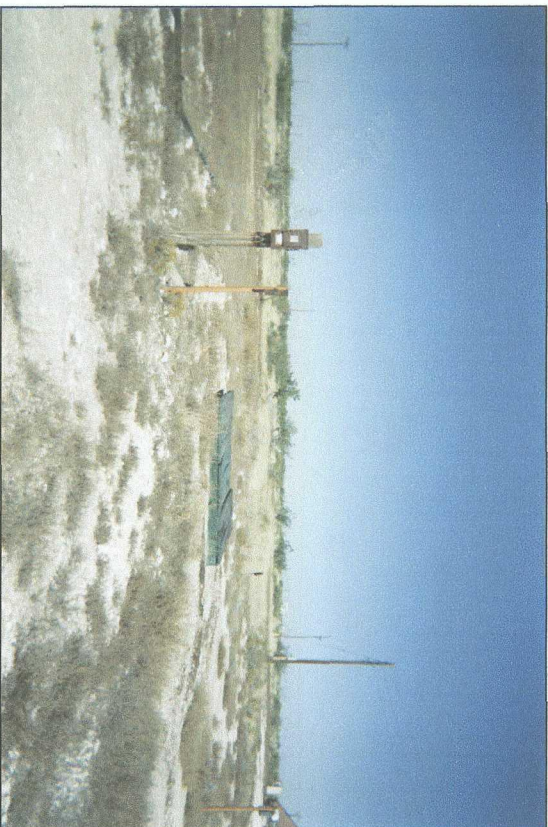
undisturbed junction box prior to excavation 11/8/2005

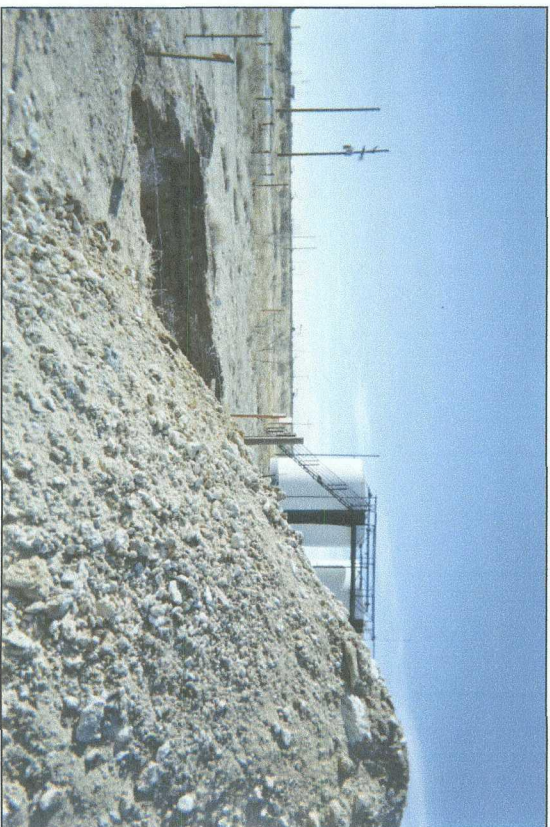
box removed; NORM decontamination 1/30/2006

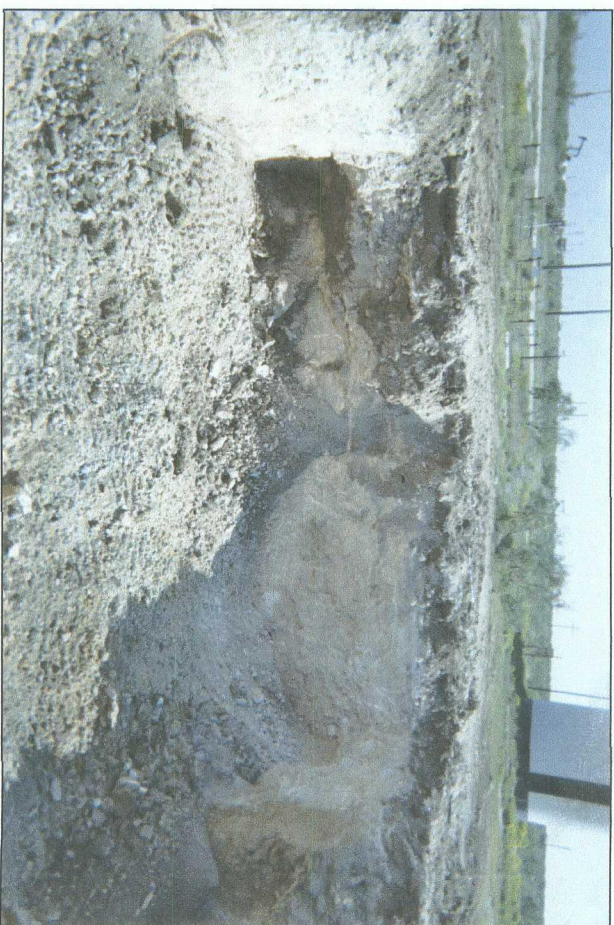
final 30 x 30 x 12-ft excavation 9/12/2007

This junction was addressed as part of
the Vacuum SWD System abandonment. After the junction box was removed, the site was delineated using a backhoe to collect soil samples at regular intervals producing a 30 x 30 x 12-ft-deep excavation. Organic vapors in the soil were measured using a PID which yielded slightly elevated concentrations in some areas. Chloride field tests were performed on each sample and yielded elevated concentrations which generally did not relent with depth. Composite samples were collected from the excavation bottom, walls, and excavated soil for laboratory confirmation of chloride, TPH, and BTEX concentrations. The excavated soil was blended on site and then returned to the excavation and contoured to the surrounding surface. An identification plate was placed on the surface of the backfilled site to mark the location of the former junction for future environmental consideration. R.T. Hicks Consultants of Albuquerque have been assigned to this project. OCD was notified of potential groundwater impact of this site on 12/20/2007.

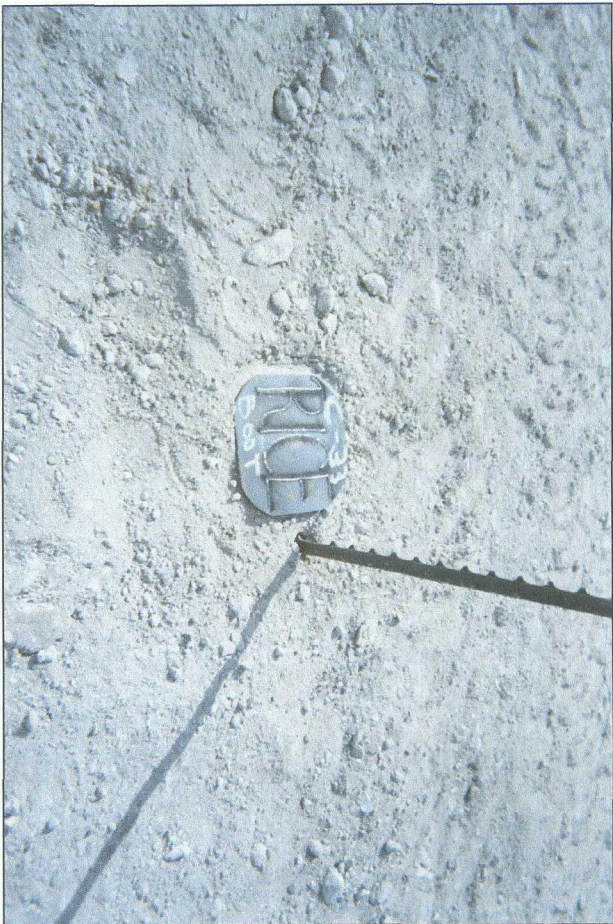
identification plate at surface of backfilled site marking former
junction 10/11/2007

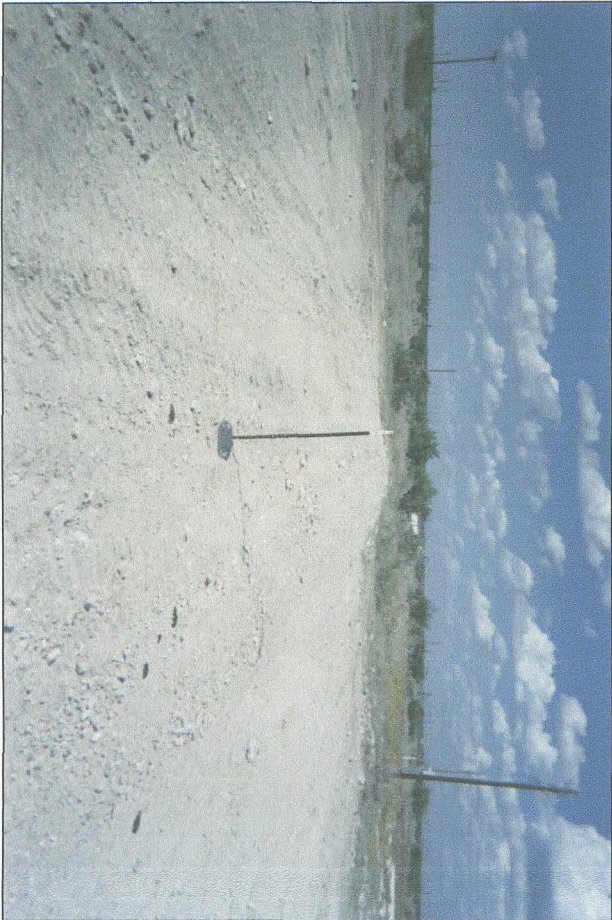
backfilled excavation with identification plate 10/11/2007

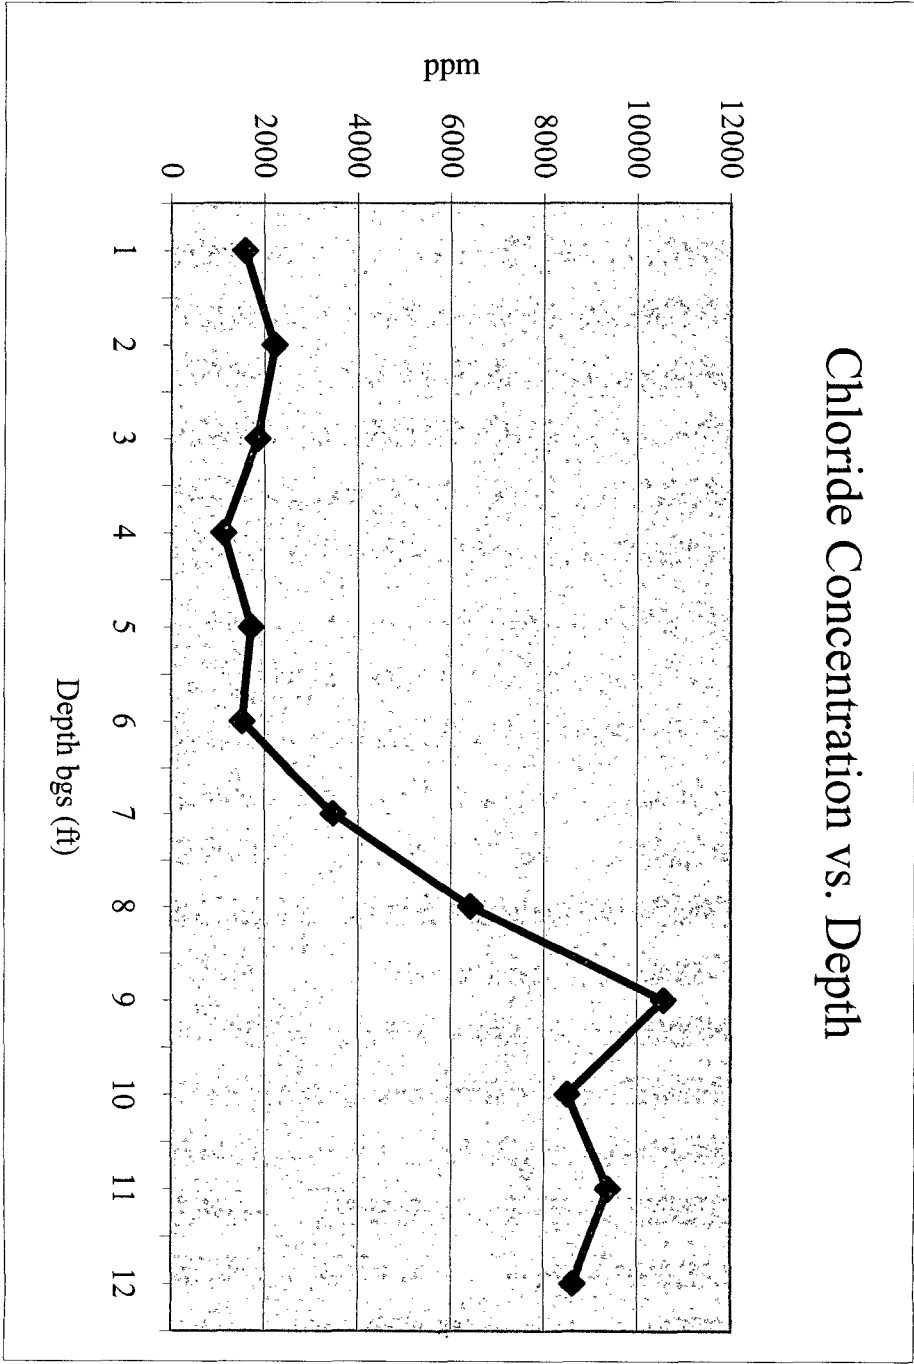
15 ft NORTH of former junction

Depth bgs (ft)	[Cl] ppm
1	1575
2	2218
3	1851
4	1116
5	1707
6	1518
7	3462
8	6428
9	10572
10	8500
11	9373
12	8621

Groundwater = 85 ft
