Release Notification and Corrective Action

Name of Company Rice Operating	Contact Tony Grieco
Address 122 W. Taylor St., Hobbs, NM 88240	Telephone No. (575) 393-9174
Facility Name: BD Junction N-29	Facility Type: Salt Water Gathering System

BD N-29 LEAK

BD N-22 LEAK

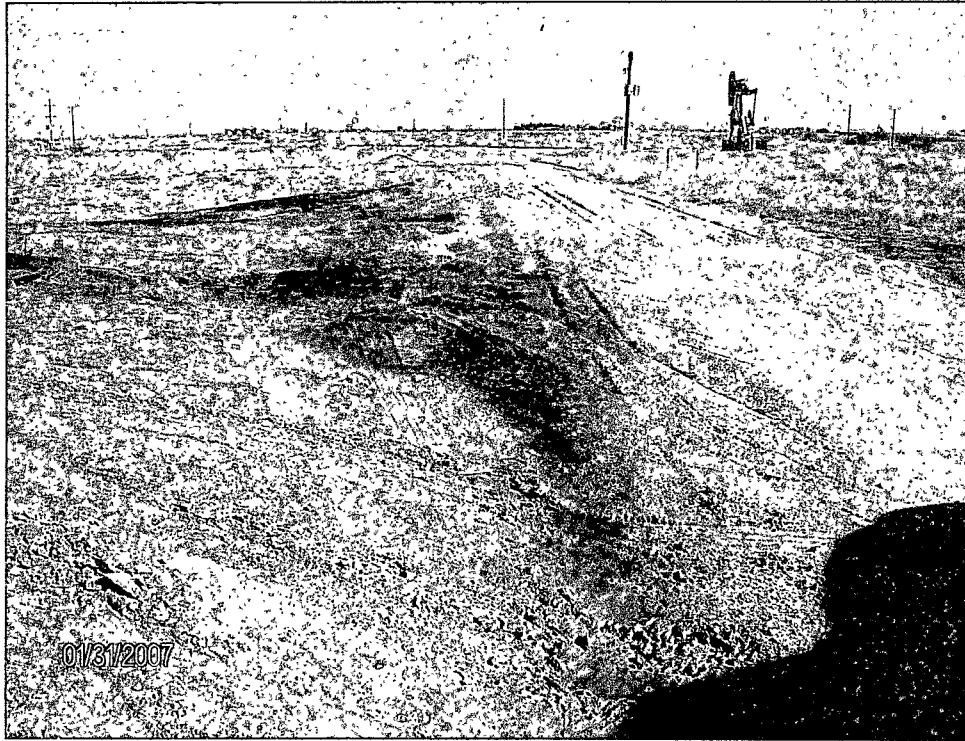
SPILL FROM SOURCE LOOKING EAST

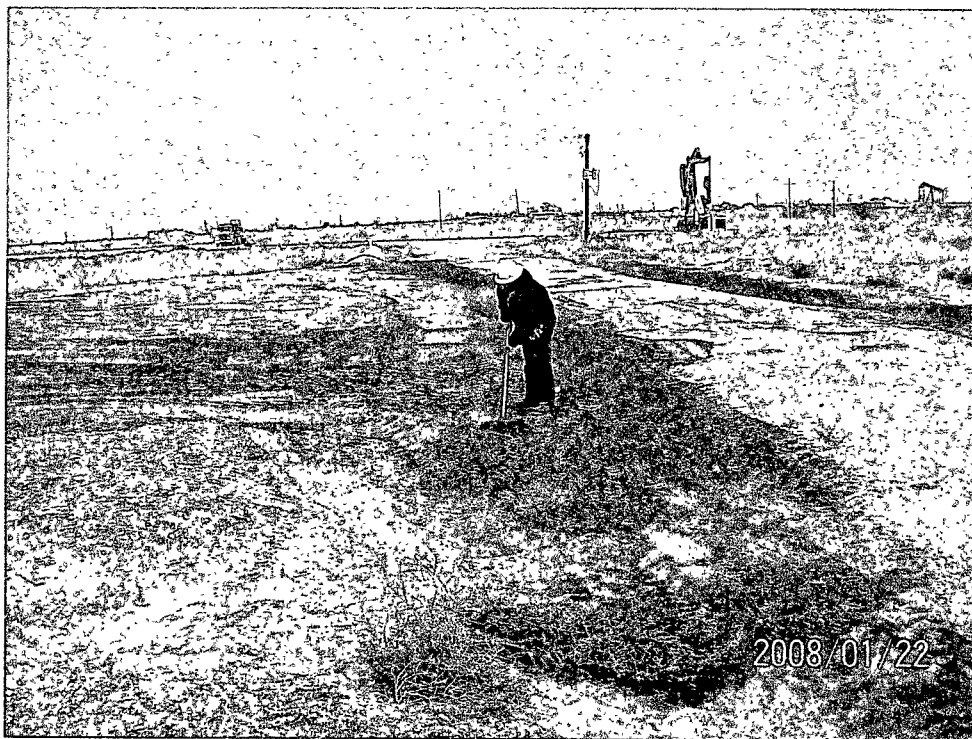
SAME VIEW AFTER BACKFILL, DURING SEEDING

Approximately 5,428 sq ft were affected. A vacuum truck was used to pick up standing fluid. Leak area was scraped on 2/1 and 2/2/07 to a depth of 6 in and the impacted soil (a total of 216 yds) was properly disposed at Sundance disposal facility. An initial C-141 was submitted 2/7/07, and a Corrective Action Plan was submitted 2/19/07. Delineation with a backhoe and hand auger was conducted 2/1,2,5/07, and additional delineation with a hand auger was done on 12/11/07. On 1/9,10 /08, 216 yds of clean soil were imported, this soil was spread and contoured, and the site was seeded, on 1/22/08.

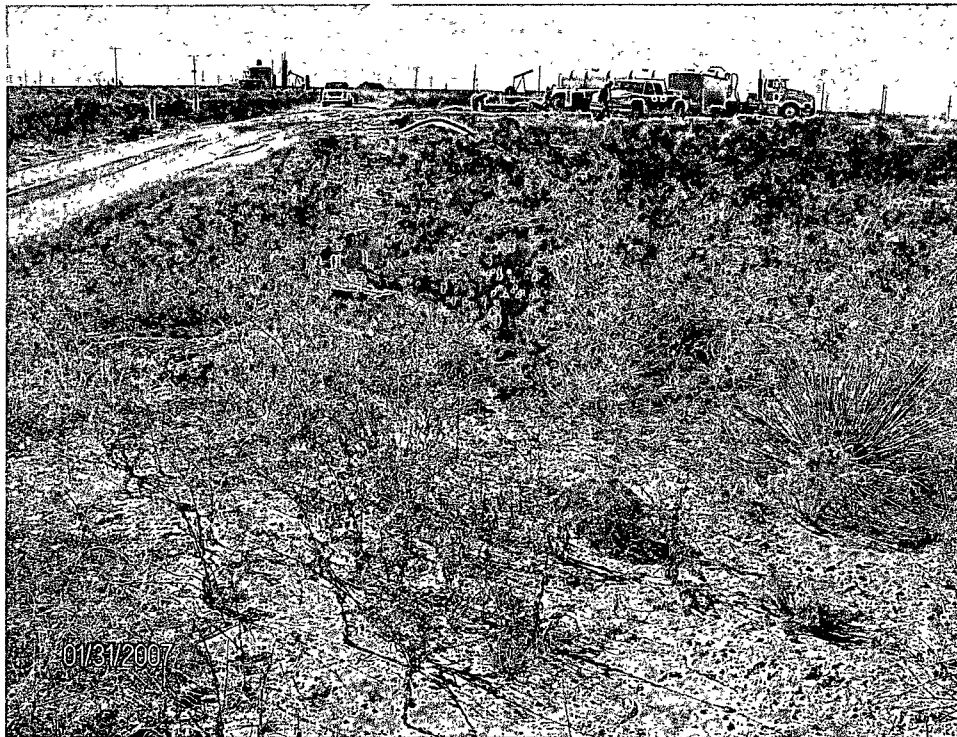
BD N-29 LEAK

NORTH SIDE OF ROAD, LOOKING WEST FROM EAST EDGE OF SPILL AREA

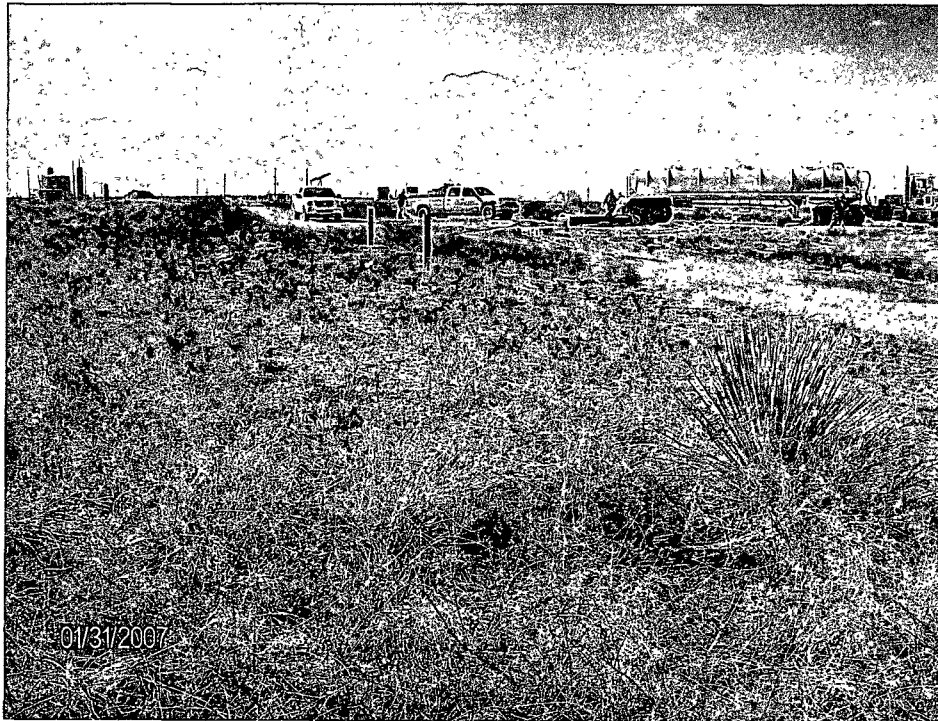
BD N-29 LEAK

SOUTH SIDE OF ROAD LOOKING WEST FROM EAST EDGE OF SPILL AREA

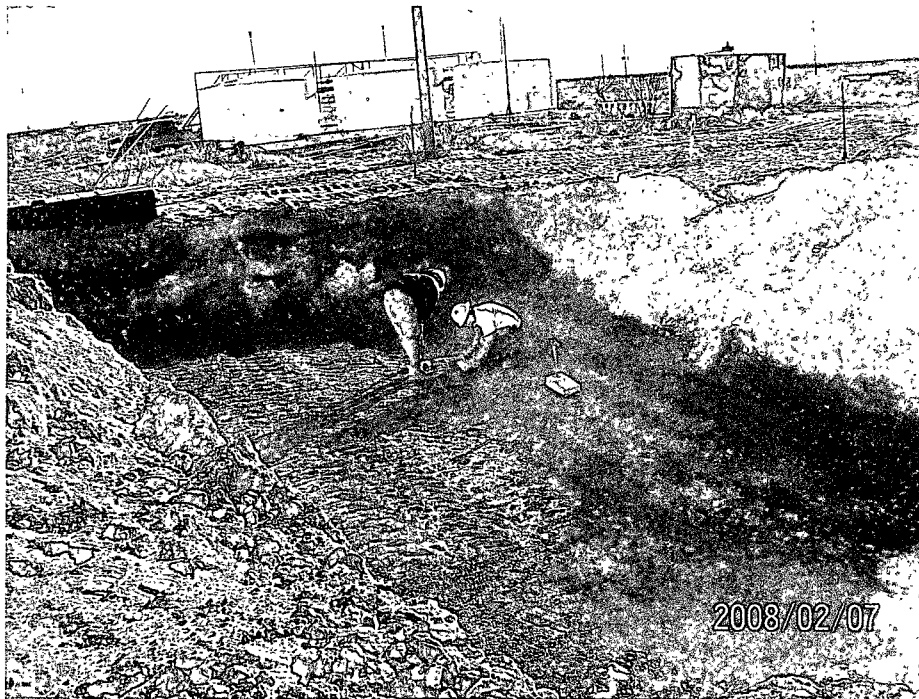
BD N-22 LEAK

COMPACTION OF INSTALLED CLAY BEING MEASURED
