EME Jct B-7 (2 Boxes)

1R427-230

CLOSURE

**RICE OPERATING COMPANY
JUNCTION BOX FINAL REPORT**

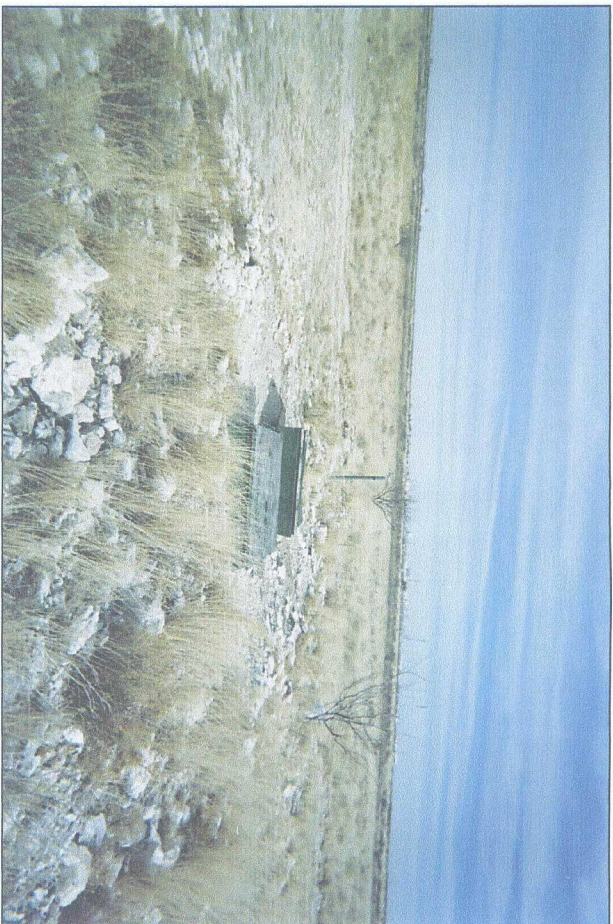
2/14/2006

undisturbed junction boxes

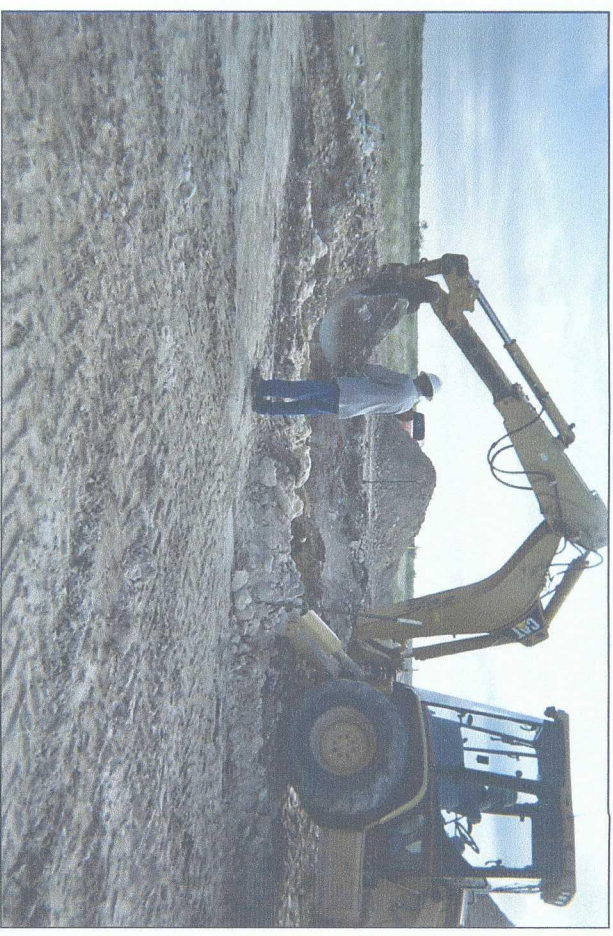
Sept. 2007

collecting soil samples from excavation

This site contained 2 junction boxes that were eliminated as part of the ongoing pipeline replacement/upgrade program. Once the box lumber was removed, a backhoe was used to collect soil samples at regular intervals producing a 30 x 30 x 12-ft-deep excavation. Chloride field tests were conducted on each sample and yielded low chloride concentrations throughout. Organic vapors were also measured using a PID instrument. Representative composite samples from the excavation floor, walls, and excavated soil were collected for laboratory confirmation. NMOCD TPH guideline concentrations were met for BTEX and TPH. The excavated soils were blended on site and returned to the excavation and contoured to the surrounding terrain. On 9/19/2007 the disturbed area was seeded with a blend of native vegetation and is expected to return to productive capacity at a normal rate.

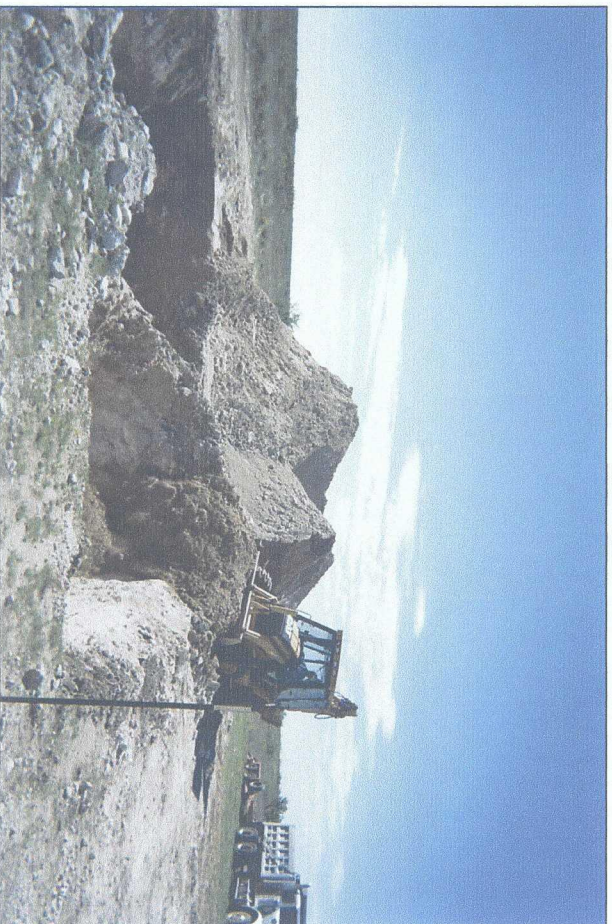
Sept. 2007

backfilling excavation

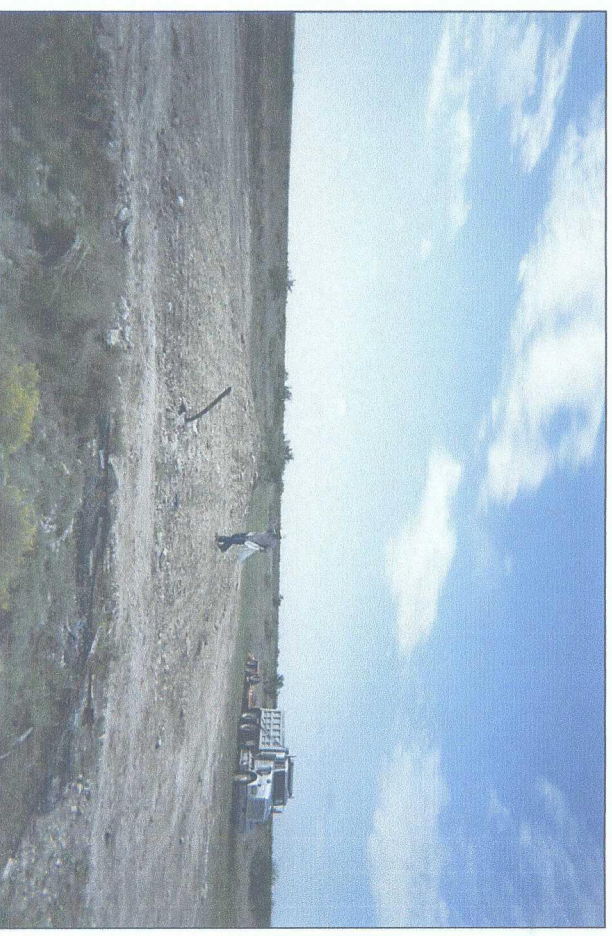
9/19/2007

seeding disturbed area

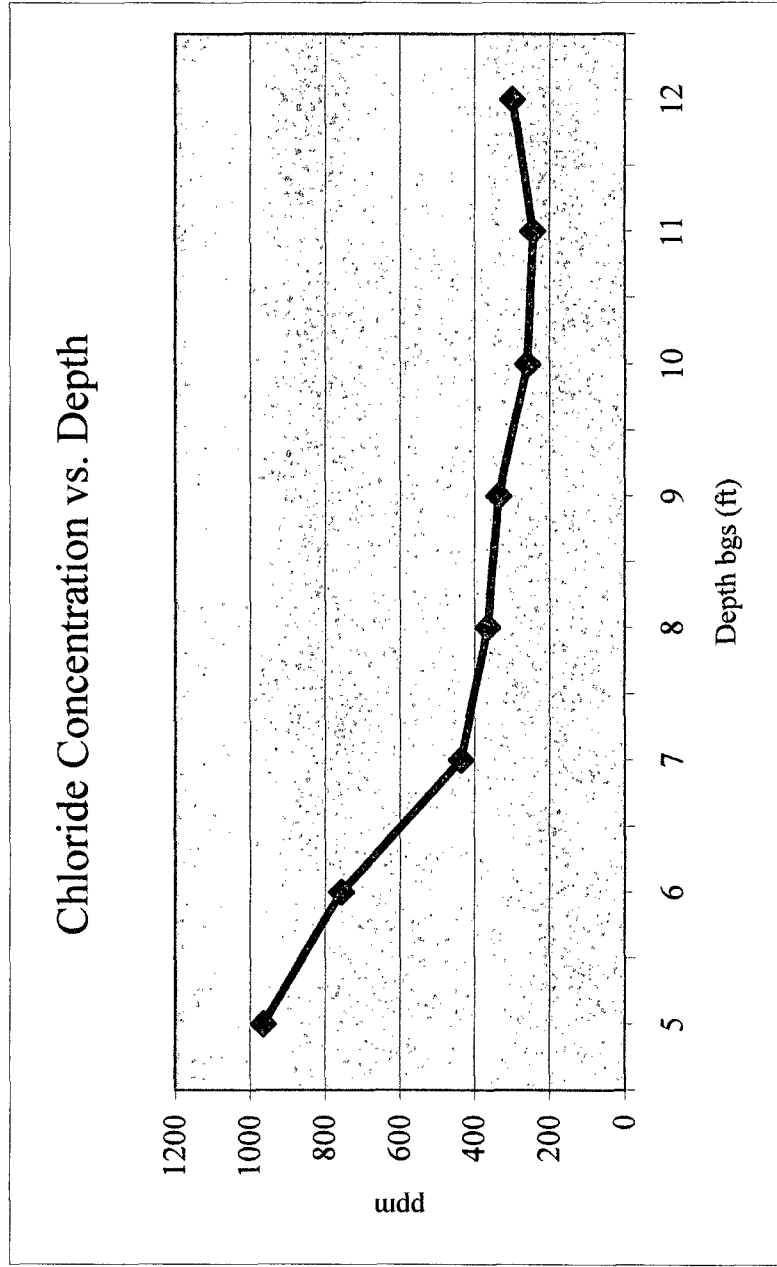
EME jct. B-7 unit 'B', Sec. 7, T19S, R37E

Backhoe samples at junction (source)

Depth bgs (ft)	[Cl ⁻] ppm
5	965
6	756
7	436
8	365
9	336
10	259
11	245
12	299

Groundwater = 47 ft

LOCATION	DEPTH (ft)	ppm
vertical delineation trench at former junction	5	965
	6	756
	7	436
	8	365
	9	336
	10	259
	11	245
	12	299
4-wall comp.	n/a	161
bottom comp.	12	240
backfill comp.	n/a	288
