EME Jct A-34-1

RICE OPERATING COMPANY
JUNCTION BOX FINAL REPORT

EME jct. A-34-1

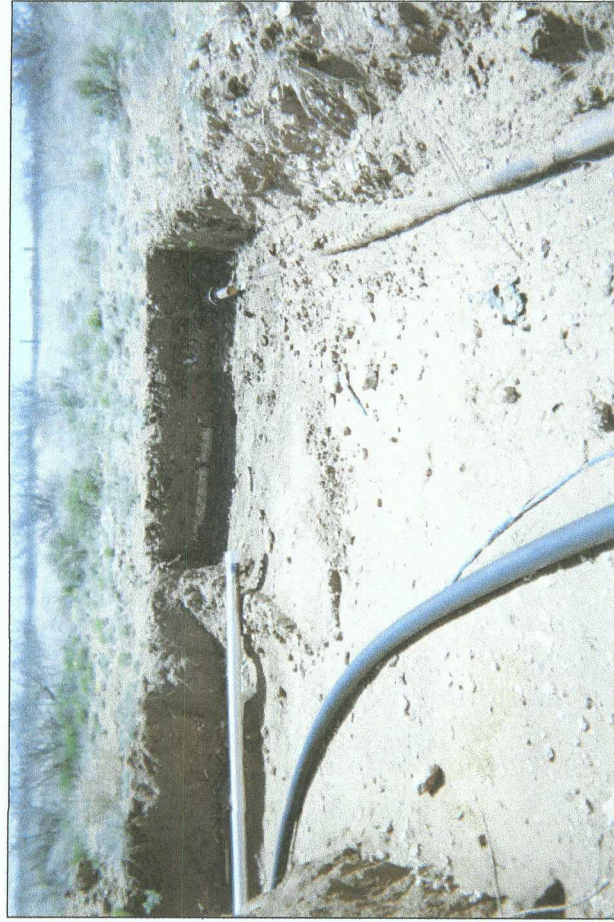
junction and box removed; upgraded with new poly line 4/20/2007

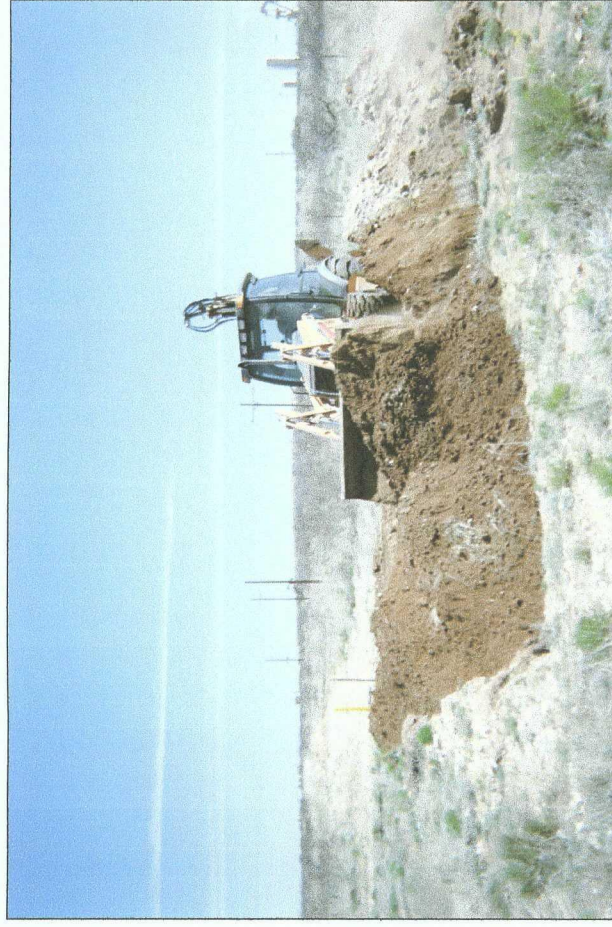
4/18/2007

backfilling with clean, imported backfill

remaining hydrocarbon will naturally attenuate. The 3-ft-deep area was backfilled with clean, imported fill dirt and contoured to the

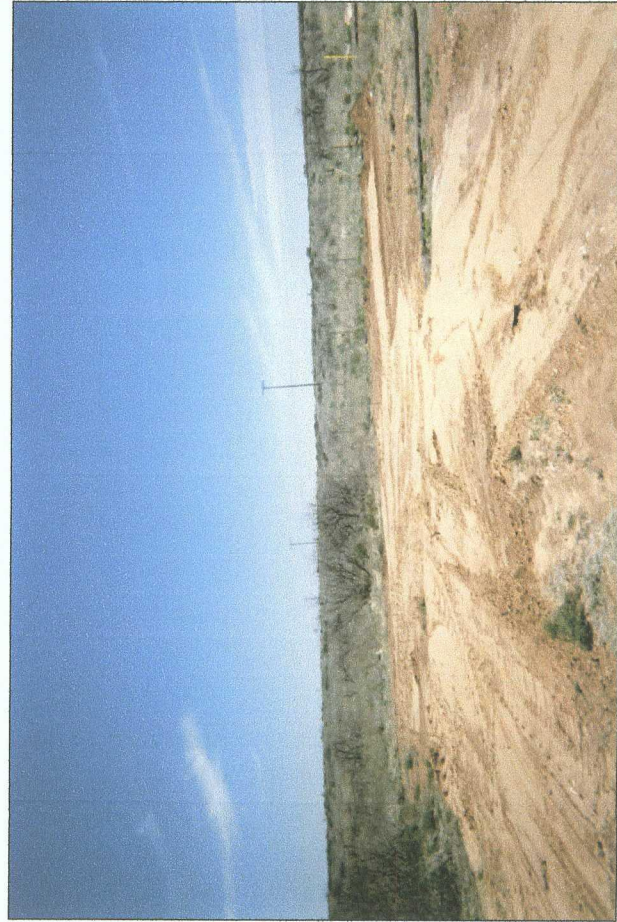
4/18/2007

backfill complete

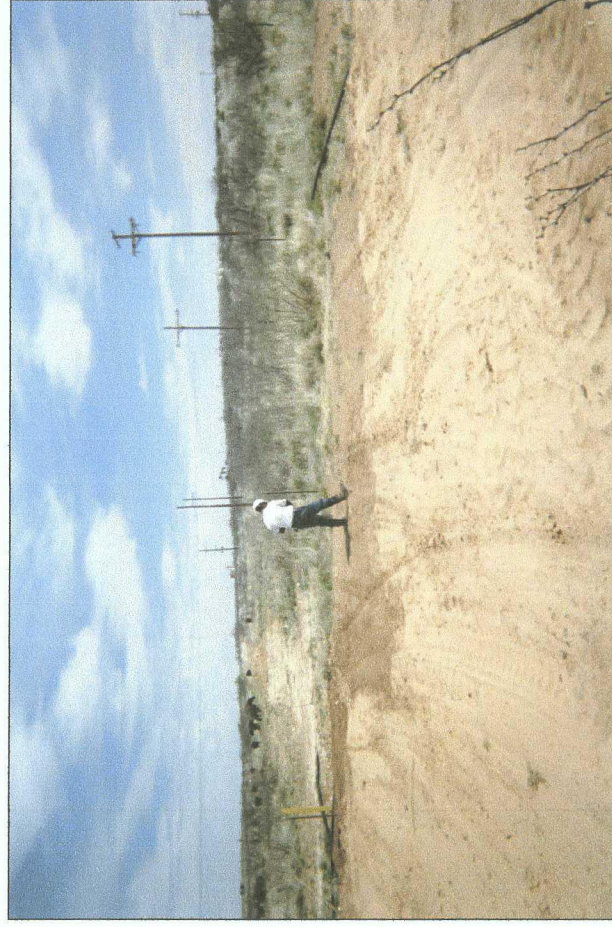
4/23/2007

seeding backfilled site

surrounding area. The disturbed surface was seeded with a blend of native vegetation and is expected to return to productive capacity at a normal rate.
