EME Jct J-33

RICE OPERATING COMPANY
JUNCTION BOX FINAL REPORT

EME jct. J-33

Unit J, Section 33, T19S, R37E

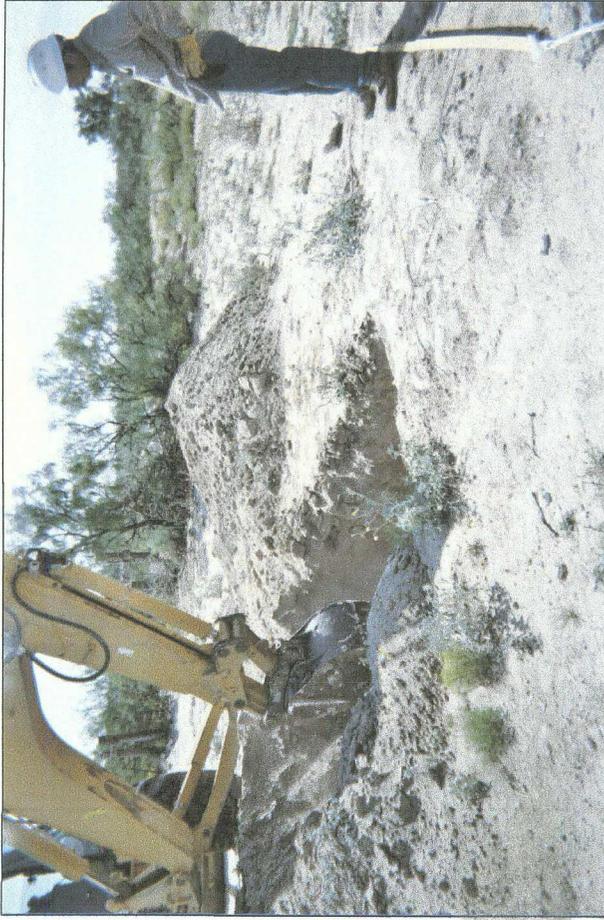
8/22/2007

excavating delineation trench at former junction site

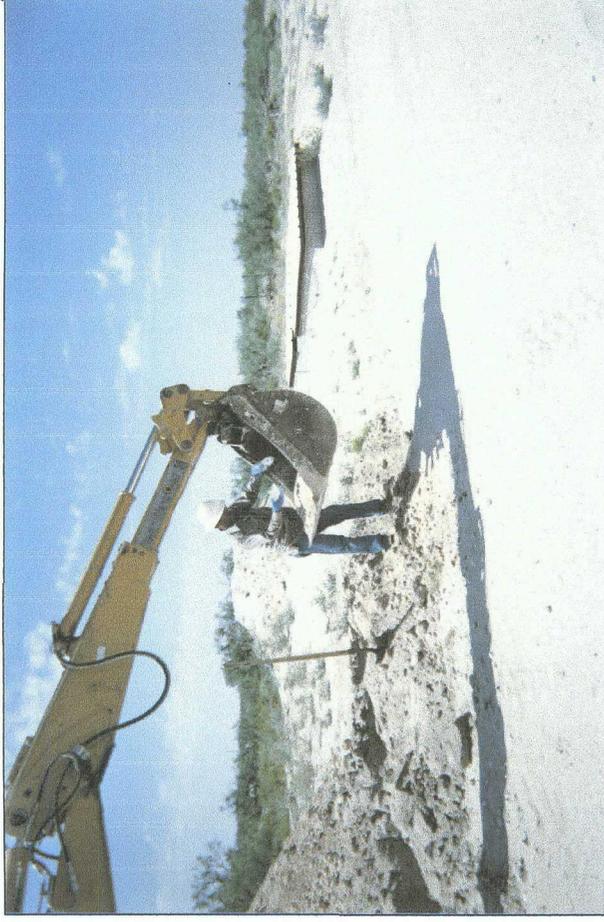
8/22/2007

collecting soil samples from trench

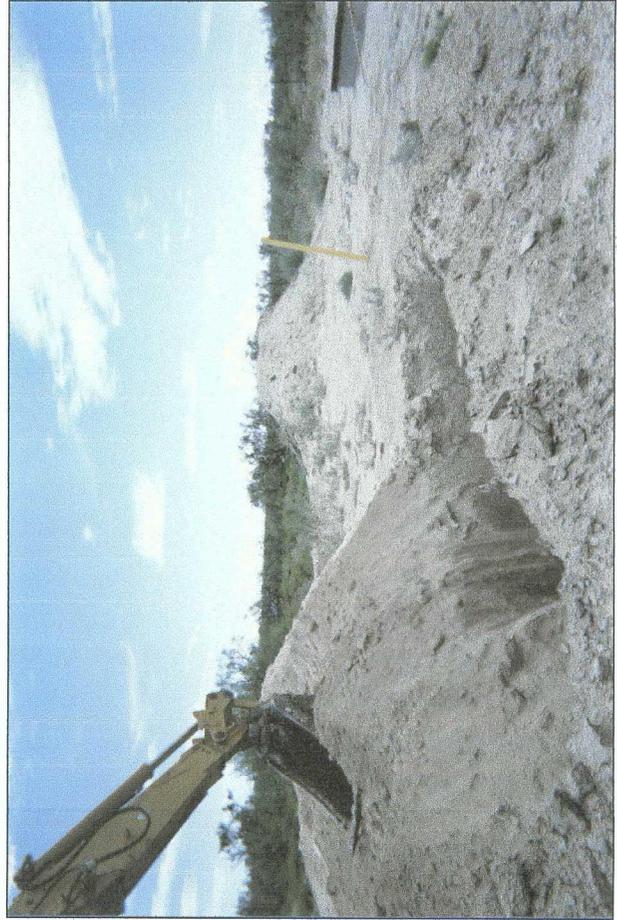
8/24/2007

backfilling trench

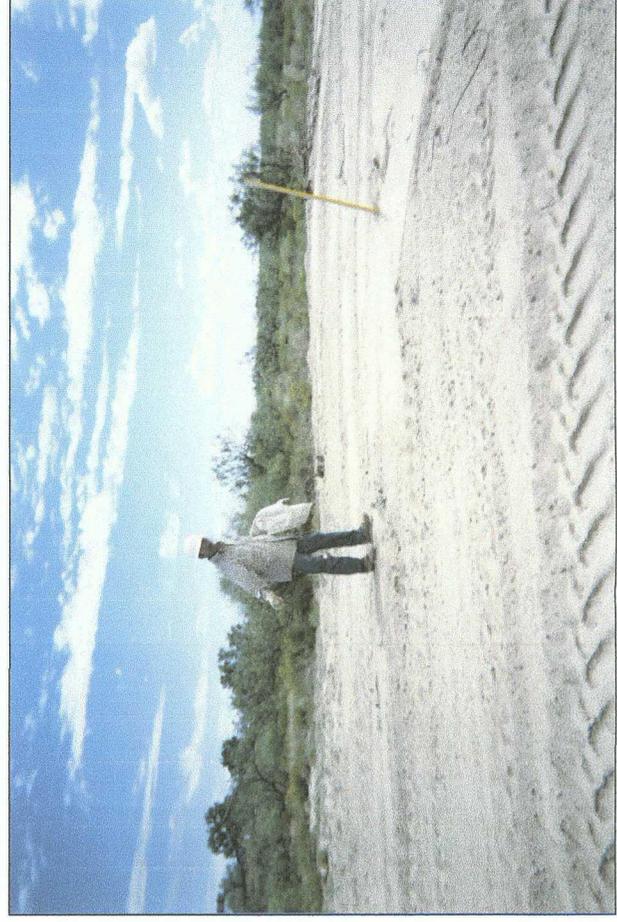
8/24/2007

seeding backfilled site
