EME Jct G-20

CLOSURE

RICE OPERATING COMPANY
JUNCTION BOX FINAL REPORT

SWD SYSTEM	JUNCTION	UNIT	SECTION	TOWNSHIP	RANGE	COUNTY	NEW BOX DIMENSIONS - FEET		
Eunice-Monument-Eumont (EME)	jct. G-20	G	20	20S	37E	Lea	Length	Width	Depth
							moved 50 ft east

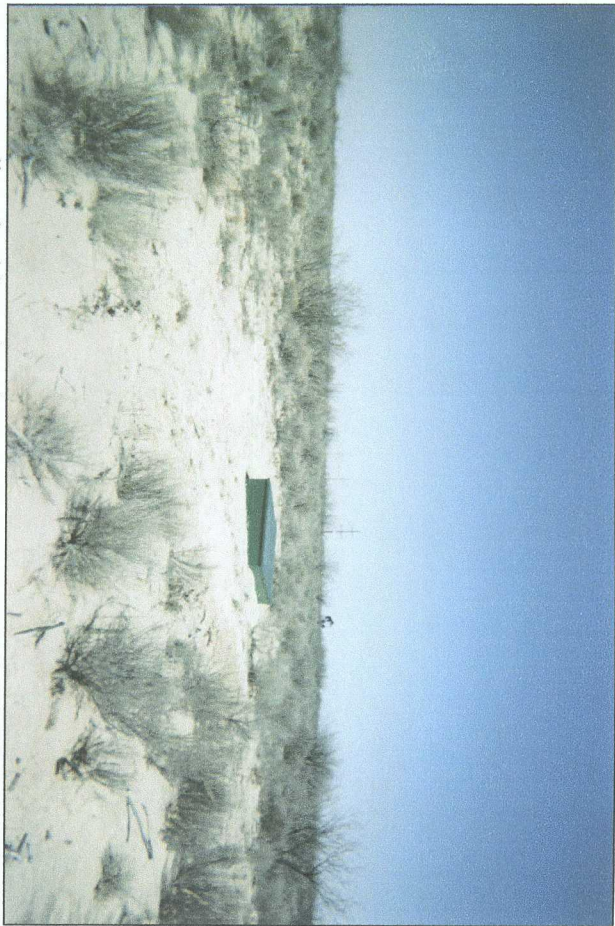
undisturbed junction box

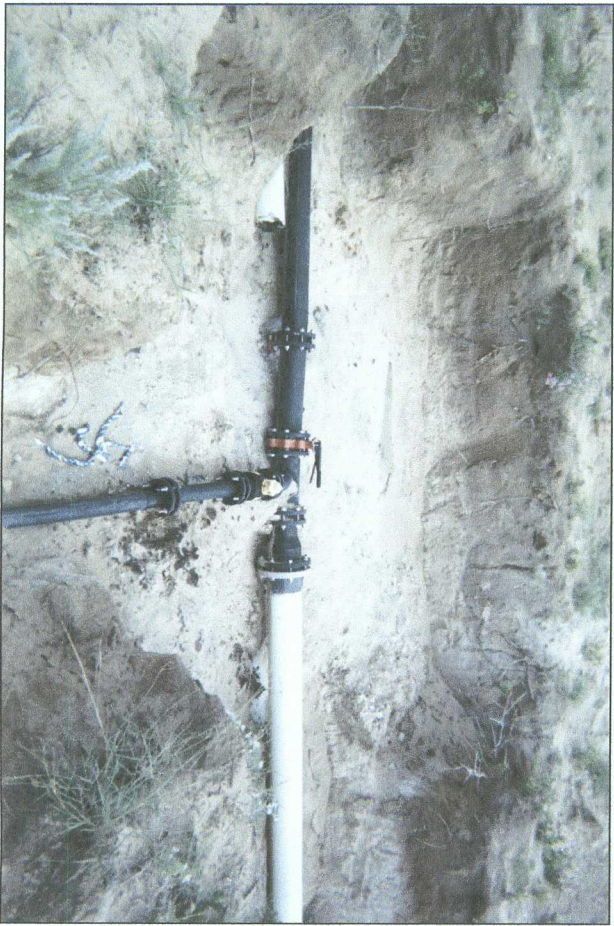
new junction G-20 50 ft east of former

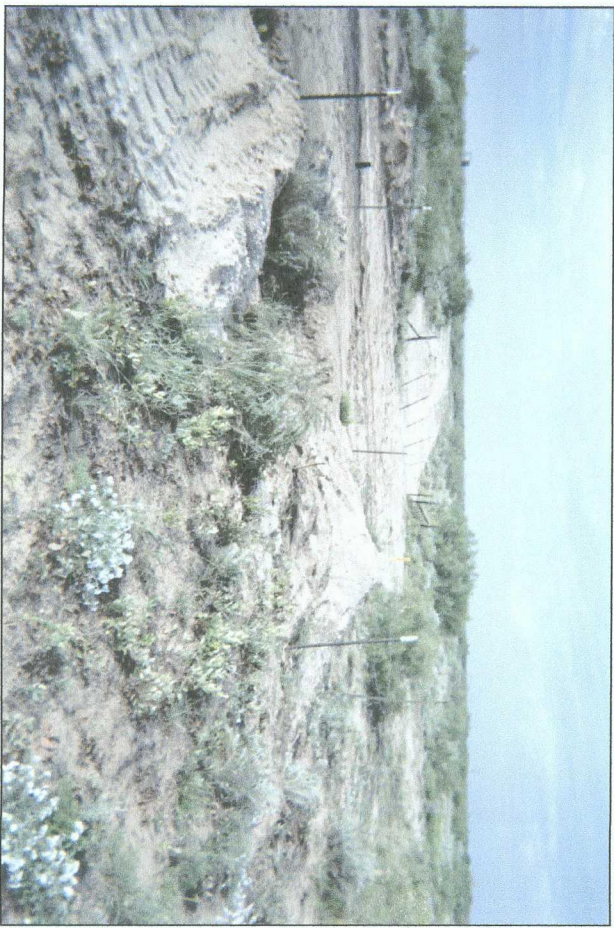
former junction site with box removed

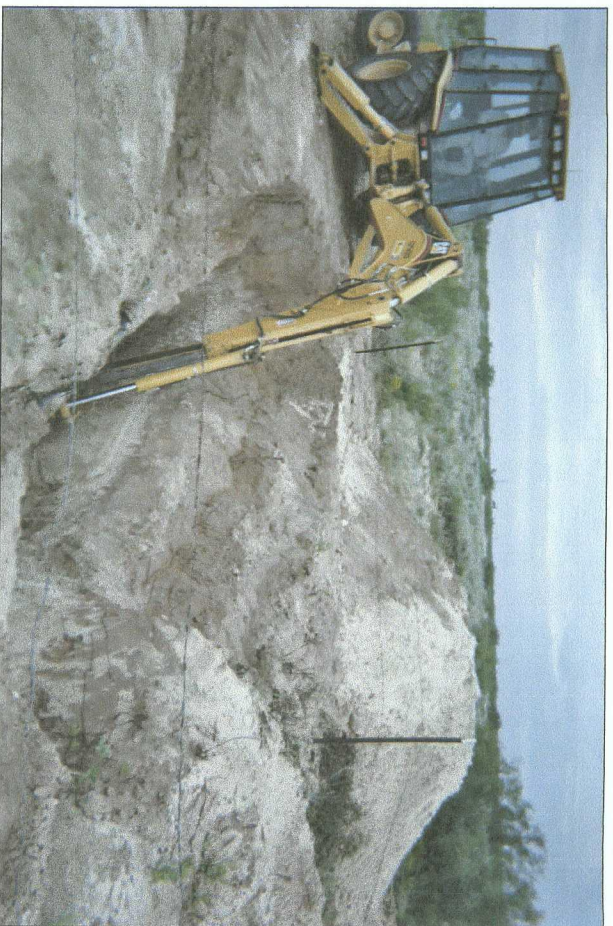
collecting samples from delineation trench

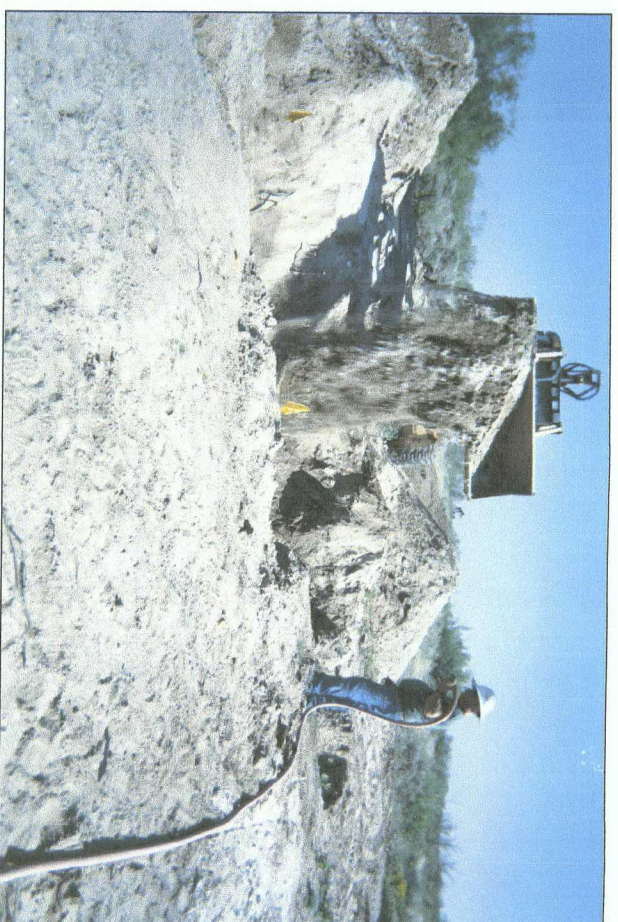
backfilling delineation trenches

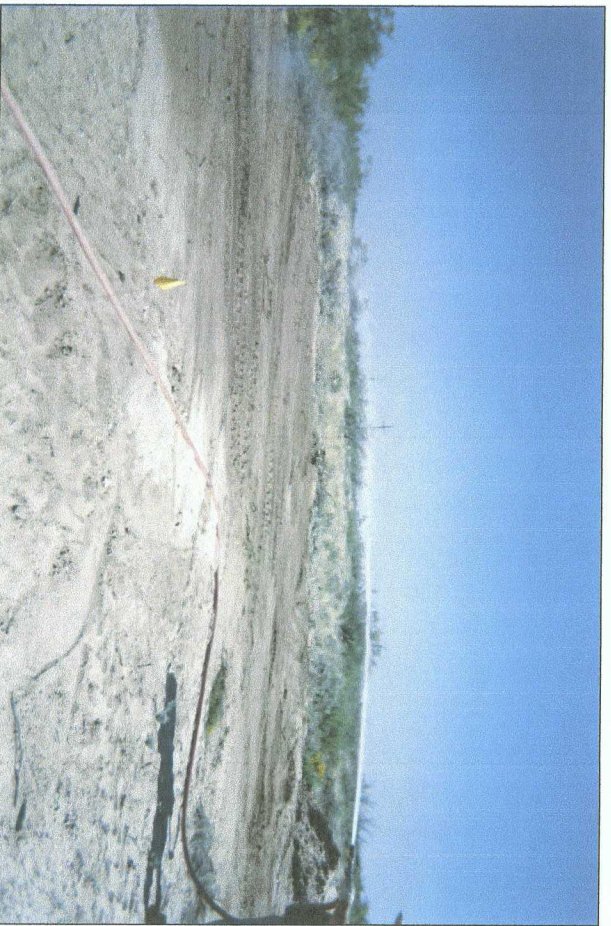
backfilled excavation at former junction site

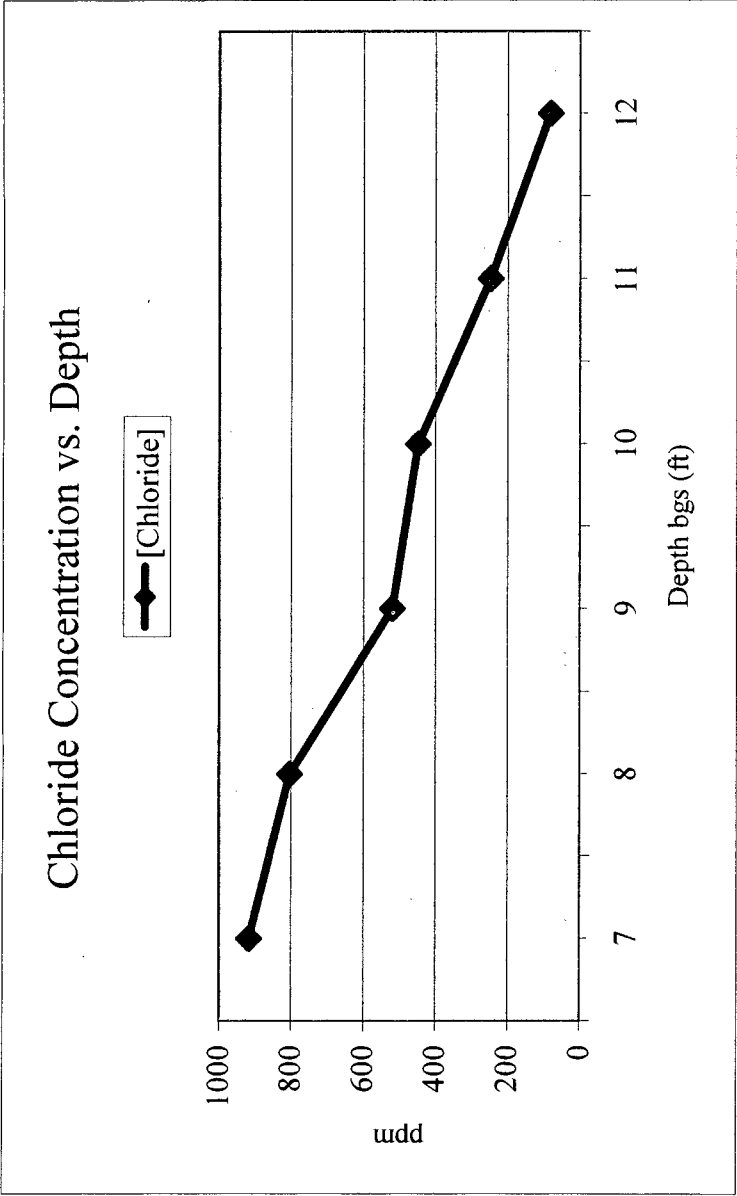
Vertical Delineation at Source

Depth bgs (ft)	[Cl ⁻] ppm
7	917
8	804
9	520
10	448
11	247
12	81

Groundwater = 30 ft
