EME Jct K-31 Vent

**RICE OPERATING COMPANY
JUNCTION BOX FINAL REPORT**

SWD SYSTEM	JUNCTION	UNIT	SECTION	TOWNSHIP	RANGE	COUNTY	NEW BOX DIMENSIONS - FEET		
							Length	Width	Depth
EME	K-31 vent	K	31	20S	37E	Lea	no box--junction eliminated

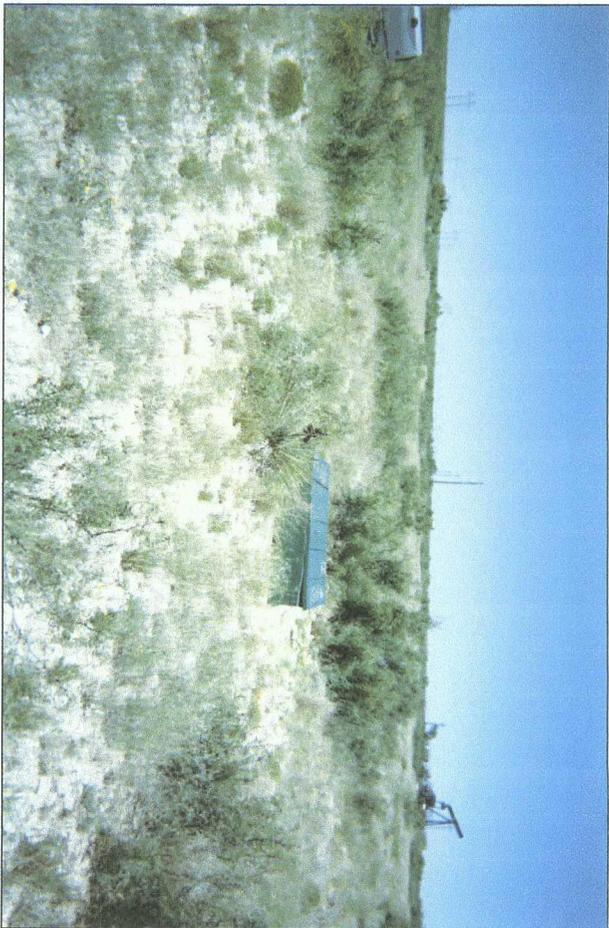
8/25/2004

undisturbed junction box

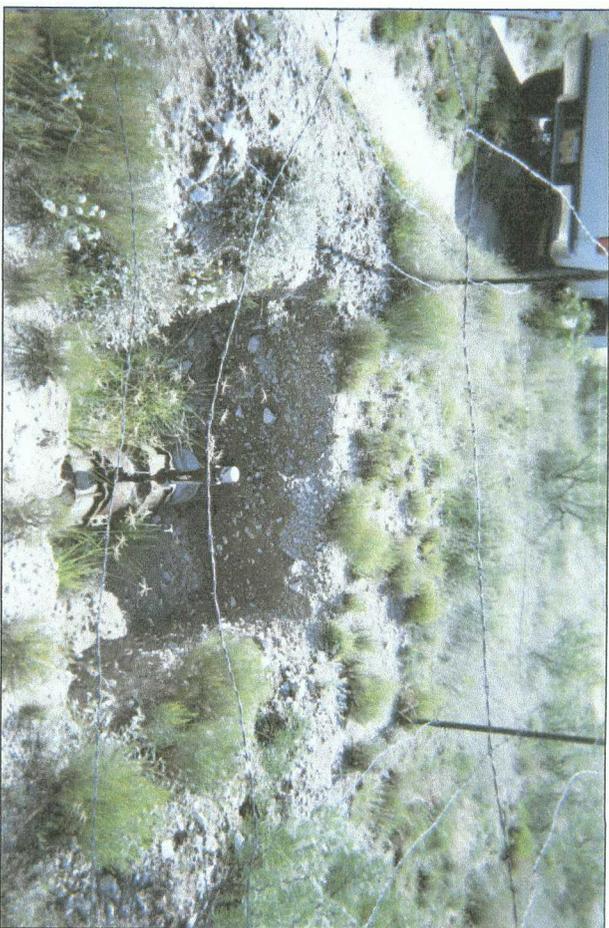
11/8/2004

box removed; NORM clear

This junction was eliminated with the pipeline replacement/upgrade program. After the box lumber was removed, the site was evaluated using a hand auger to collect soil samples. Field chloride tests revealed chloride concentrations at the site to be similar to background concentration. The soils at and surrounding the site did not exhibit any signs of hydrocarbon impact. Representative samples were collected for laboratory analysis and results confirmed chloride field tests. TPH concentrations were also low, meeting NMOCD guideline concentrations. The 6 x 6 x 4-ft-deep hole was backfilled with clean, imported fill dirt and contoured to the surrounding area. The disturbed surface was seeded with a blend of native vegetation and is expected to return to productive capacity at a normal rate.

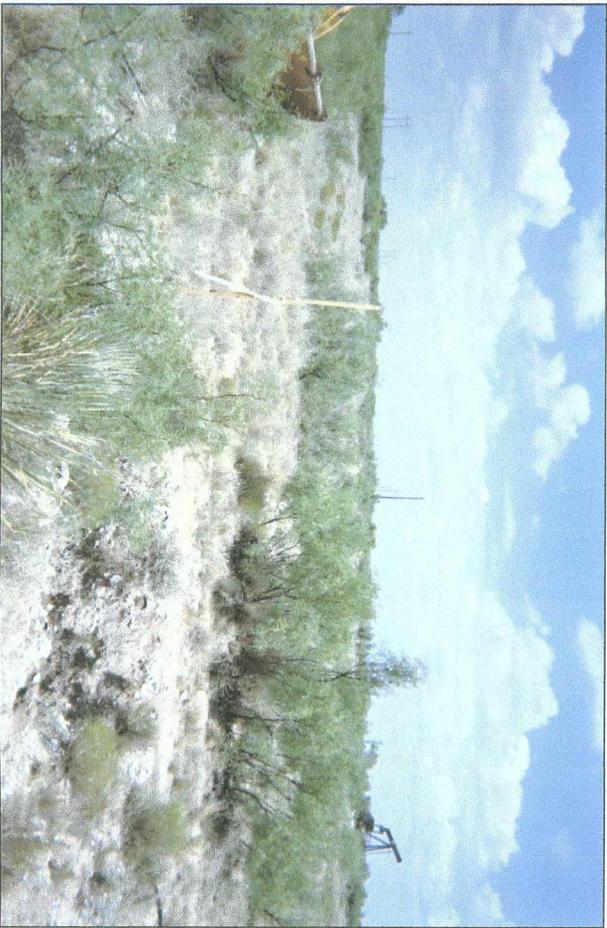
7/13/2007

former junction box site (flagged stake) prior to backfill

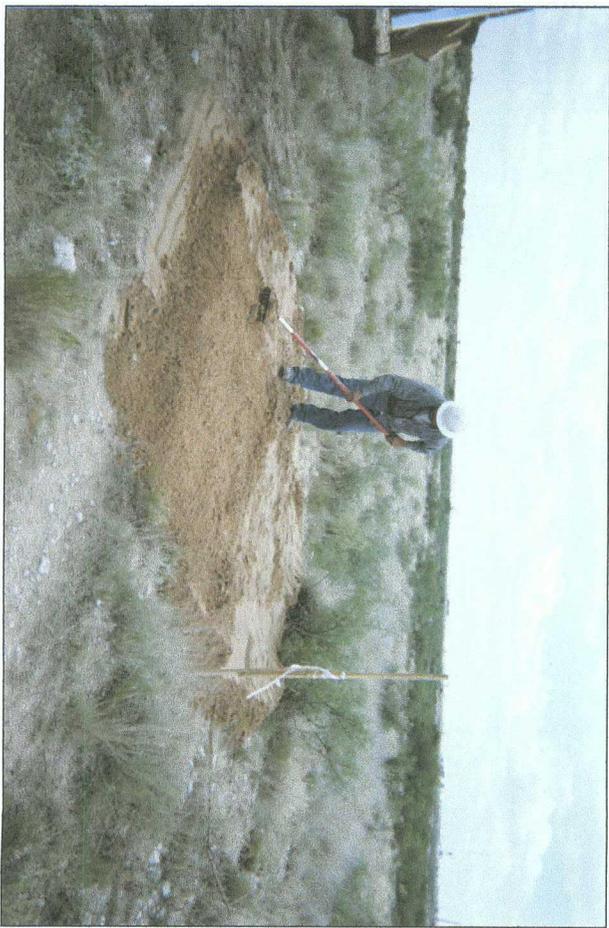
7/13/2007

seeding at site backfilled with clean, imported soil
