## **M-5 SWD Closure Report**

**Section 5 T20S R37E Unit M**  
**NMOCD # 1R 0424**

**R.T. Hicks Consultants, Ltd.**

**April 4, 2008**

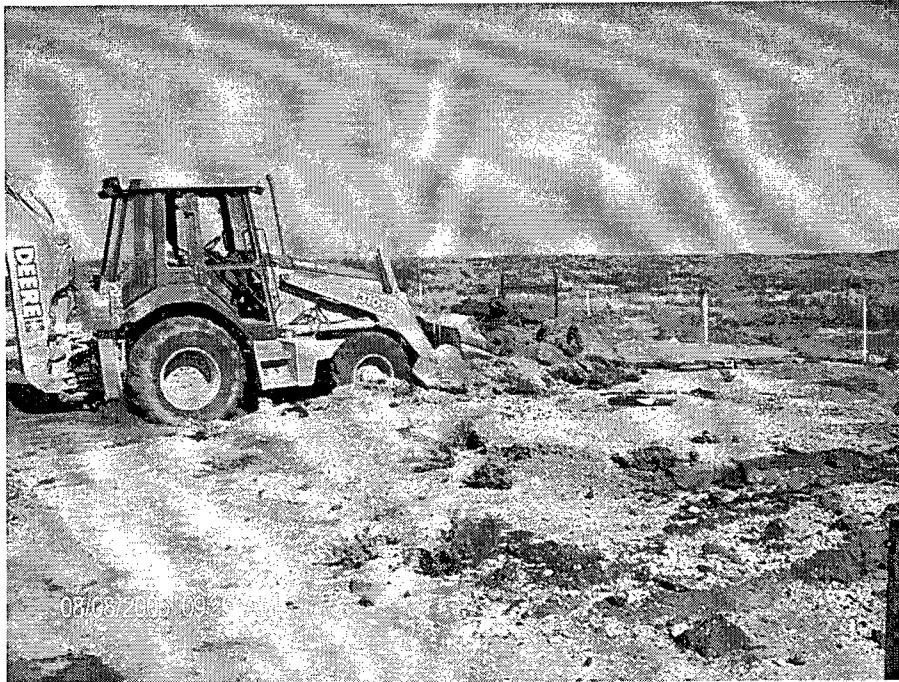
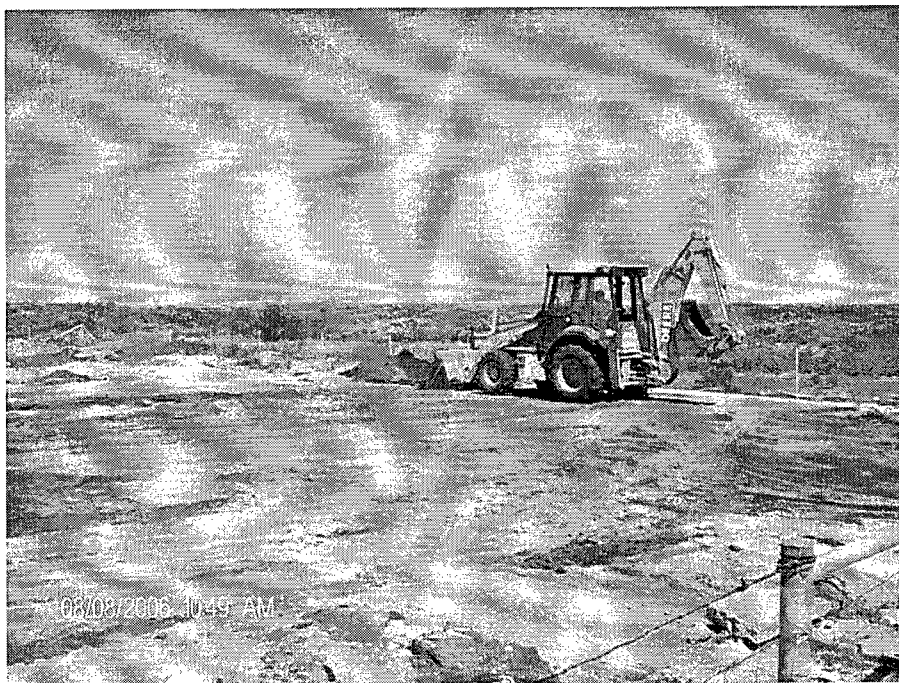
**Grading/Restoring Surface at EME M-5, August 2006**

The caliche pad was restored at the site as a safety precaution due to continued operation of the SWD well there.

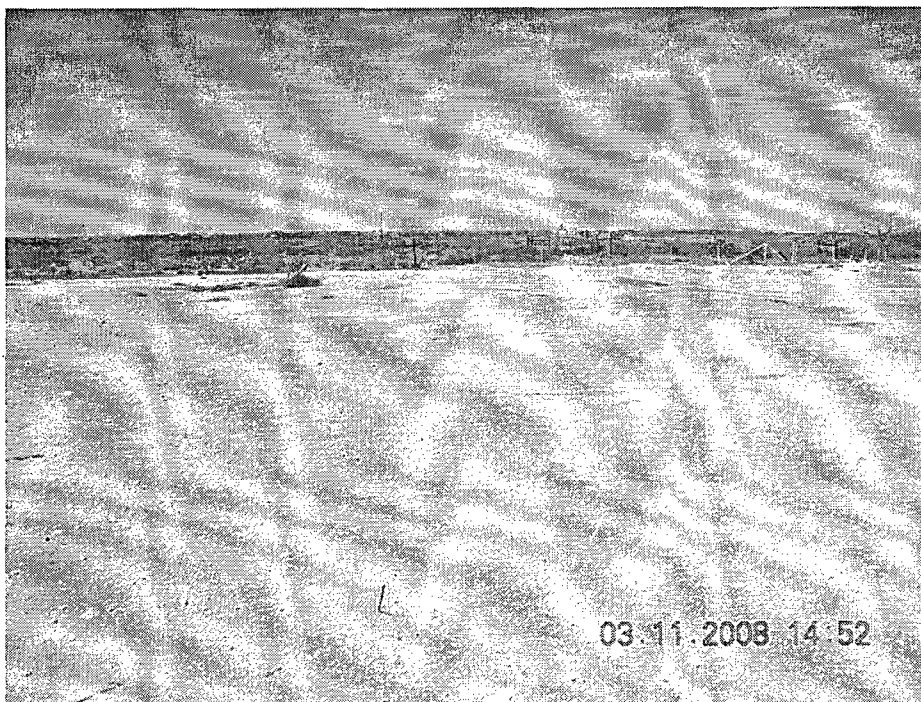
**The Restored Caliche Pad, March 2008**

As proposed in the September 2004 Corrective Action Plan (verbally approved by the NMOCD 3-30-06 and 10-11-06), Rice Operating Company (ROC) mobilized to conduct surface restoration at the site in August of 2006 due to safety concerns at this active SWD well. Work included burial of asphaltic hydrocarbon sands previously on the ground surface into the hole created by redwood tank removal and importation of clean fill to level the site. Surface asphaltic material was either buried in place or removed to the Sundance disposal facility. As noted, the subsurface asphaltic material does not contain regulated constituents in concentrations high enough to cause impairment of fresh water or threat to human health.

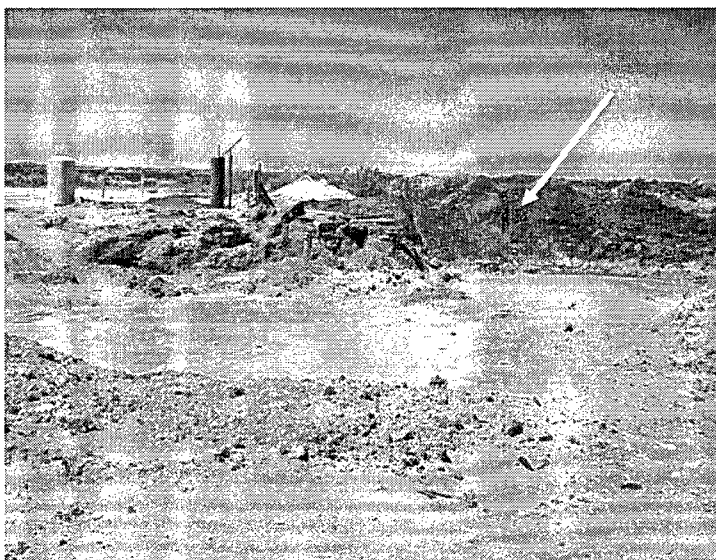
With respect to items 1 and 3, ROC routinely collects samples such as you requested prior to closure of sites. In the future, we will specifically reference this standard closure protocol our corrective action plan. We will notify the local NMOCD office 72 hours before ROC obtains the samples. Please examine Figure 1, which is a southwestern looking view of the depression caused by removal of the redwood tanks. We have attached the original file of this digital image to this submission to permit close examination. The green hardware (well control valve) and 165-gallon white tank are associated with the active salt water disposal well that will remain on-site. In the bottom of the depression are the two circular concrete bases of the former tanks. Cleaning and inspection of these concrete bases shows no discoloration of the concrete due to intrusion of produced water and hydrocarbons and no fractures or other conduits that would allow seepage to the subsurface through the concrete. The attached image labeled

"hole 1" provides a close-up of the concrete pad. We do not propose to compromise the integrity of these concrete pads to obtain samples directly below the tanks. These images suggest that seepage from the tanks occurred through the redwood or where the redwood met the concrete. We will sample in the areas of obvious seepage at or near the edges of the concrete slab.
