# STAGE 2 REPORTS

RE: **Request for Closure  
Amended Stage 2 Abatement Plan  
EME Jct N-5 Site (AP-66)  
T20S, R37E, Section 5, Unit Letter N  
Lea County, New Mexico**

### HISTORICAL AERIAL PHOTOGRAPHS

DIGITAL PHOTOGRAPHS

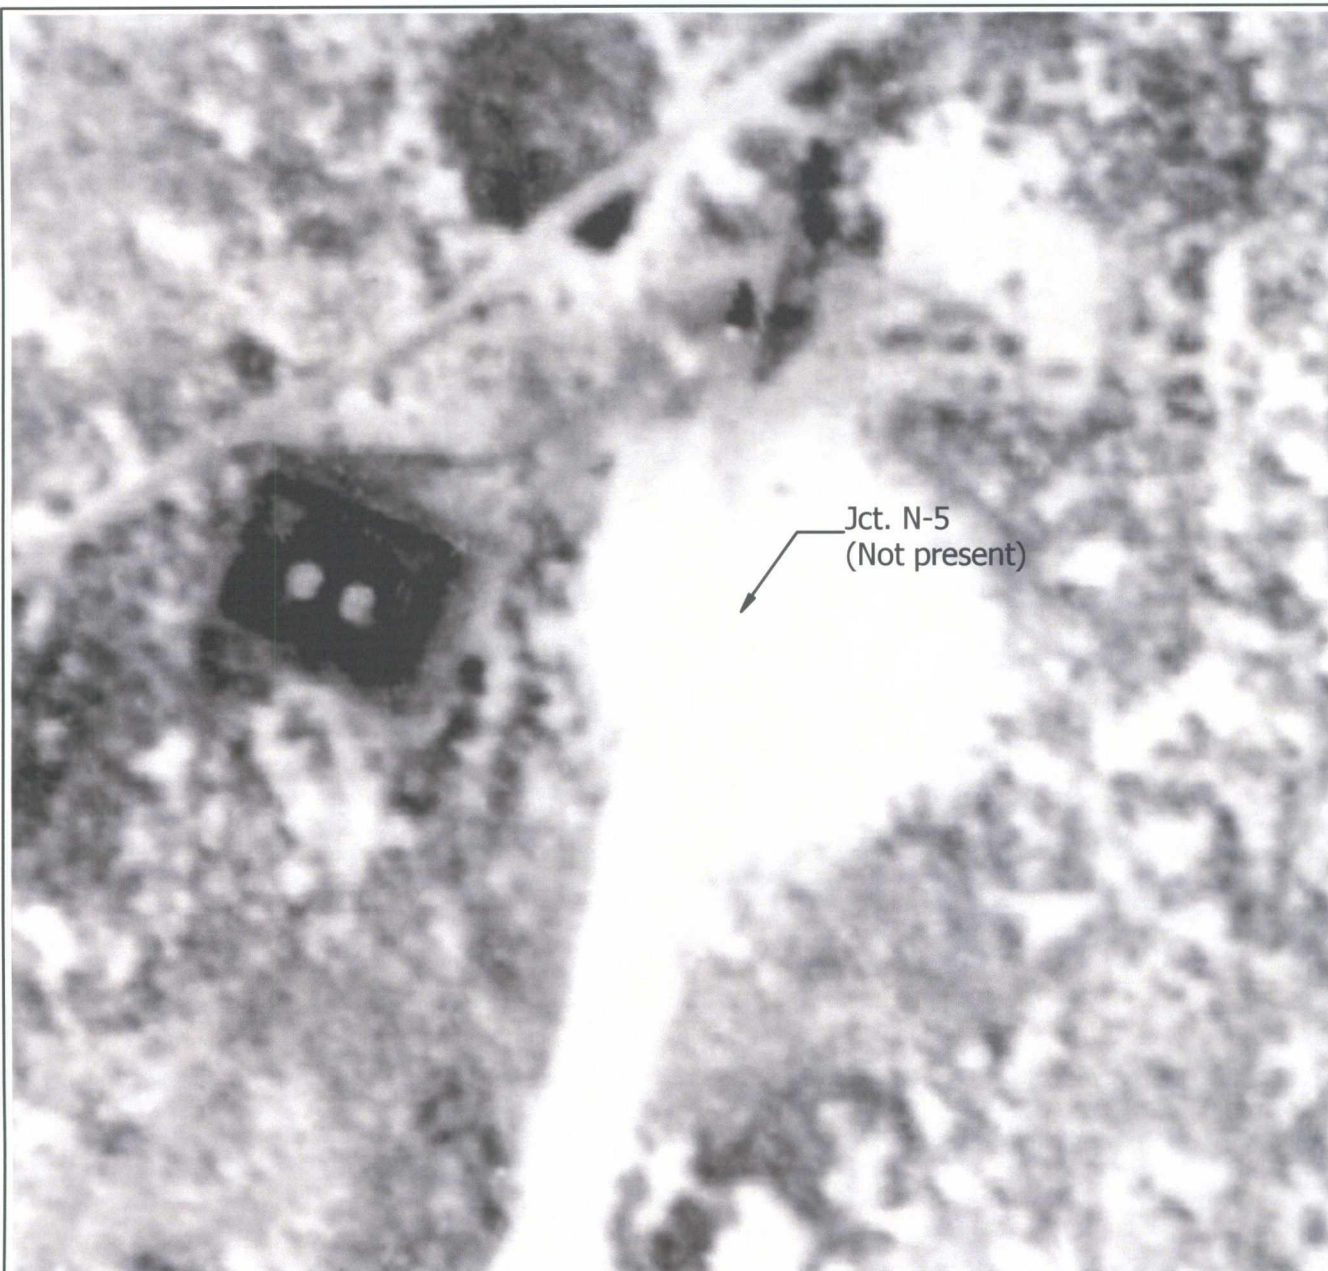
**1949**

Anderson Prichard Oil Company tank battery in place with at least two tanks and dark-stained soil. Large barren area at center is apparent and might be the location of where the original drilling pit for the H. M. Britt B #1 well was. The Britt B #1 was put into oil production by Anderson Prichard Oil Company in 1937 according to OCD well records. The well was approved for dual completion and commenced gas production in 1957 along with oil production.

Ownership of Britt B #1 changed from Anderson Prichard Oil Company to Union Texas Natural Gas Corp in 1961 and then to Union Texas Petroleum Corp in 1962. There are no OCD well records for Britt B #1 between 1962-1976.

- Anderson Prichard Oil Company tank battery in place with at least two tanks.
- Large barren area at center is apparent and might be the location of where the original drilling pit for the H. M. Britt B #1 well (API # 30-025-05923) was. The Britt B #1 was put into oil production by Anderson Prichard Oil Company in 1937 according to OCD well records. The well was approved for dual completion and commenced gas production in 1957 along with oil production.
- Ownership of Britt B #1 changed from Anderson Prichard Oil Company to Union Texas Natural Gas Corp in 1961 and then to Union Texas Petroleum Corp in 1962. There are no OCD well records for Britt B #1 between 1962-1976.

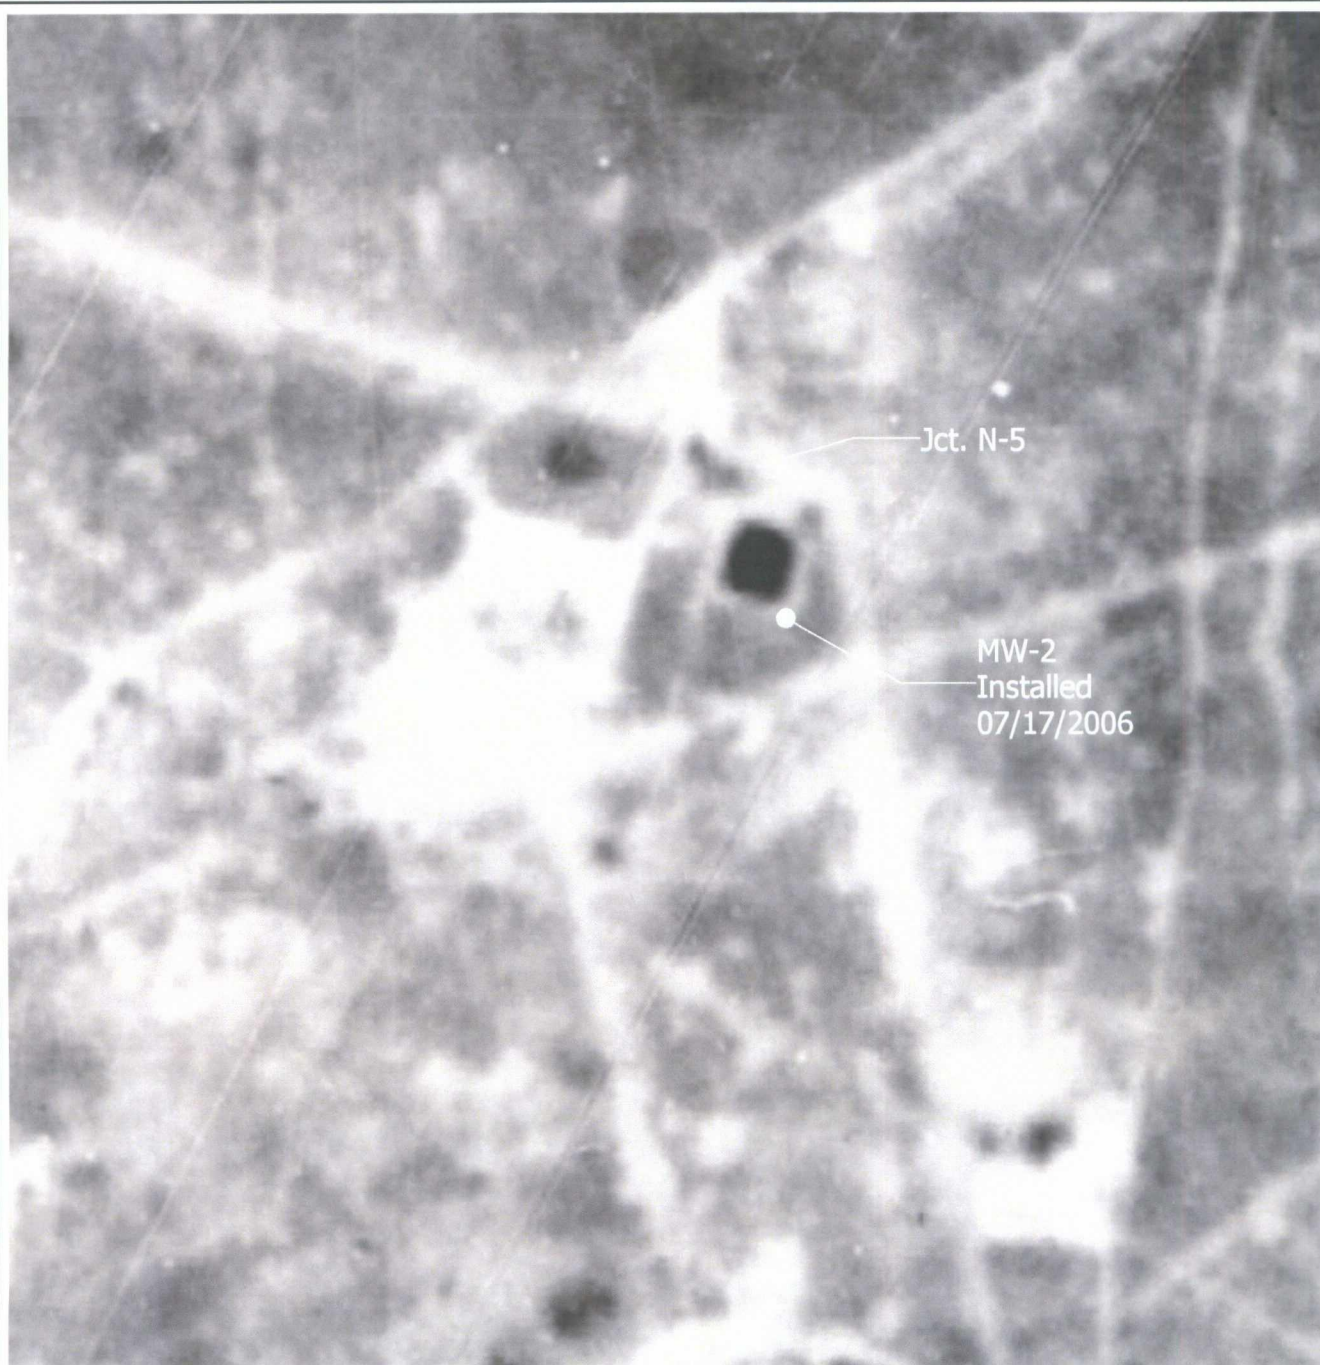
**1964**

Union Texas Petroleum Corp tank battery in place  
 Britt B #1 oil & gas well is present (no OCD well records between 1962-1976)  
 First evidence of a large pit located southeast of tank battery and the N-5 junction box  
 Northwest-Southeast trending ROC pipeline along north side of tank battery and pit  
 According to ROC records the N-5 junction box was constructed in 1959  
 Other non-ROC pipelines present (stressed vegetation)

- Union Texas Petroleum Corp tank battery in place
- Britt B #1 oil & gas well is present (no OCD well records between 1962-1976)
- First evidence of a large pit located southeast of tank battery and the N-5 junction box
- Northwest-Southeast trending ROC pipeline along north side of tank battery and pit
- According to ROC records the N-5 junction box was constructed in 1959
- Other non-ROC pipelines evident (stressed vegetation)

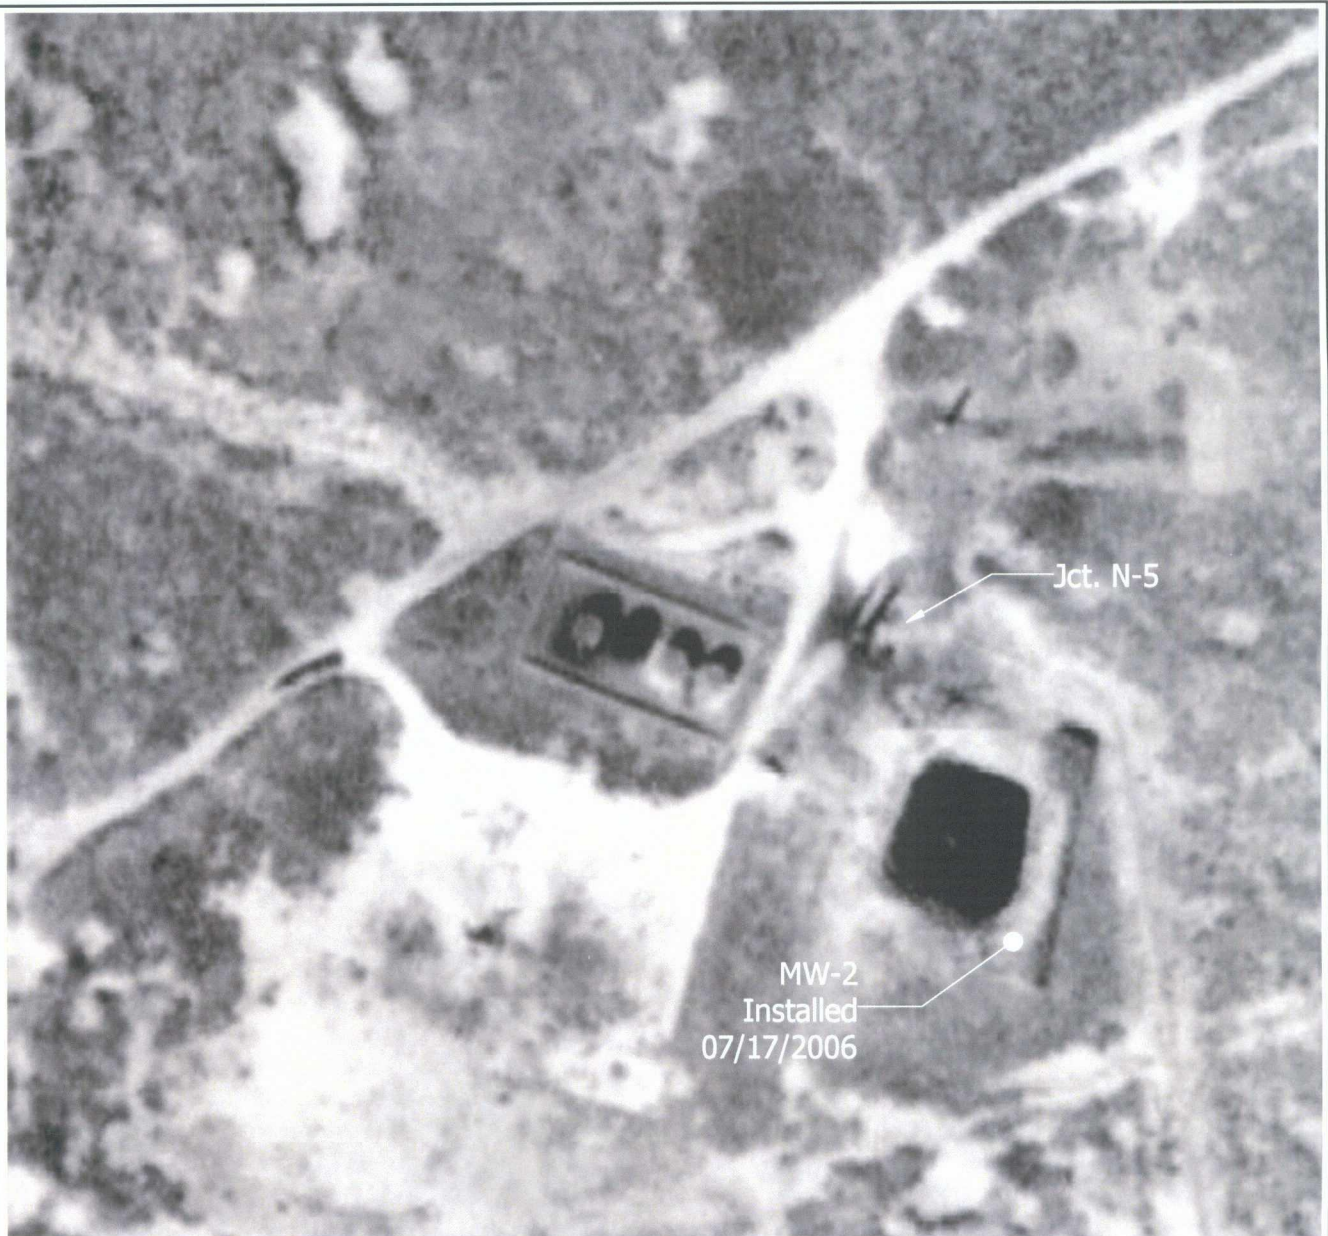
**1966**

Union Texas Petroleum Corp tank battery in place with four tanks.  
 Britt B #1 oil & gas well is present and active  
 Large pit located southeast of tank battery and the N-5 junction box is in use.  
 The future location of MW-2 is noted at the southeast edge of the pit.  
 Unknown structure between tank battery and large pit  
 Northwest-Southeast trending ROC pipeline along north side of tank battery and pit  
 Non-ROC pipelines present (stressed vegetation)

- Best quality photo and the same one used in the Lea County Soil Survey (Sheet No. 125)
- Union Texas Petroleum Corp tank battery in place with four tanks.
- Britt B #1 oil & gas well is present and active
- Large pit located southeast of tank battery and the N-5 junction box is in use. The future location of MW-2 is noted at the southeast edge of the pit.
- Unknown structure between tank battery and large pit
- Northwest-Southeast trending ROC pipeline along north side of tank battery and pit
- Other non-ROC pipelines evident (stressed vegetation)

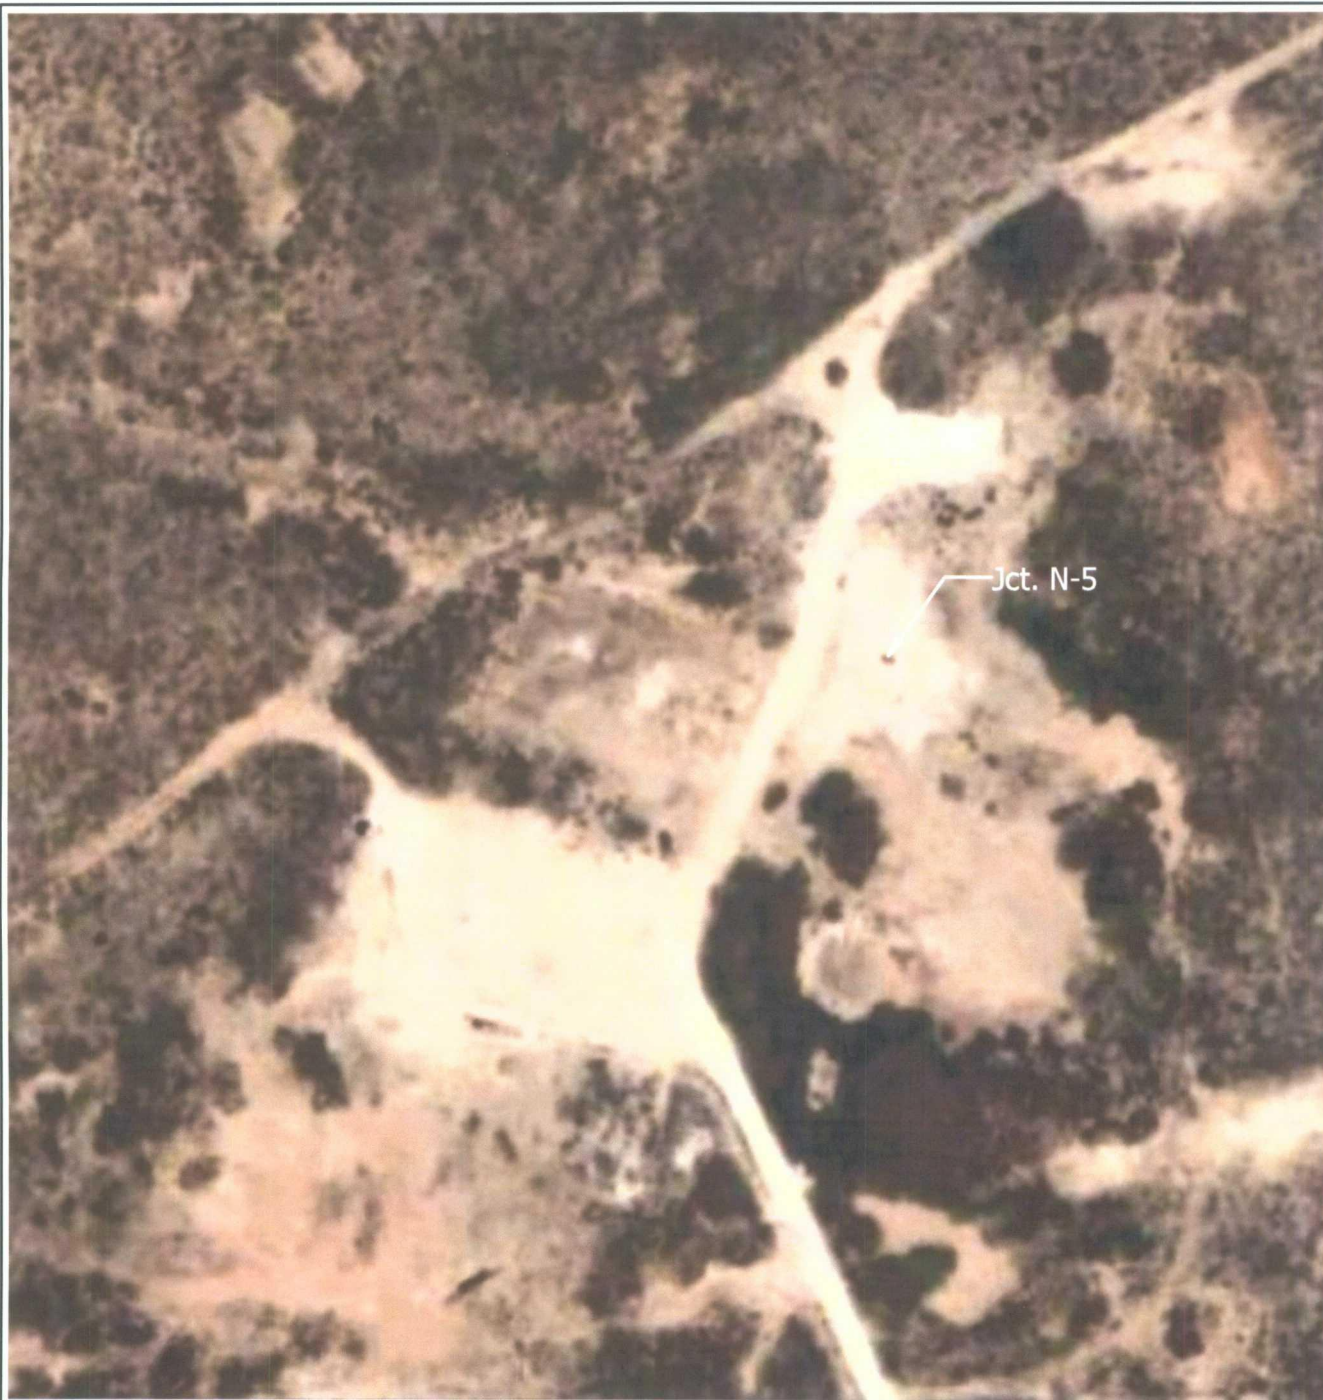
2003

Union Texas Petroleum Corp tank battery removed sometime after 1978 (stressed vegetation).

Outline of large pit still evident (stressed vegetation).

Outline of Britt B #1 well site still evident (stressed vegetation).

Non-ROC pipeline with circular outline of spill evident (stressed vegetation).

- Union Texas Petroleum Corp tank battery removed sometime after 1978.
- Outline of large pit still evident
- Outline of Britt B #1 well site still evident
- Non-ROC pipeline with circular outline of spill evident (stressed vegetation).

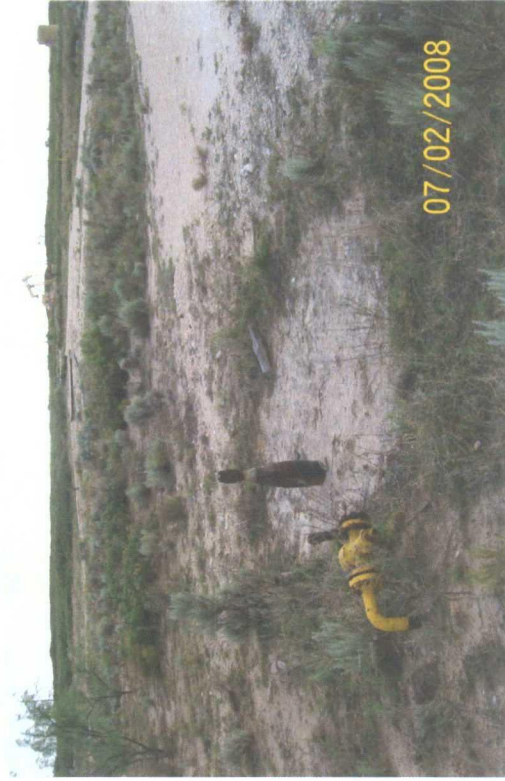
1: Southwest view showing plugged Britt B #1 well (foreground) ~140 ft NNW of the N-5 junction box (background, top-center).

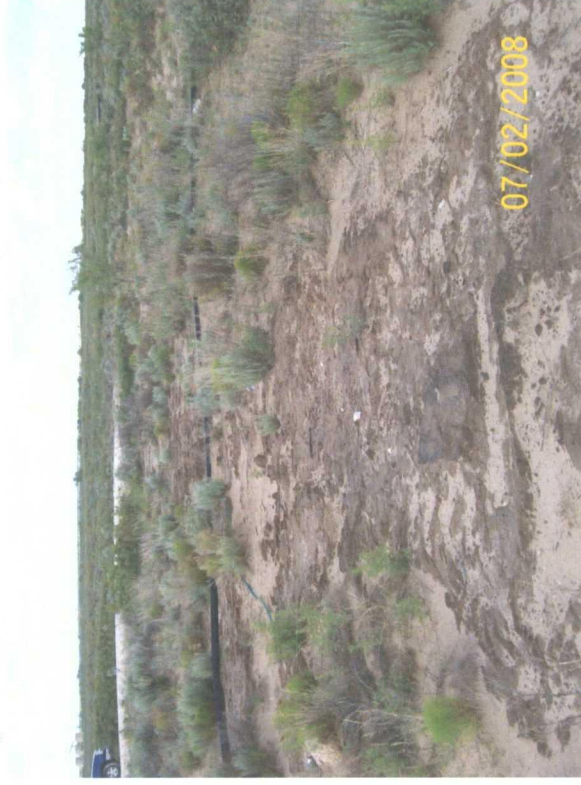
2: View facing north in direction of Britt B #1 well (top-center) showing encrusted crude oil-impacted surface soil.

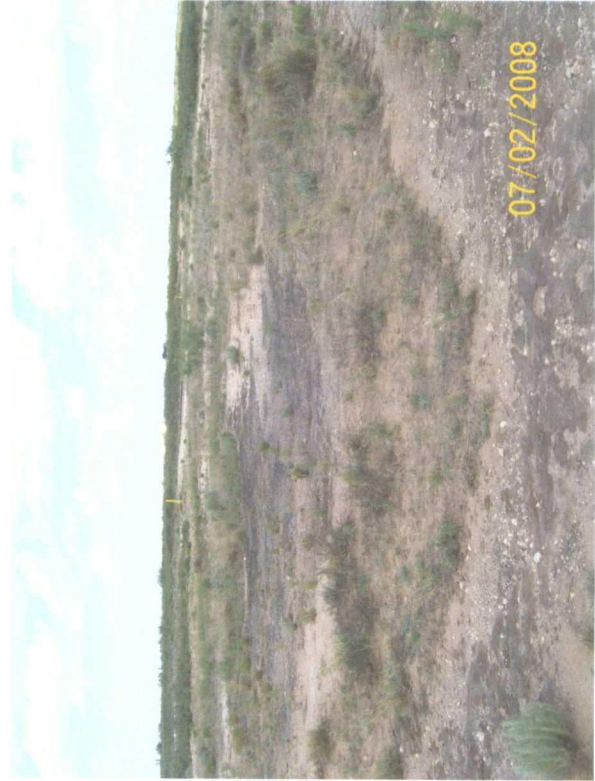
3: View facing northeast showing old crude-impacted surface soil at former tank battery (~120 ft west of N-5 junction box).

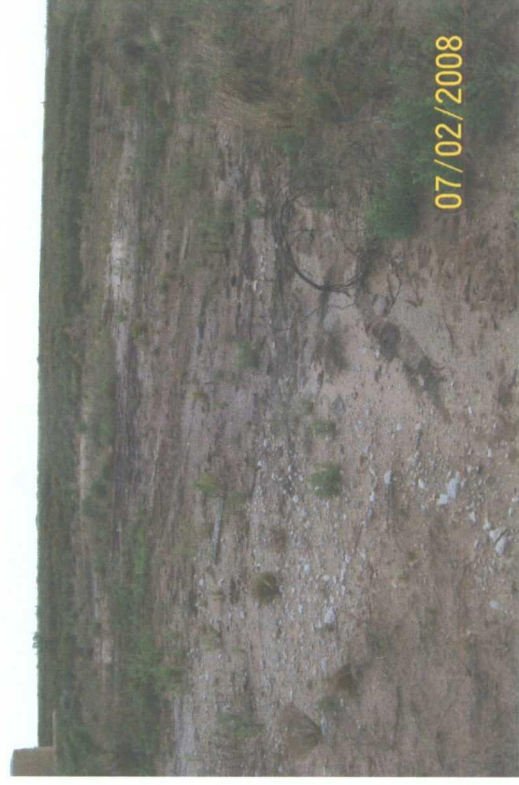
4: View facing southwest showing old crude-impacted surface soil at former tank battery (~60 ft west of N-5 junction box).

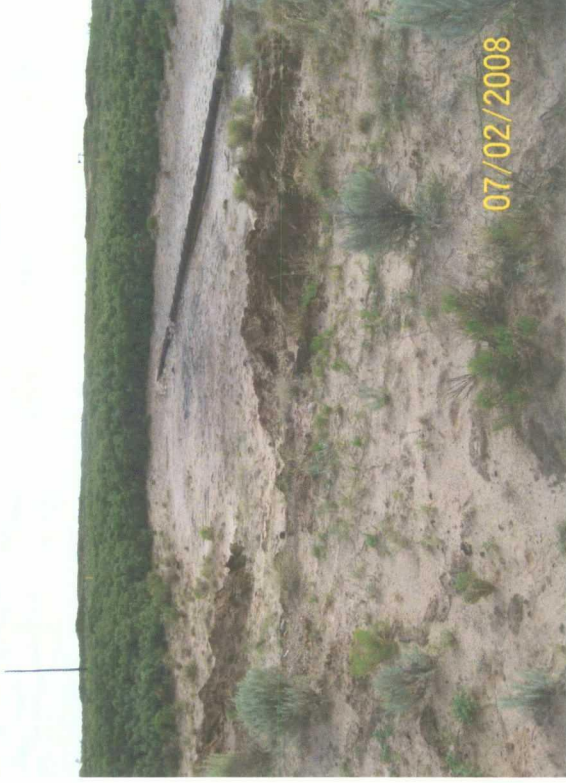
6: View facing southwest showing evidence of historic spill and stressed vegetation caused by non-ROC pipeline (~ 150 ft south of N-5 junction box).

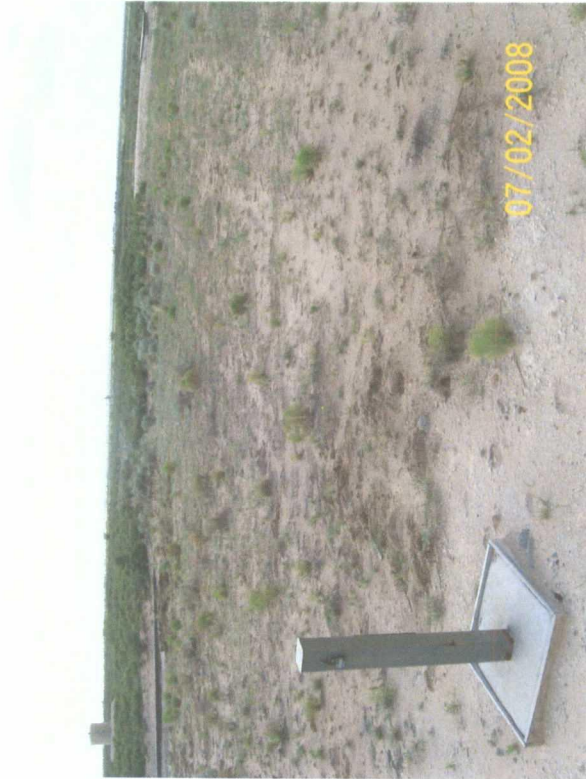
7: View facing northwest showing former pit area (ranging from 50 ft to 200 ft SSE of junction box) with MW-2 in foreground.

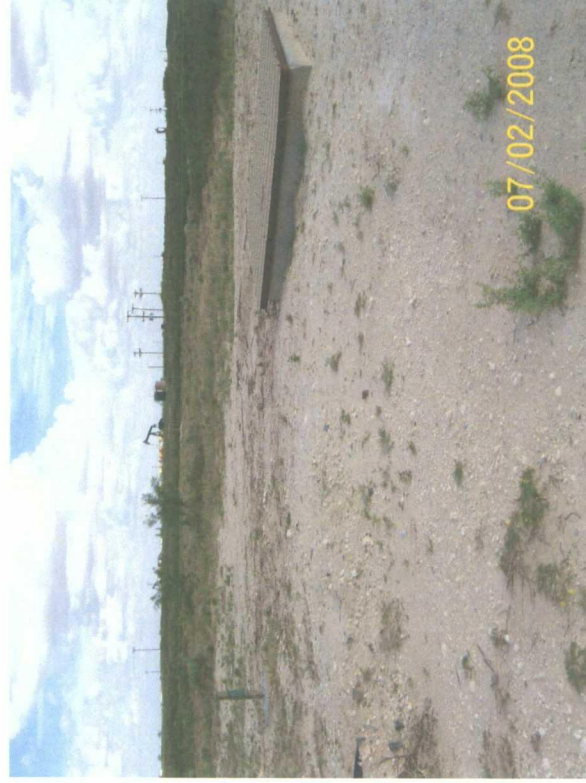
8: View facing southeast showing new N-5 junction box and former pit area in background (top-center) with MW-1 (left-center).
