### Release Notification and Corrective Action

Name of Company <b>Rice Operating</b>	Contact <b>Tony Grieco</b>
Address <b>122 W. Taylor St., Hobbs, NM 88240</b>	Telephone No. <b>(575) 393-9174</b>
Facility Name <b>Conoco Philips NewMex 'D' EOL</b>	Facility Type <b>Salt Water Gathering System</b>

# BD NEW MEXICO 'D' EOL LEAK

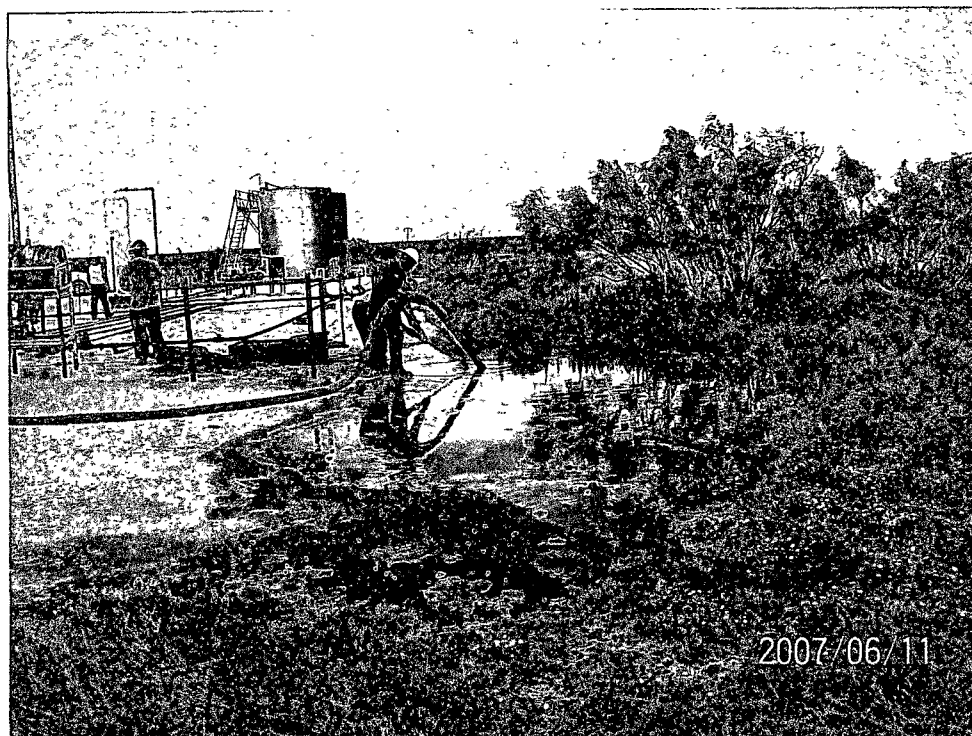
LOOKING EAST FROM WEST END OF LEAK

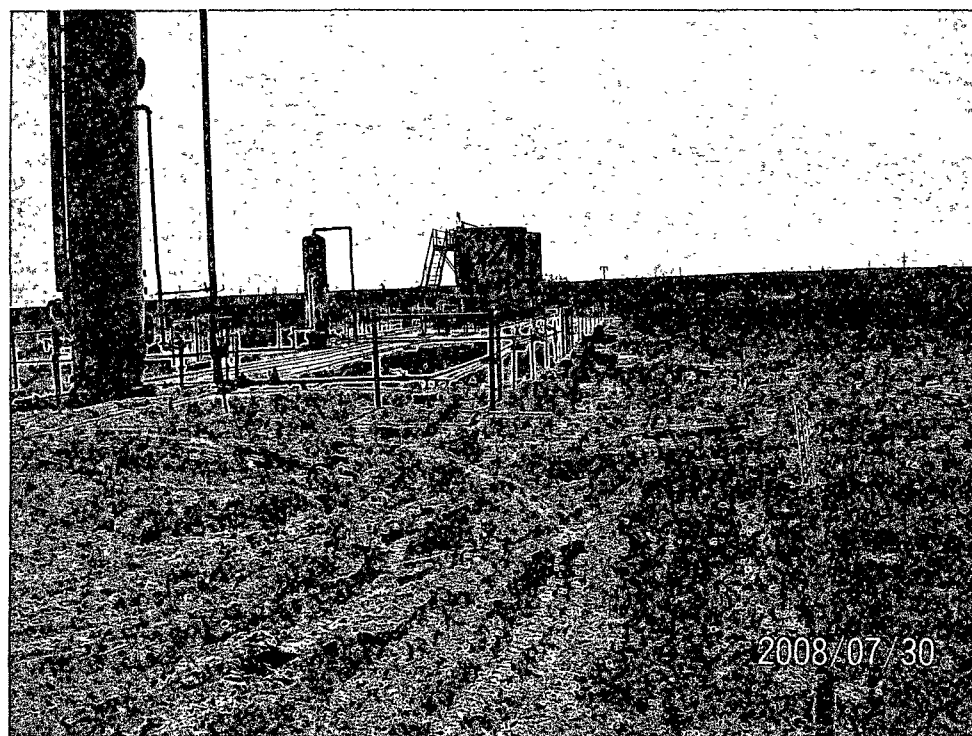
SAME VIEW AFTER REMEDIATION. NOTE NON-ROC PIPELINE MARKER,  
THIS PIPELINE WAS PLACED SOMETIME AFTER REMEDIATION WAS  
COMPLETED.

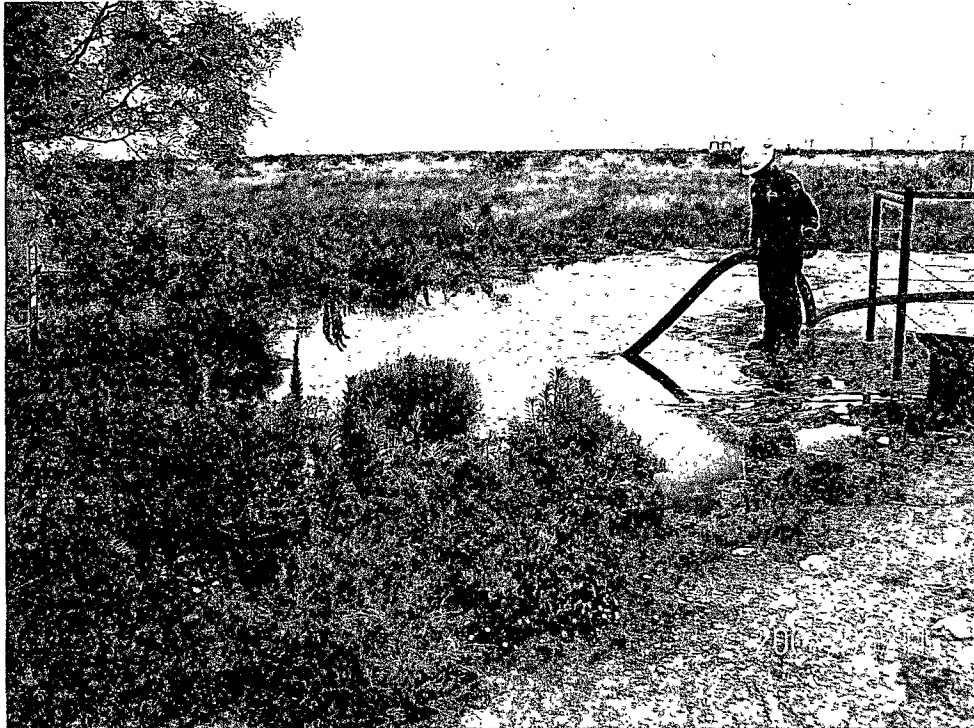
LOOKING WEST FROM EAST END OF LEAK. THE SOURCE IS THE BOX  
VISIBLE TO THE RIGHT.

A steel pipe rotted out and broke. Flow was shut off to break. Line will be capped as a permanent repair.

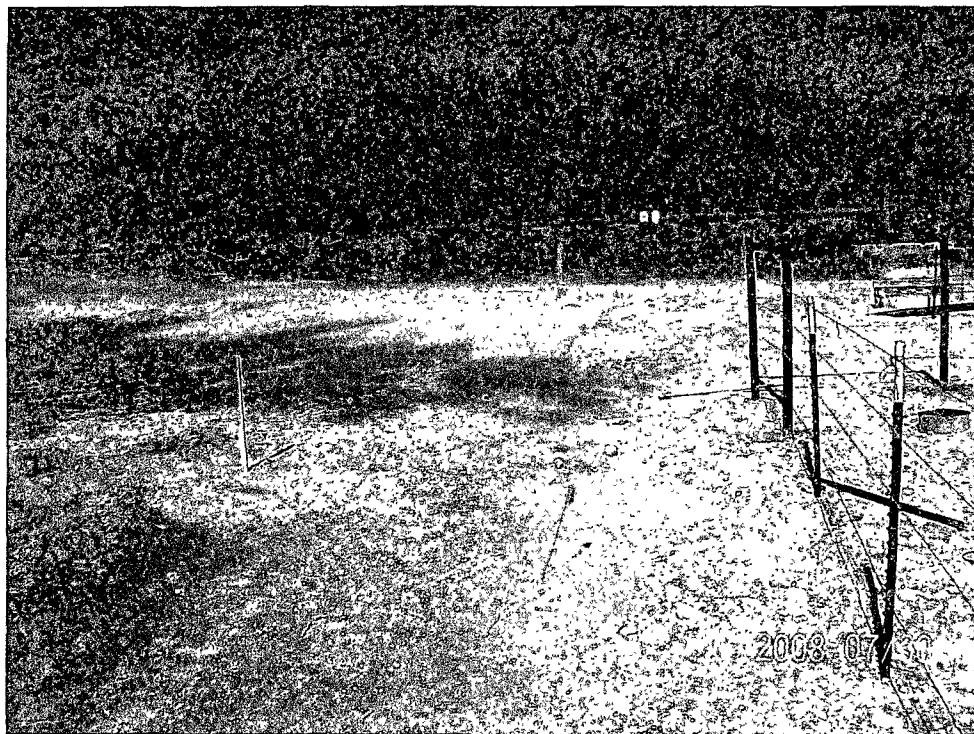
SAME VIEW, AFTER REMEDIATION. THE NEW NON-ROC P/L ROW GOES OFF  
TO THE WEST.
