**Release Notification and Corrective Action**

## TETRA TECH, INC.

RE: James A State #3 Findings Report  
Eddy County, New Mexico  
Unit K, Sec. 2, T22S, R30E  
API No. 30-015-25758  
Request for Closure

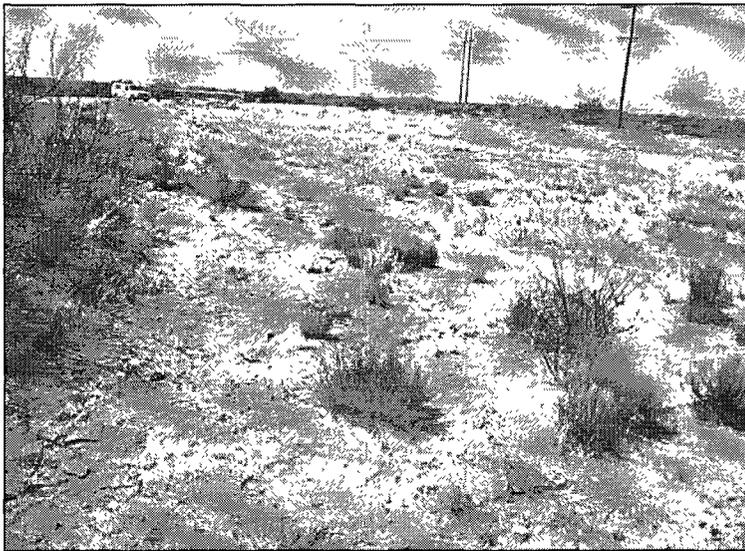
Before Remediation

View: Southwest

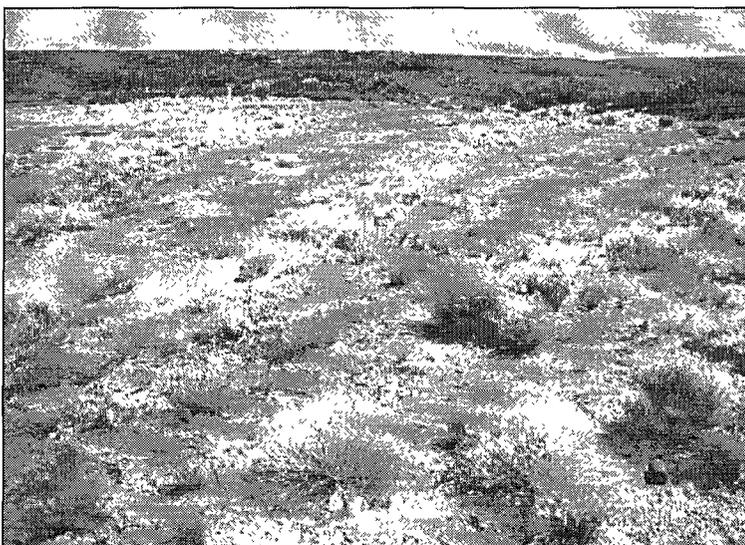
Before Remediation

View: Northeast

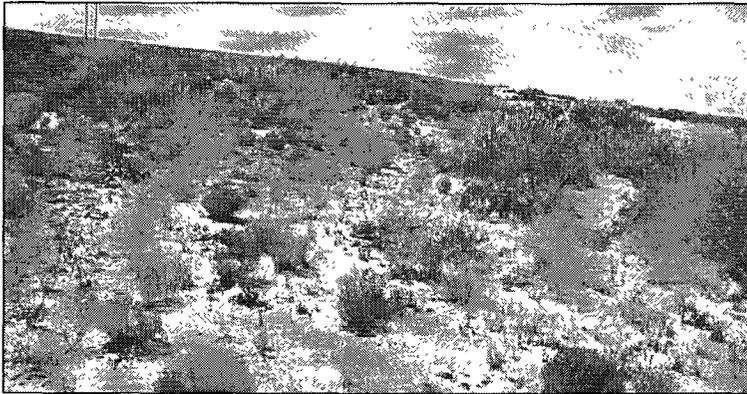
**Before Remediation**

**View: South**

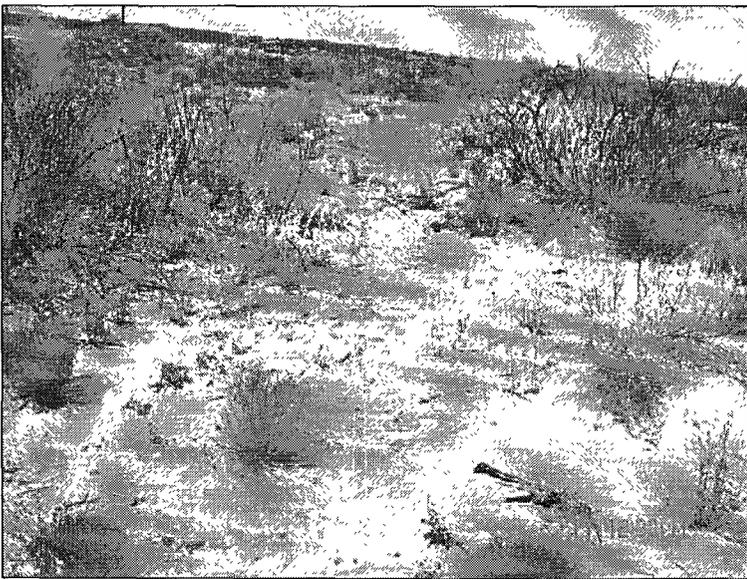
**Before Remediation**

**View: Southwest**

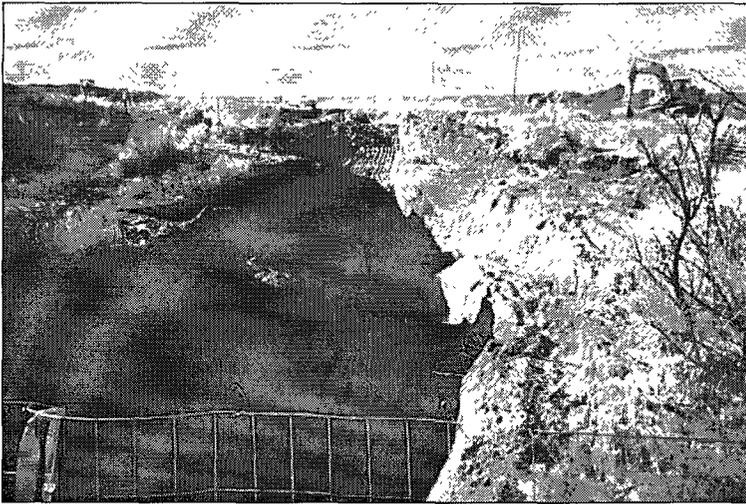
**During Remediation**  
Excavation

**View:** Southwest

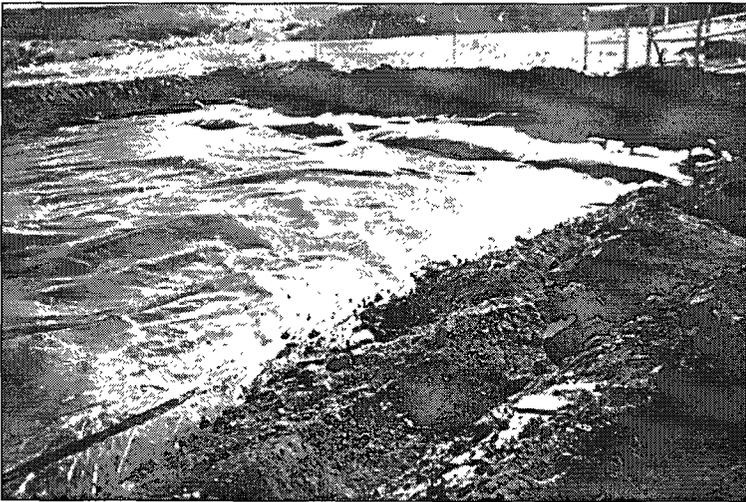
**During Remediation**  
Geomembrane

**View:** Southeast

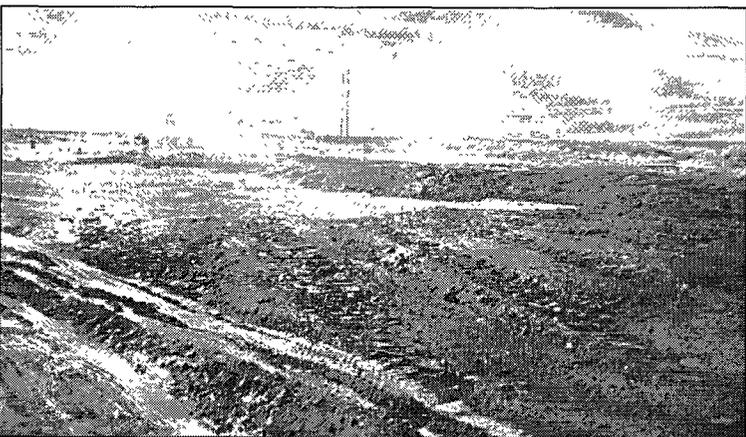
**During Remediation**  
Backfill

**View:** Southwest

4. Clean backfill was placed into the undisturbed area excavation with depths ranging up to approximately 9-feet. Photographs were taken to document the excavation at the Site (Photo Log).

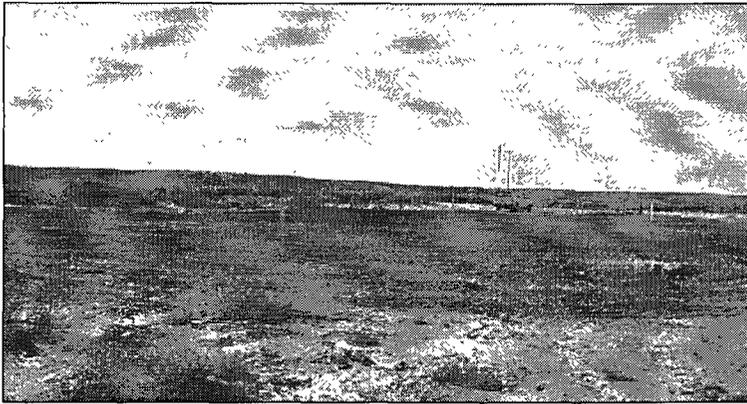
After Remediation  
Perimeter Signs

View: Southeast
