1R - 952

November 21, 2008

Re: 1RP-952 - Notification of Groundwater Impairment - North 10" Pipeline Release
Targa Midstream Services, L.P., Unit B (NW/4, NE/4), Section 22, Township ~~22~~ South,
Range 37 East, Lea County, New Mexico ²¹

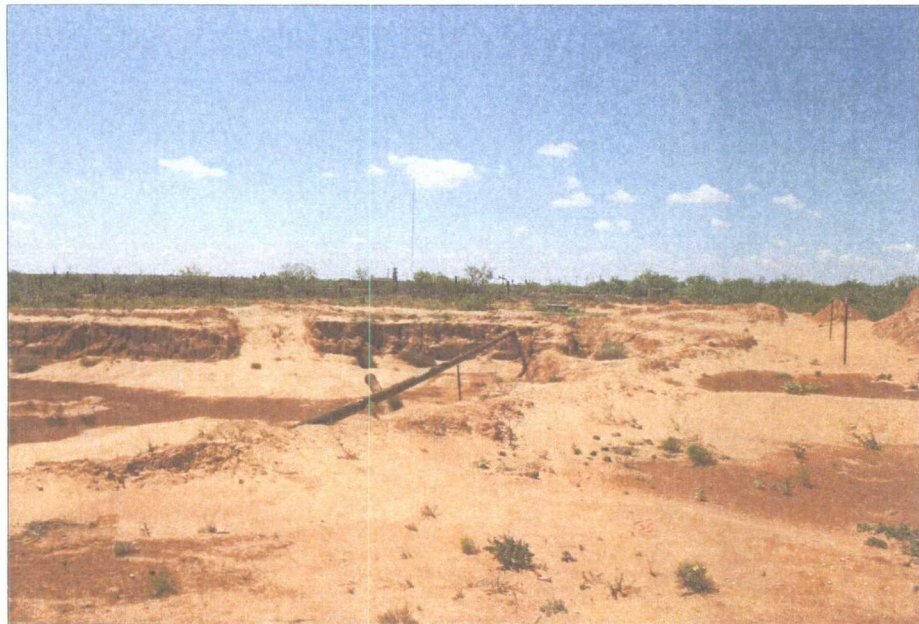
Leak Location
Looking West

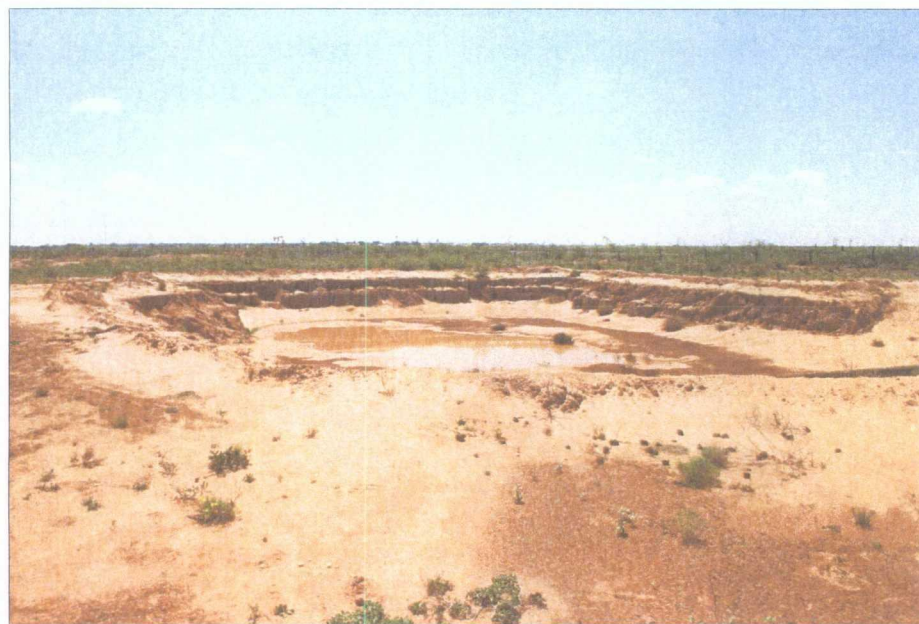
Leak Location
Looking Southwest

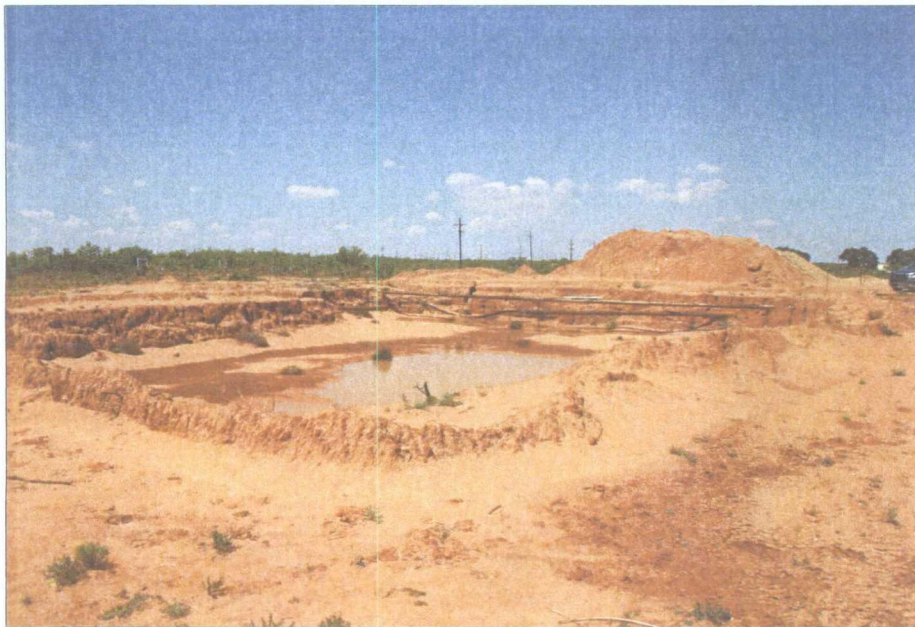
Leak Location
Looking Northwest

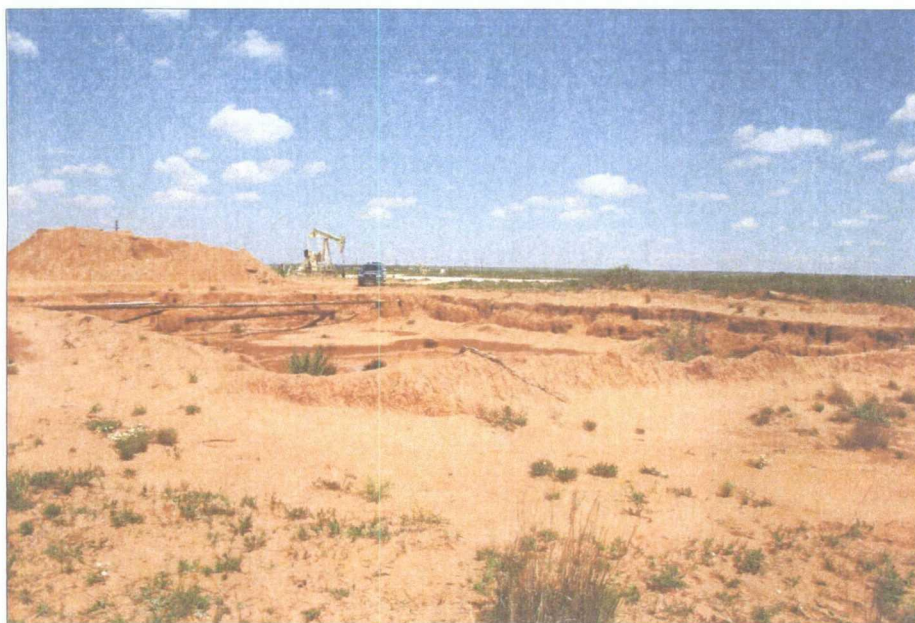
Leak Location
Looking Northeast
