Release Notification and Corrective Action

Closure Report

Todd Lower San Andres #8 Flowline Leak Roosevelt County, NM

1RP-09-4-2152

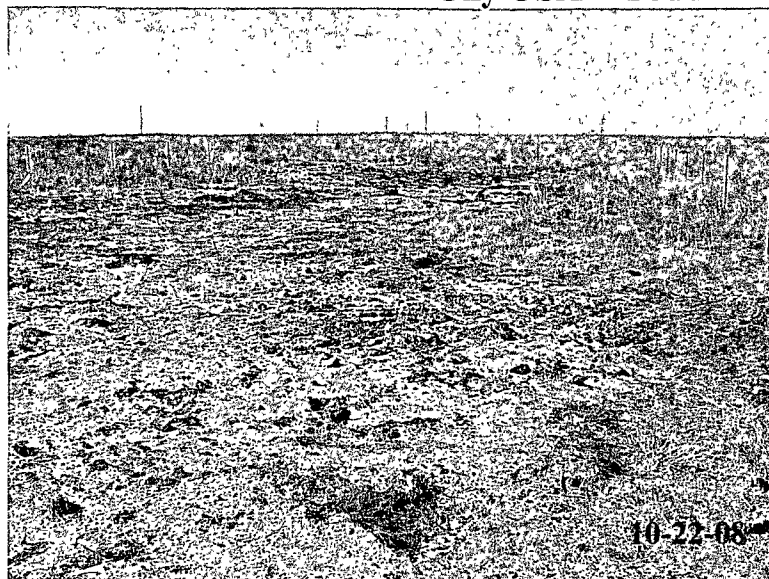
Spill before remediation of impacted soil.

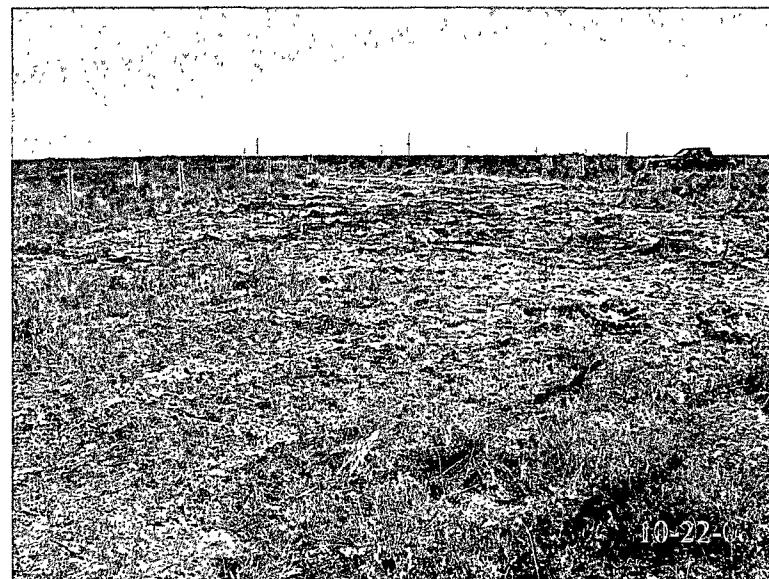
Spill before remediation of impacted soil.

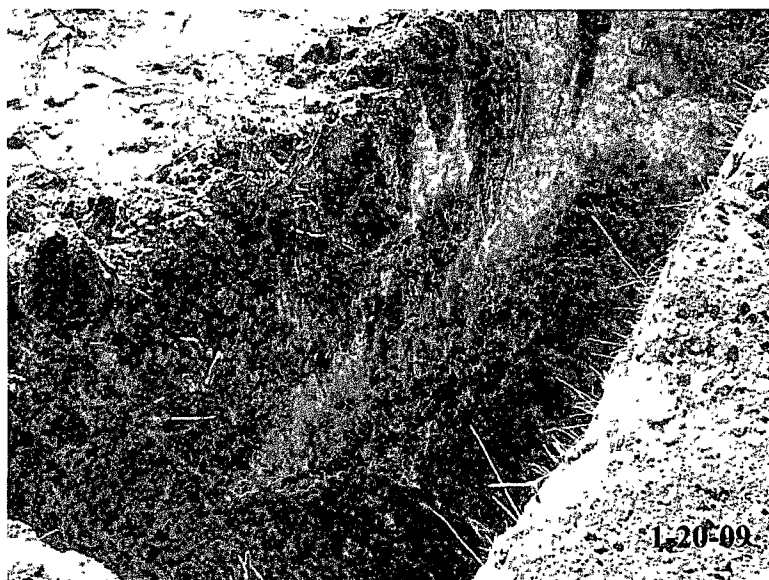
Delineation trench of impacted soil.

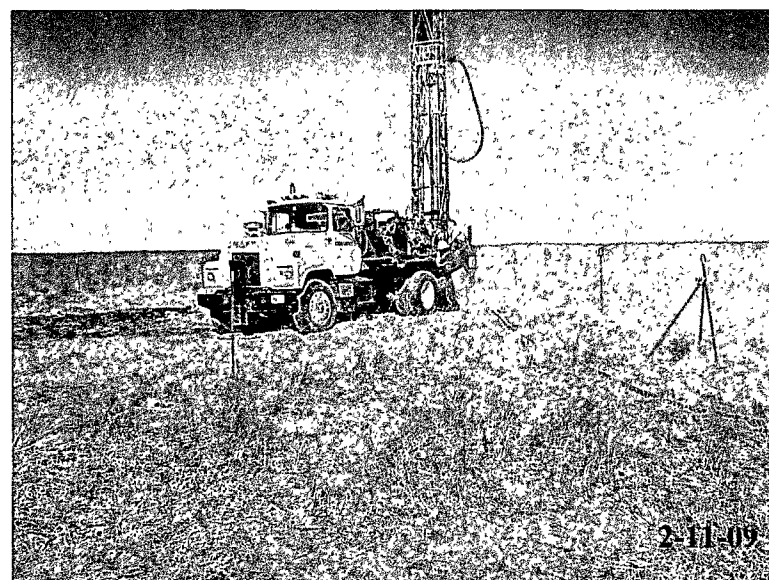
Vertical delineation of impacted soil using air rotary rig.

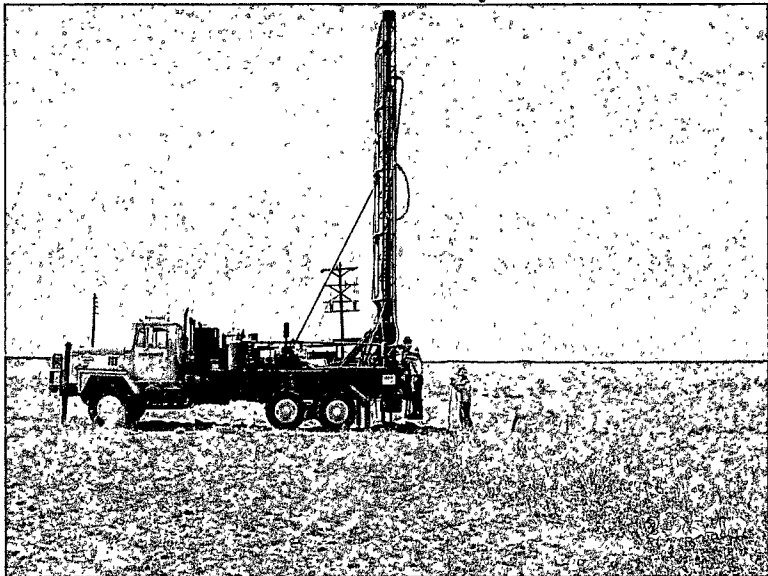
Setting monitor well to determine groundwater depth.

A monitor well was set at the site to prove groundwater conditions. During the drilling of the borehole no signs of a water bearing zone were present. The borehole was left open for 72 hrs and an interface probe was used to show groundwater at 126' bgs. Seven days after the borehole was drilled a monitor well was set. The initial borehole was drilled to 150' bgs, after 7 days the borehole collapsed and Total Depth was 114' bgs. After setting the monitor well a groundwater reading was taken a 112' bgs. During the development, the well dried up. A water reading was taken every 15 minutes until an estimated yield was determined. The estimated yield was determined to be 0.4 Gallons per Day. The groundwater was sampled for TDS and returned a result of 516 mg/L. NMAC 19.15.1.19, Section B, Subsection 2 states **"Ground-water pollution at any place of withdrawal for present or reasonably foreseeable future use, where the TDS concentration is 10,000 mg/L or less, shall be abated"**. With only 0.4 GPD recharge rate, Oxy USA feels that the yield from that water zone is to low for any foreseeable future use and proposes the following remediation plan.

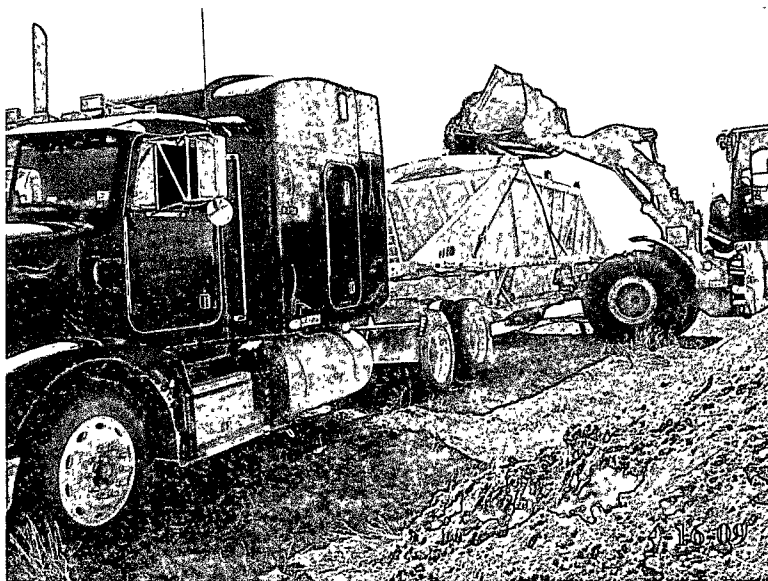
Loading impacted soil to be hauled to disposal.

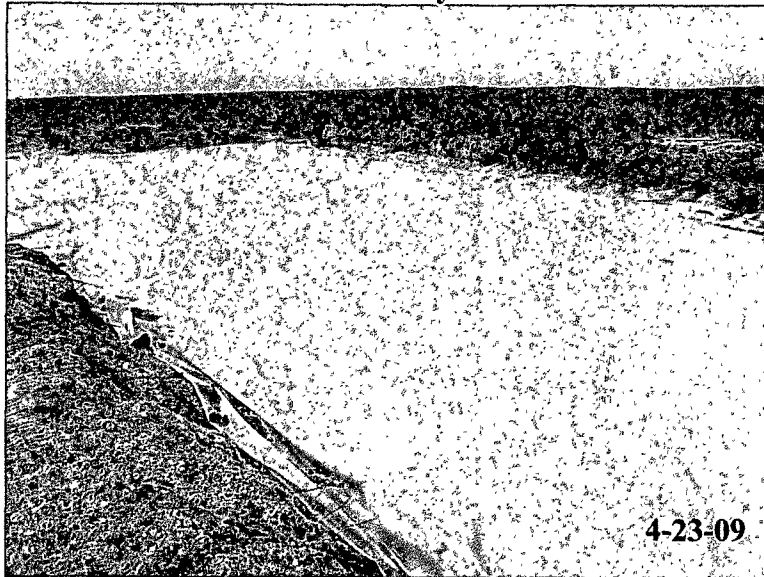
Installation of 20 mil poly liner.

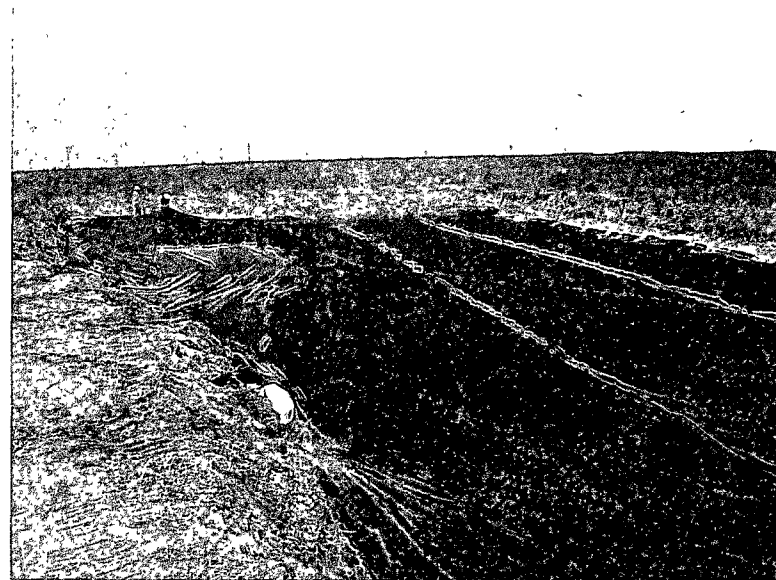
Installation of 2nd Geotextile liner above the poly liner.
