GW - 161

RE: Rosa East Compressor Station  
GW-161 Renewal -Item 16- OCD Inspections  
Operated by Williams Production Co, LLC

NMOCD  
Renewal Permit GW-161: Rosa East CS  
Followup to Item #16  
Williams Production Co, LLC

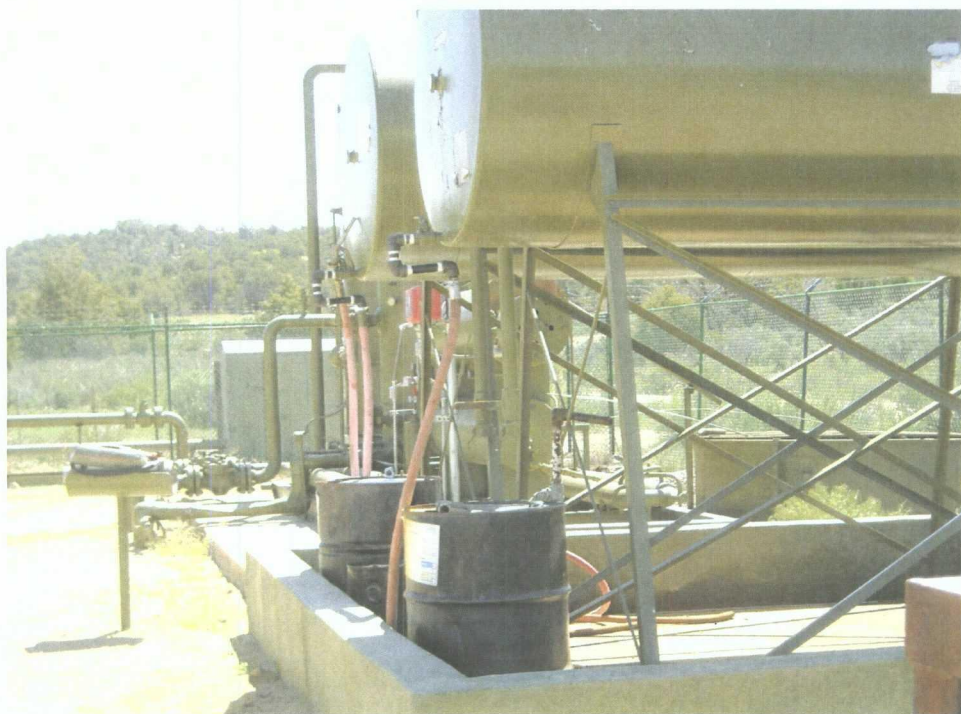
Product Storage Tanks – Drain Valves  
(Taken May 6, 2009)

2. **Photo 2:** Saddle tanks located on the southeast plot of the facility. Williams Production shall reconfigure these tanks so that the exit port (see red arrow) are kept within the secondary containment area. If either of the valves failed there would be a direct discharge onto the ground.

- #2 The saddle tanks used to store make up glycol and lube oil were reset in the concrete containment and the drain valves repiped to ensure the valves and hoses are located inside the containment in case of an accidental release. See the attached photo.
- #3 Monthly inspection are done on the BGT by our field technicians assigned to the site. These are reported using an EXCEL® spreadsheet. The following in the inspection record for May. No leak was detected.

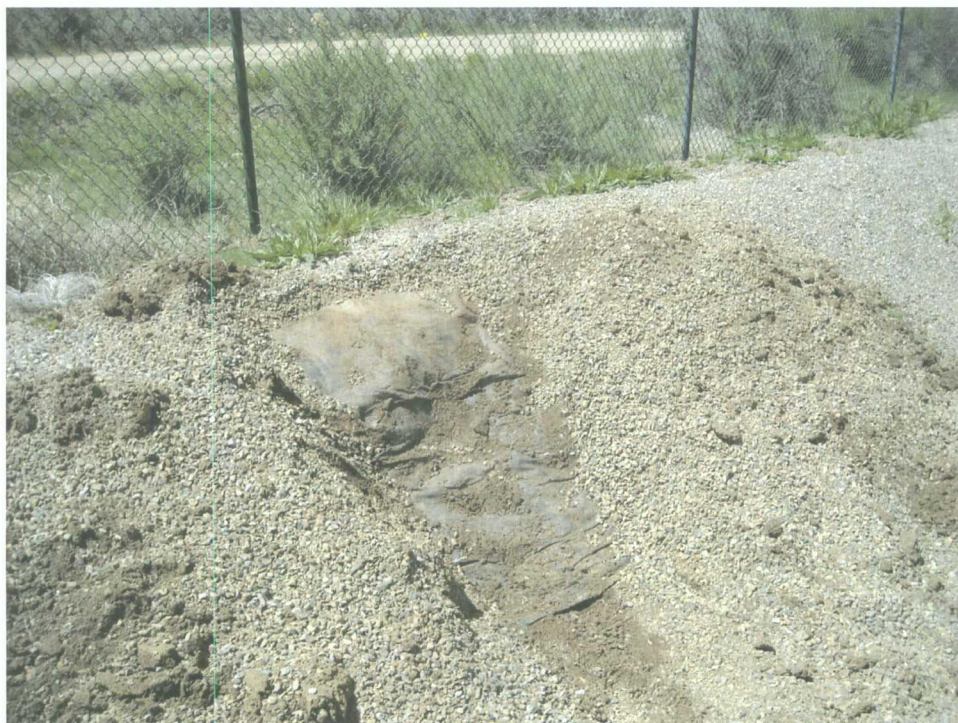
Liner under West Berm (Secondary Containment for Produced Water Tanks)  
(Taken May 6, 2009)

4. **Photo 4 - 6:** All above ground tanks shall be lined in accordance with Condition 9 of the permit conditions.
5. **Photo 6:** This tank was not identified with any labels and was not identified on the facility schematic. Williams shall mark this tank accordingly and update their facility schematic. Once done, the schematic shall be sent to the OCD to update their file for this facility.

- #4 Williams did not construct the original facility and no as-built drawings or information was provided when it was purchased. Additional investigation was done in early May to determine if a liner was installed under the above-ground tanks used to store produced water. The attached photo notes that after digging and removing the soil and gravel cover in the containment, a plastic (geosynthetic) liner was found. Williams does not at this time plan to do any future modifications or upgrades to this tank battery as we feel the liner meets the NMOCD requirements.
