GW - 325

INSPECTION

(Drain-lines, Sump, BGT, Site, etc.)

The annual sump inspection for the Gallup Compressor station was conducted on 7/27/09 by Pat Troncoso of Transwestern Pipeline. There were no problems found during the inspection. Photos of the sumps are attached.

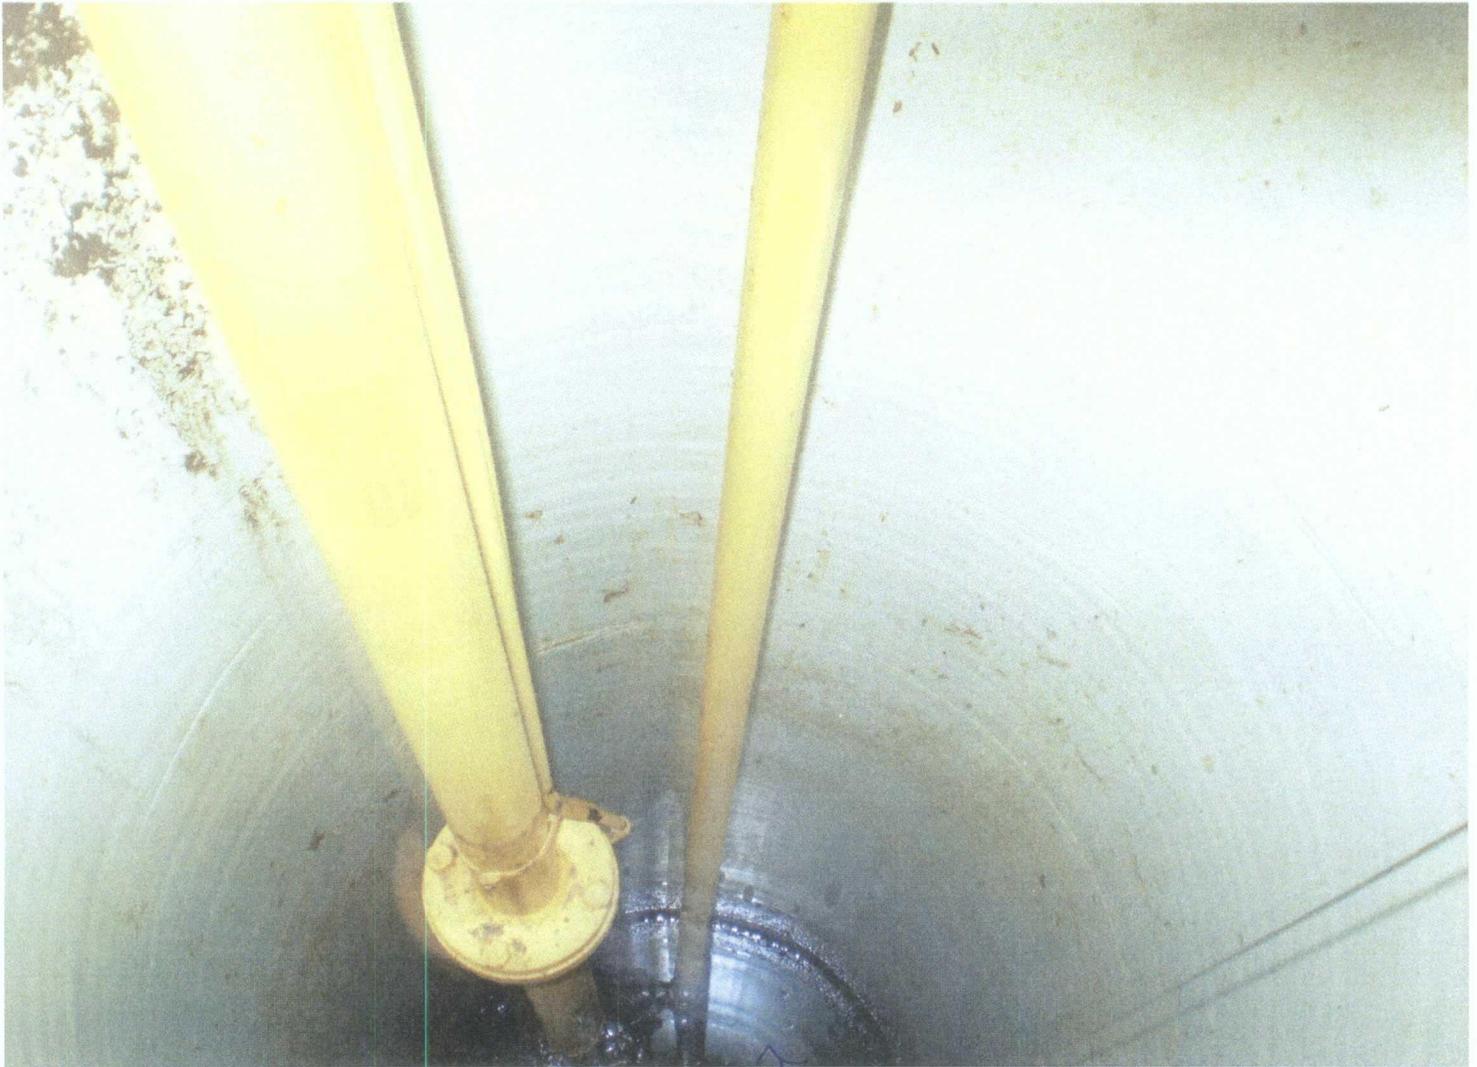
OILY WASTE WATER SUMP 1

2009 Gallup Station Oily Waste Water Sump by Engine Room

This is a fiberglass sump with auto dump controls

SN-B2001—size 1A-8ft. 8 inch X 24 inch—Fig 1910XA

Contains oily waste water from engine Room and doesn't contain liquids indefinitely?

This tank does have secondary containment and is visually checked

No problems were found

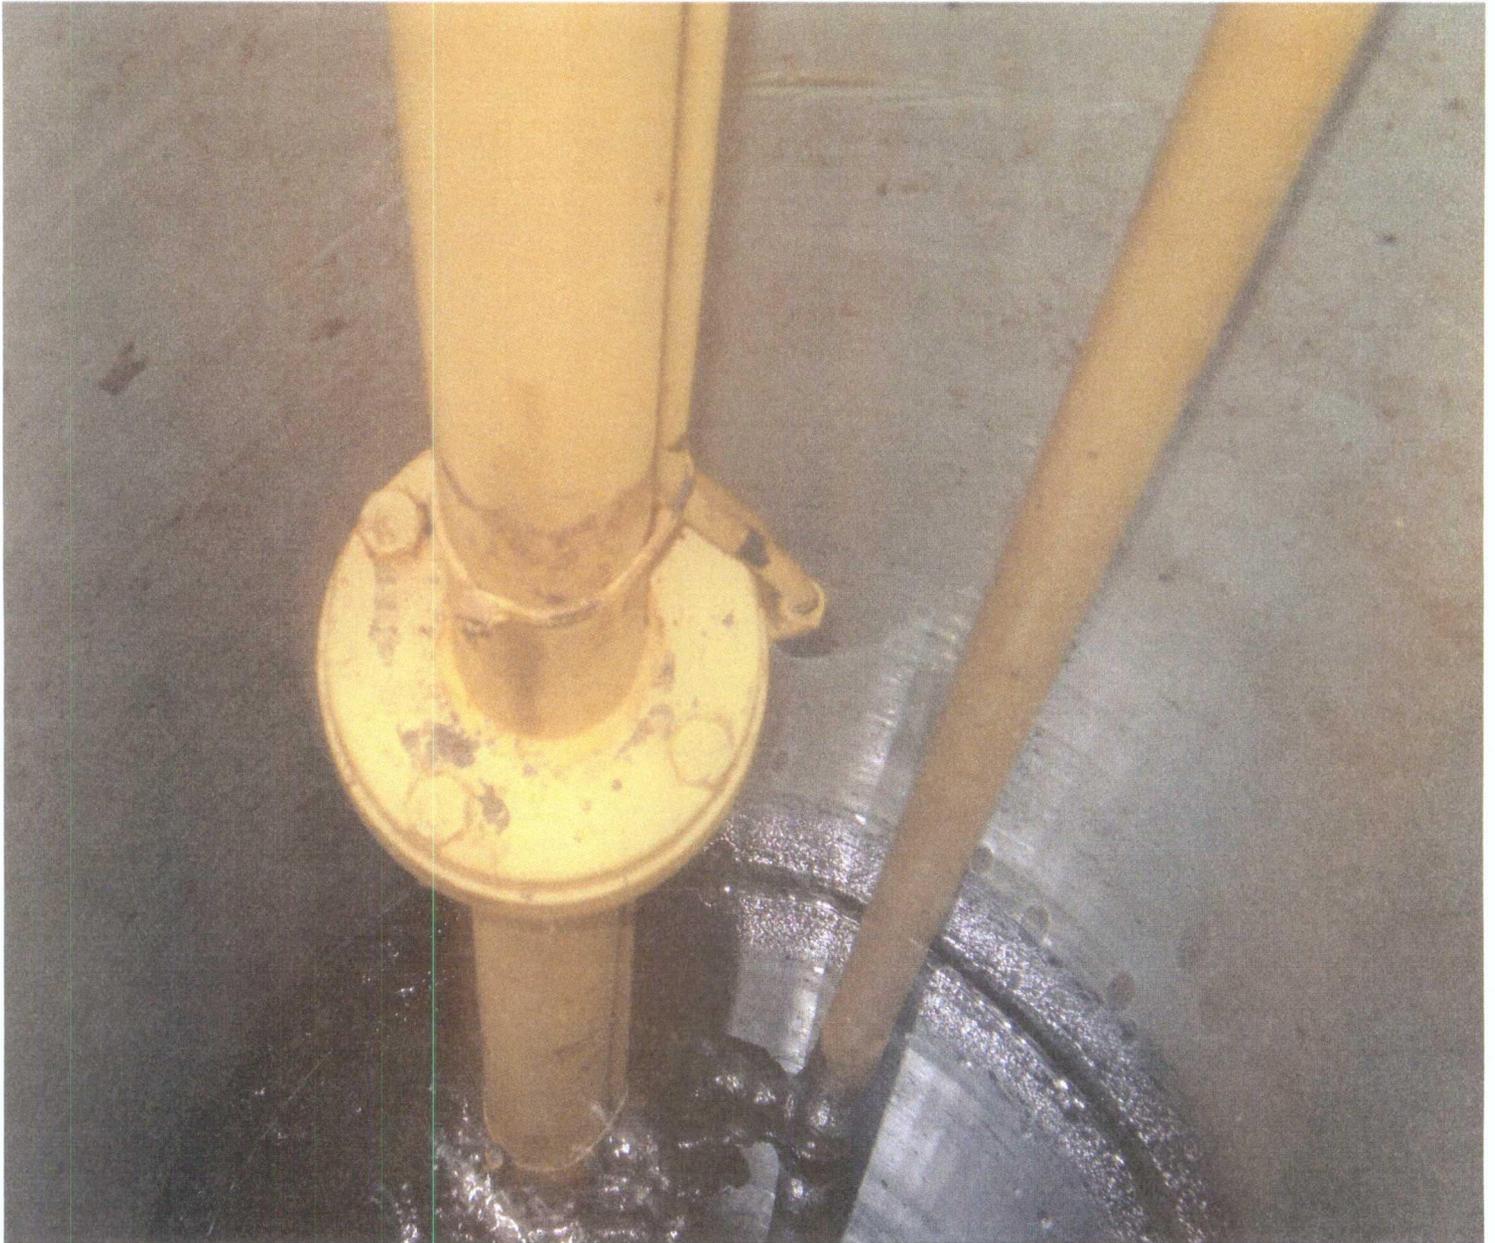
2009 Gallup Station Oily Waste Water Sump by Engine Room

This is a fiberglass sump with auto dump controls

SN-B2001—size 1A-8ft. 8 inch X 24 inch—Fig 1910XA

Contains oily waste water from engine Room and doesn't contain liquids indefinitely

This tank does have secondary containment and is visually checked

No problems were found

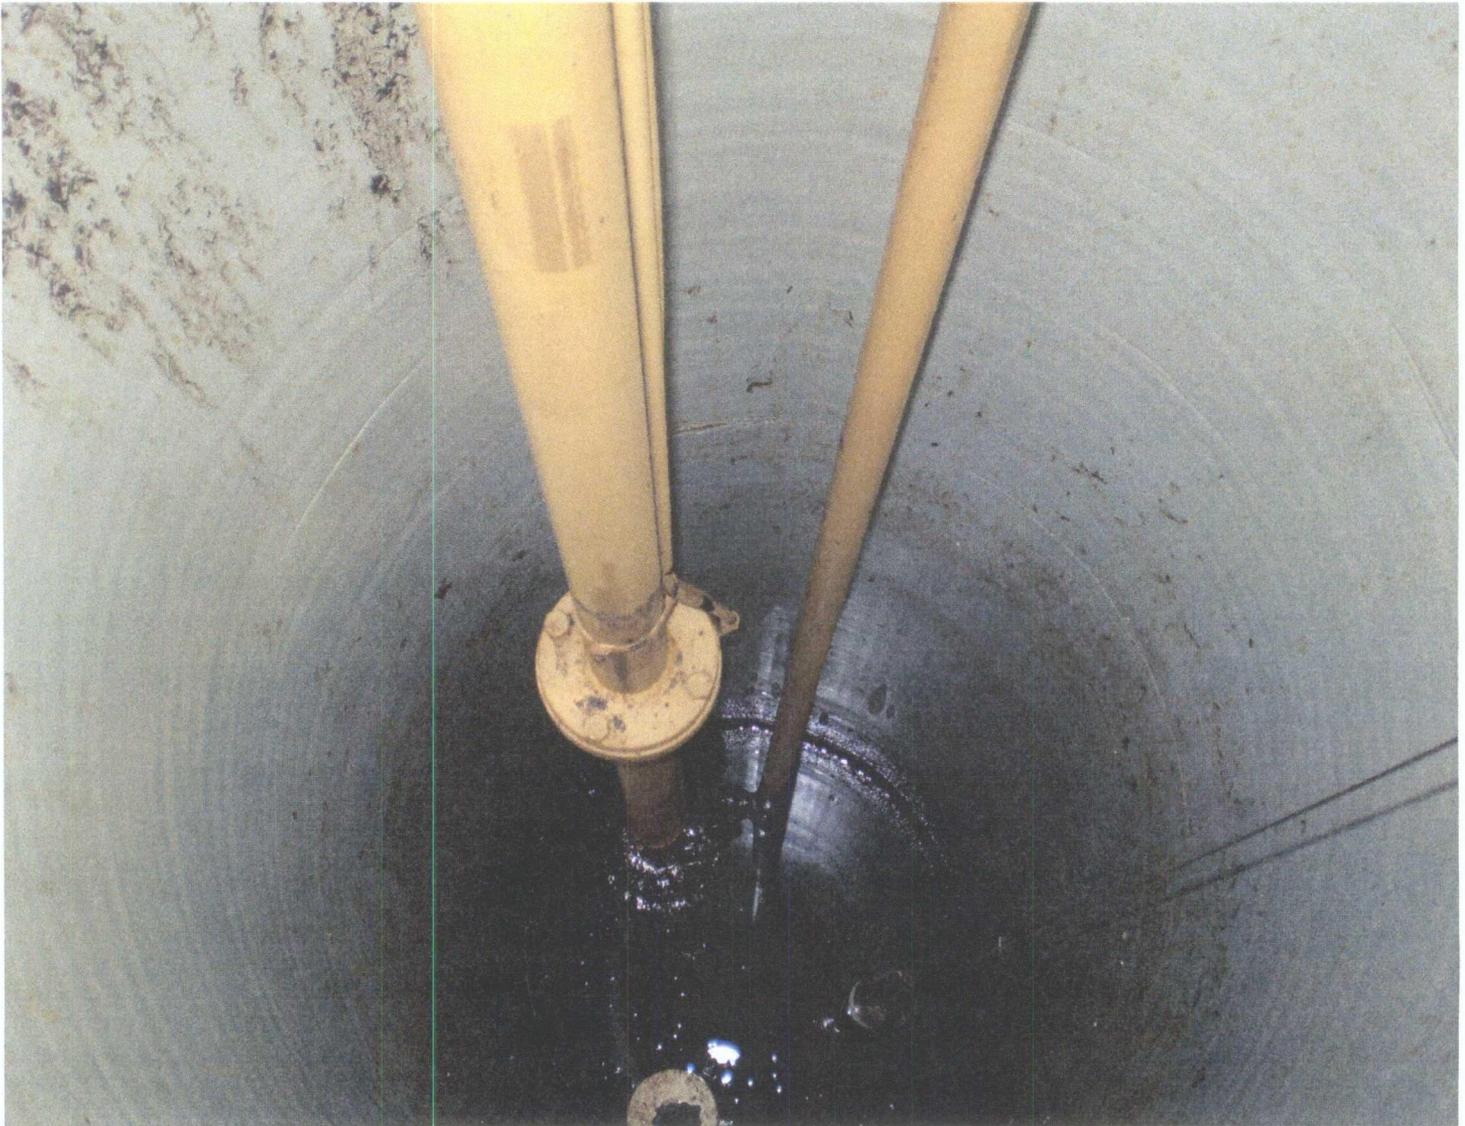
OILY WASTE WATER SUMP #3

2009 Gallup Station Oily Waste Water Sump by Engine Room

This is a fiberglass sump with auto dump controls

SN-B2001—size 1A-8ft. 8 inch X 24 inch—Fig 1910XA

Contains oily waste water from engine Room and doesn't contain liquids indefinitely

This tank does have secondary containment and is visually checked

No problems were found

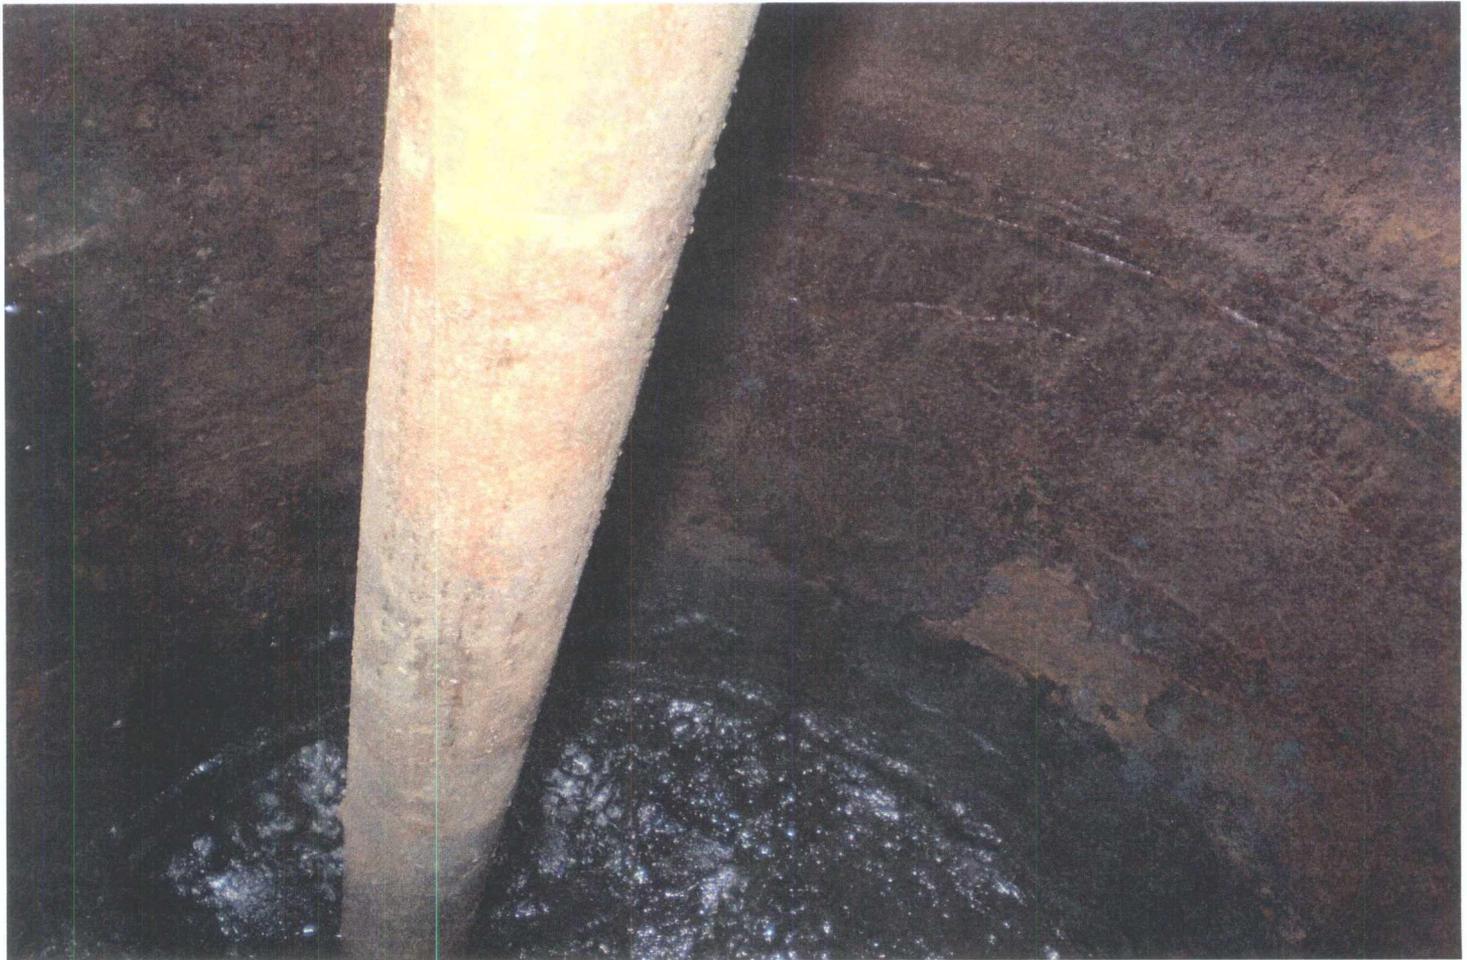
PIG RECEIVER SUMP #1

2009 Gallup Station Pig Receiver Sump
This is a metal sump with manual controls
No manufacture info (homemade)

Next to San Juan Lateral 30" pig receiver north of the Station
Contains pipeline condensate from 30" & 36" pipelines, and doesn't contain liquids
indefinitely--- Size 4ft 6 inches X 36 inches

This tank does not have secondary containment and is visually checked
Inspection was done on July 30th 2009 by Patrick Troncoso and Julian Ruiz
No problems were found

The pig receiver BGT's all indicate that they do not have a secondary containment with leak detection. When does TWP intend to re-engineer them to meet permit requirements? The discharge permit indicates that all below-grade tanks need to be retrofitted to meet a 'tank within a tank' design with leak detection before permit is renewed. This permit GW-325.

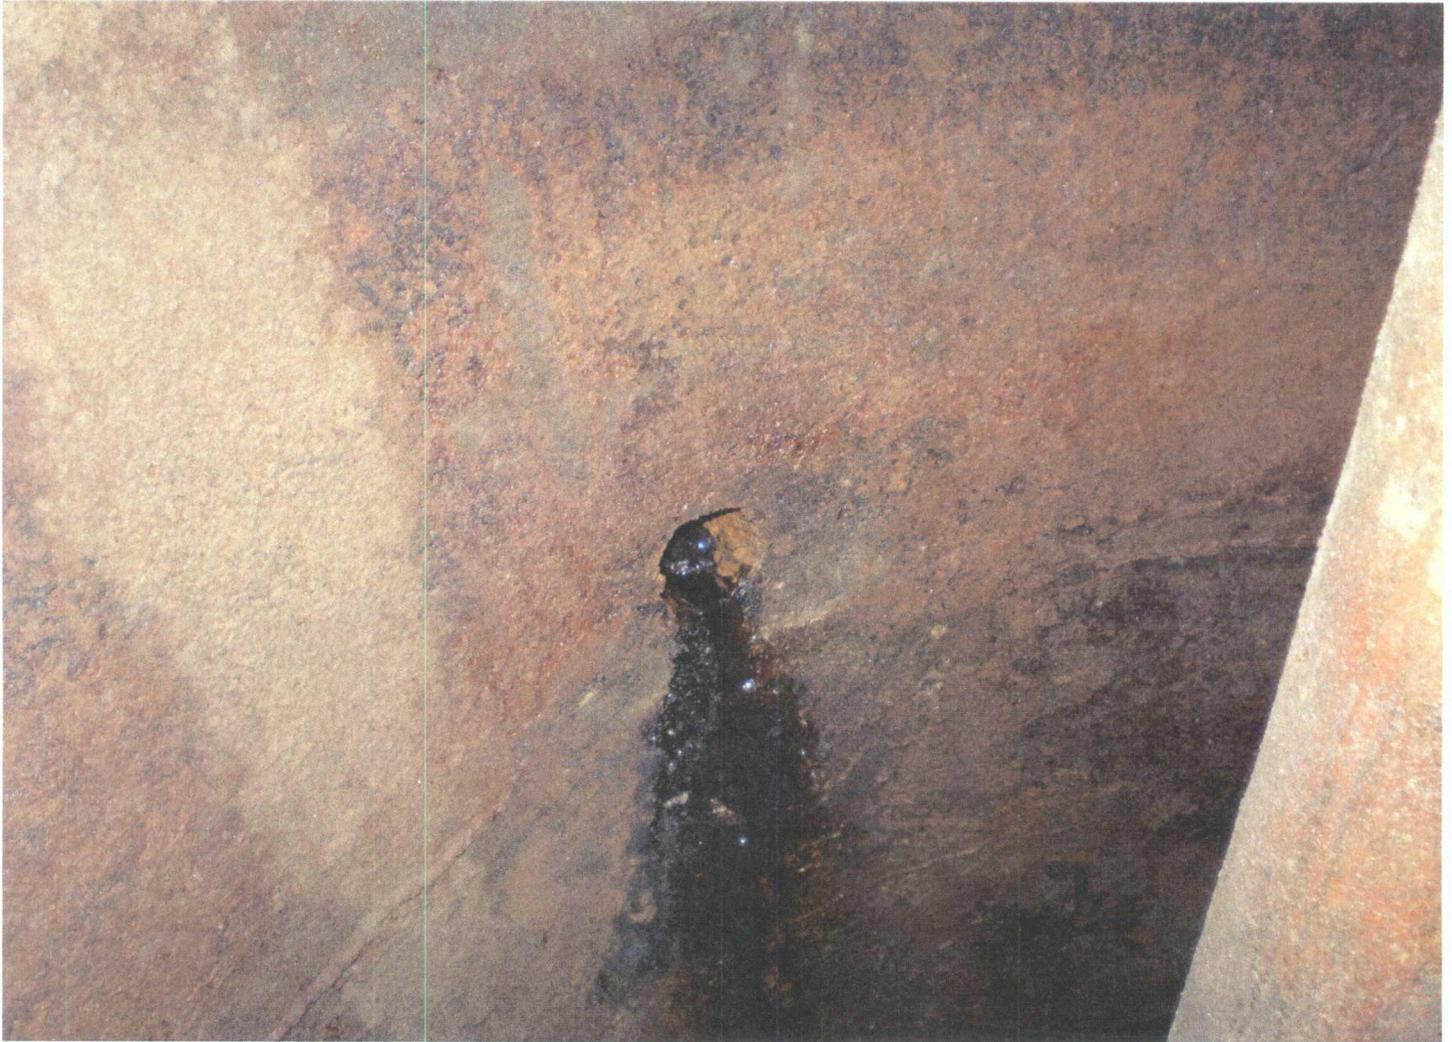
PIG RECEIVER SUMP #2

The photo of the TANK identified as Pig Receiver Sump 2 shows a hole in the side walls. Is this the inlet for fluids being discharged in to this tank?

2009 Gallup Station Pig Receiver Sump

This is a metal sump with manual controls

Contains pipeline condensate from 30" & 36" pipelines, and doesn't contain liquids indefinitely--- Size 4ft 6 inches X 36 inches

This tank does not have secondary containment and is visually checked ✓

No problems were found

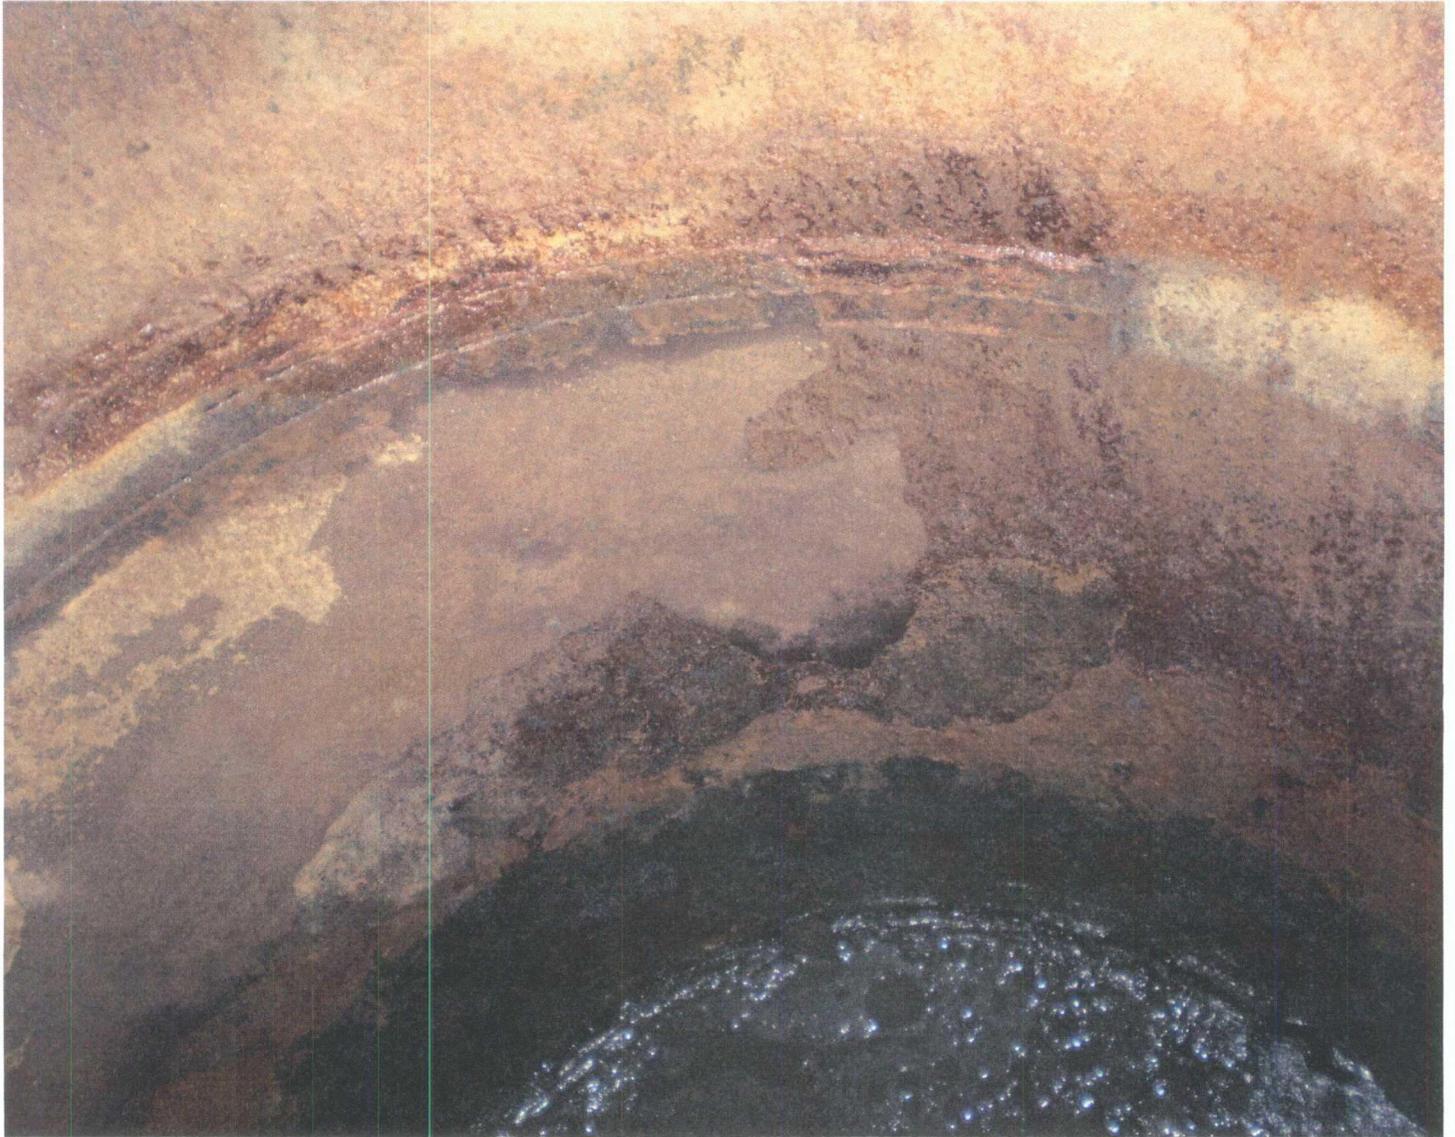
PIGRECEIVER SUMP #3

2009 Gallup Station Pig Receiver Sump
This is a metal sump with manual controls
No manufacture info (homemade)

Next to San Juan Lateral 30" pig receiver north of the Station
Contains pipeline condensate from 30" & 36" pipelines, and doesn't contain liquids indefinitely--- Size 4ft 6 inches X 36 inches

This tank does not have secondary containment and is visually checked
Inspection was done on July 30th 2009 by Patrick Troncoso and Julian Ruiz
No problems were found
