Release Notification and Corrective Action

Name of Company	Apache Corporation	Contact	Natalie Gladden
Address	P.O. Box 1849	Telephone No.	575-390-4186
Facility Name	ARNOLD A #1	Facility Type	Oil Well

1.0 Project Summary

Release Site Name: Arnold A #1
Operating Company: Apache Corporation
Company Representative: Natalie Gladden, Environmental Tech Phone: 575-390-4186
Address: PO Box 1849, Eunice, NM 88231 Email: Natalie.Gladden@usa.apachecorp.com
Remediation Company: Ocotillo Environmental - Hobbs Phone: 575-738-0138

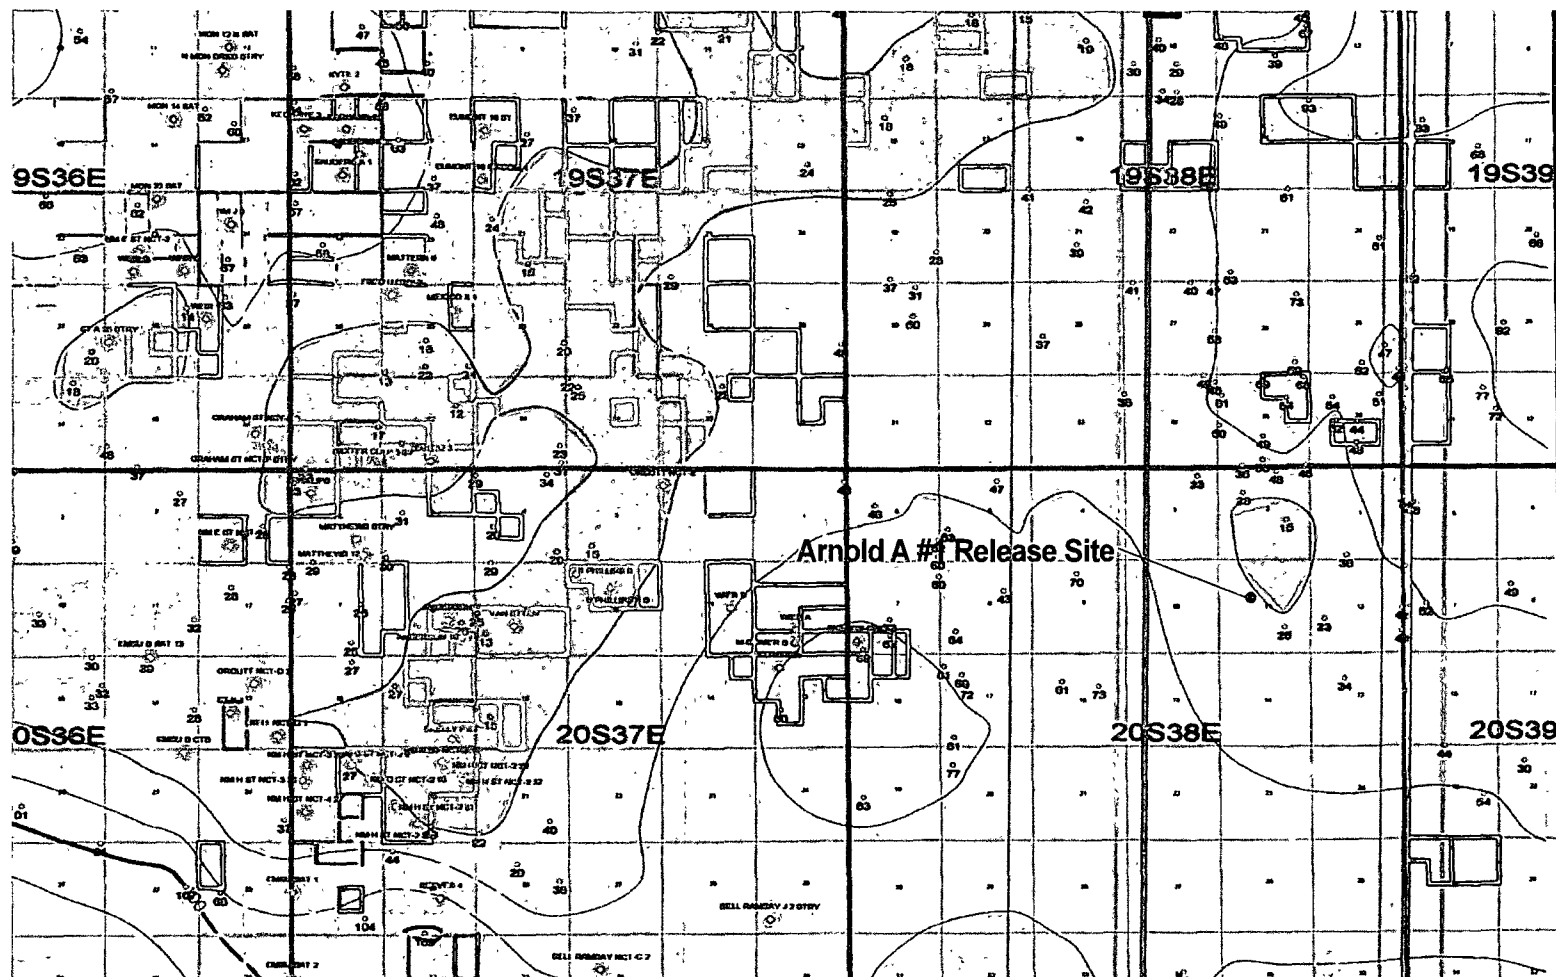
Plate 4
Release Site Water Depth Contour
Apache Corporation
Arnold A #1

The Chevron-Texaco water contour map (*Plate 4 of Attachments*) indicates that water in this area is 25' – 50' bgs. A monitor well drilled at the NW corner of the location measures 54-ft to water level.

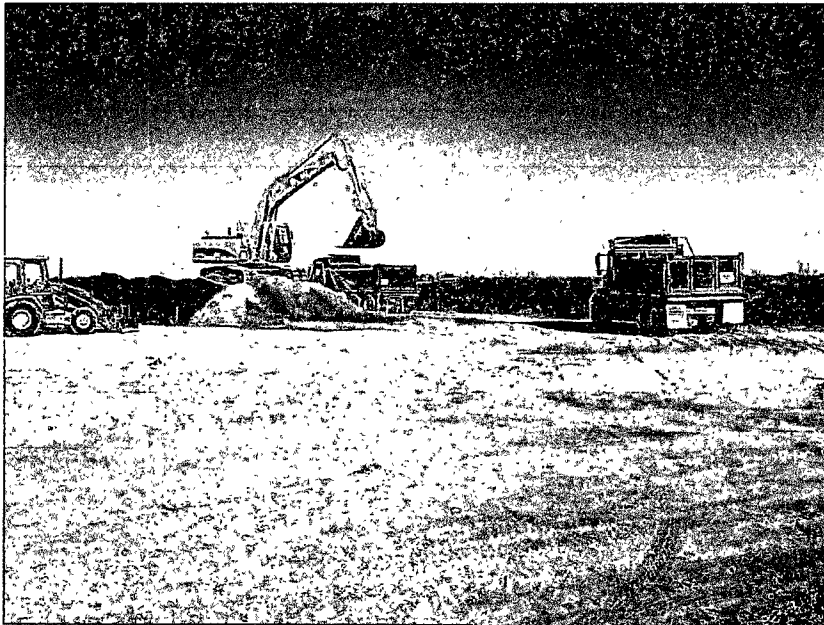
< 3/31/08 – Hauling stockpiled contaminated soil to landfarm

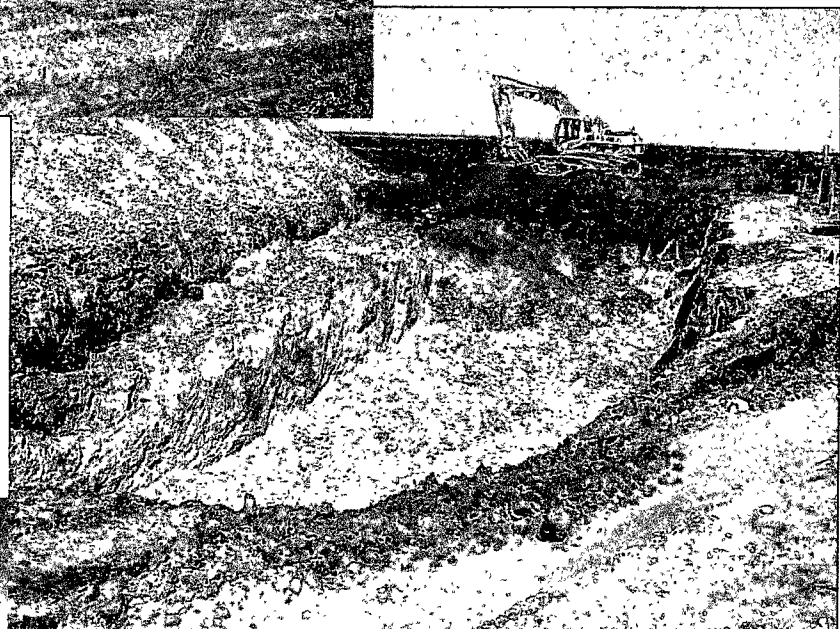
4/8/08 – Excavated area north of battery. >

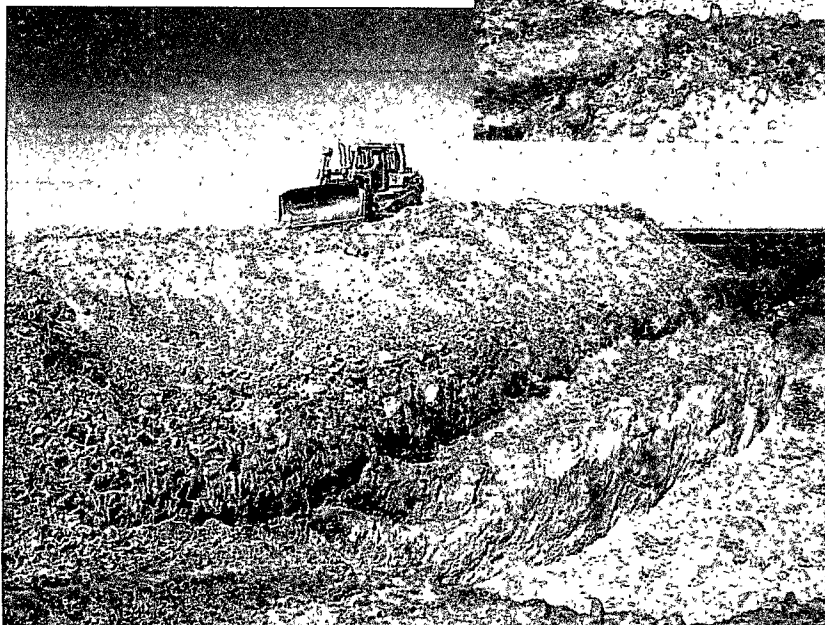
< 3/31/08 – Excavated area north of battery.

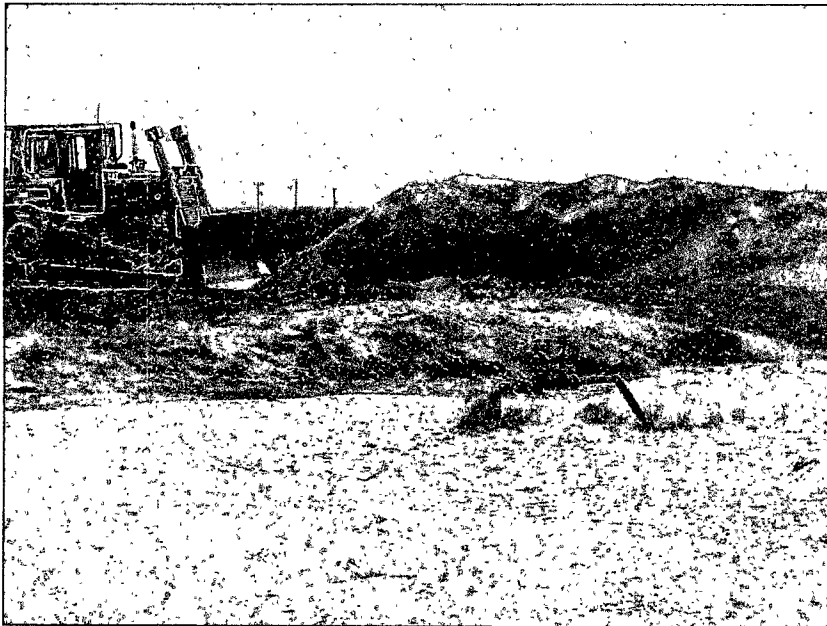
< 4/9/08 – Backfilling excavation with blended soil.

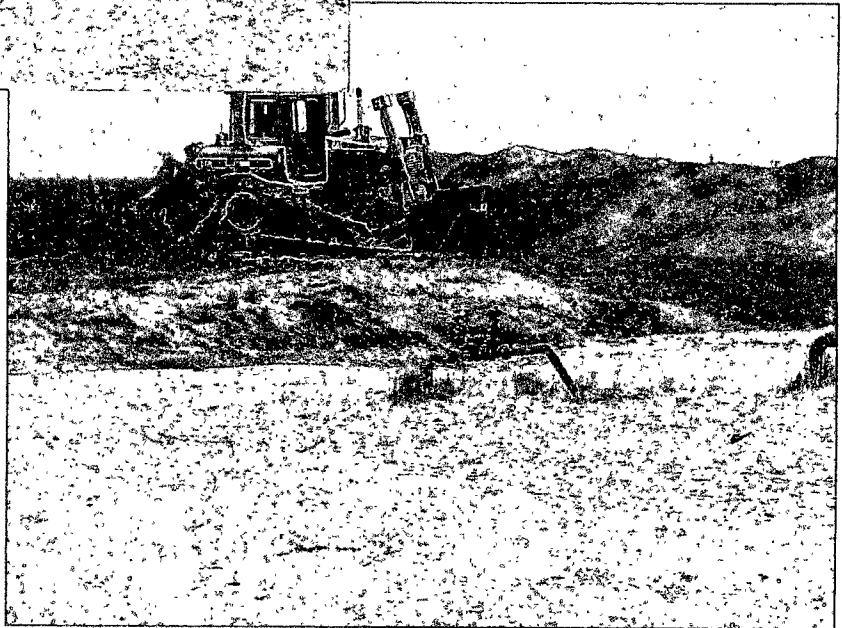
4/9/08 – Backfilling excavation with blended soil. >

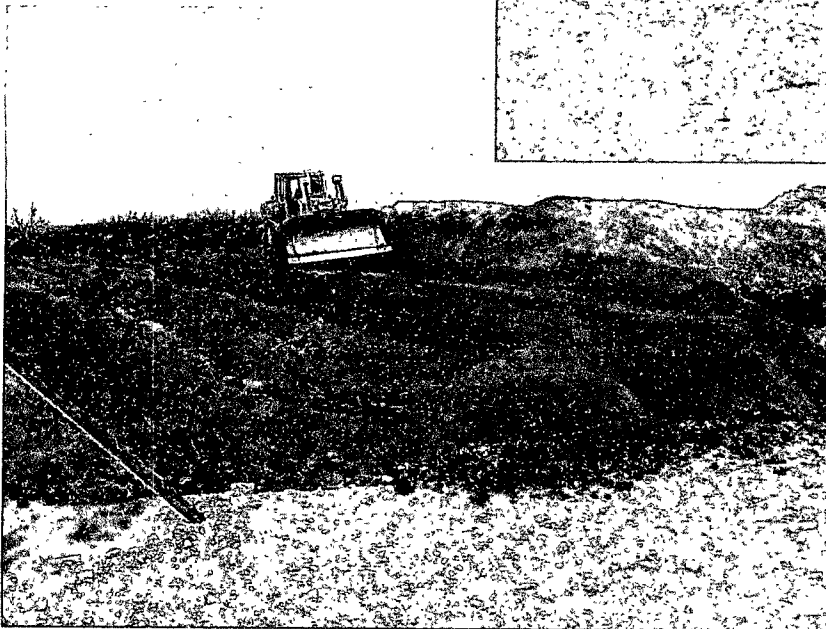
< 4/9/08 – Backfilling excavation with blended soil.

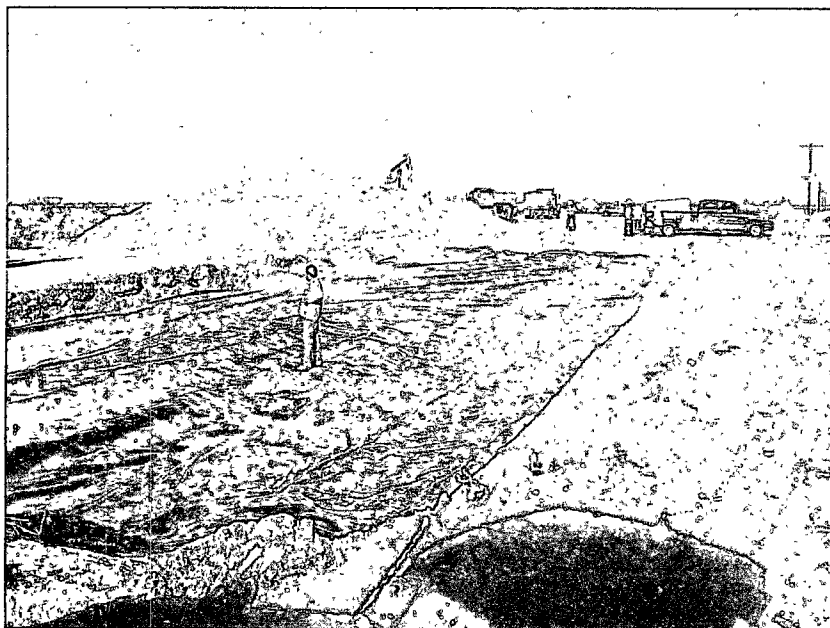
< 5/22/08 – Installing 48' X 125' liner by battery location

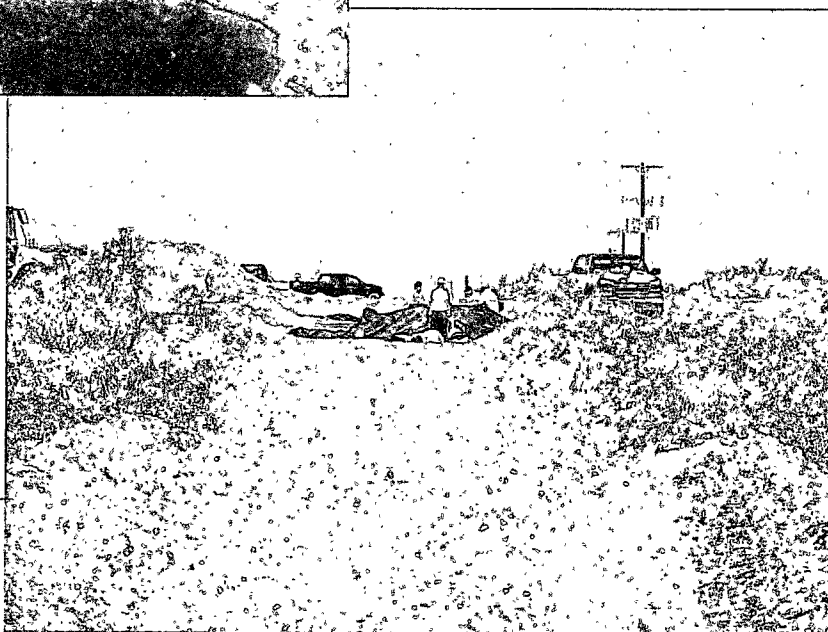
5/22/08 – Installing 465' X 20' liner along roadway. >

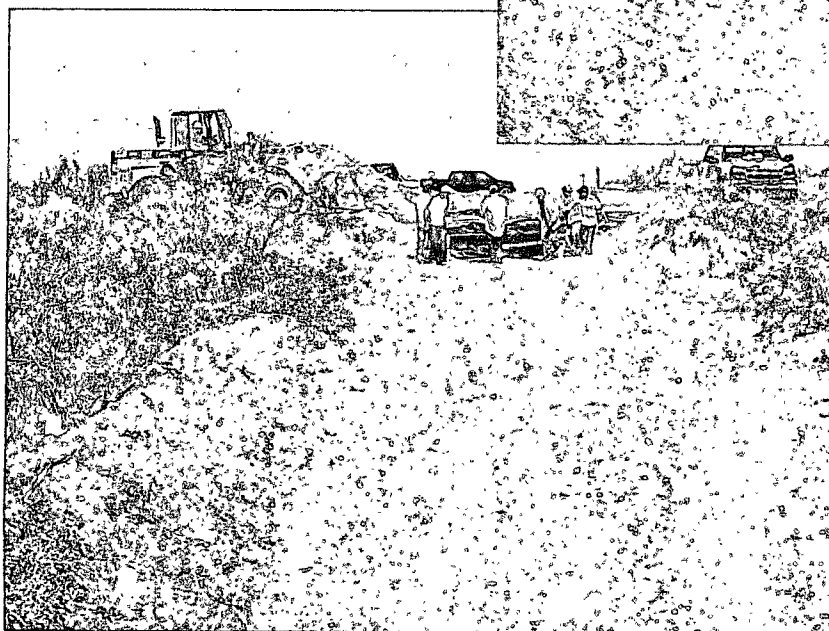
< 5/22/08 – Installing 465' X 20' liner along roadway. >

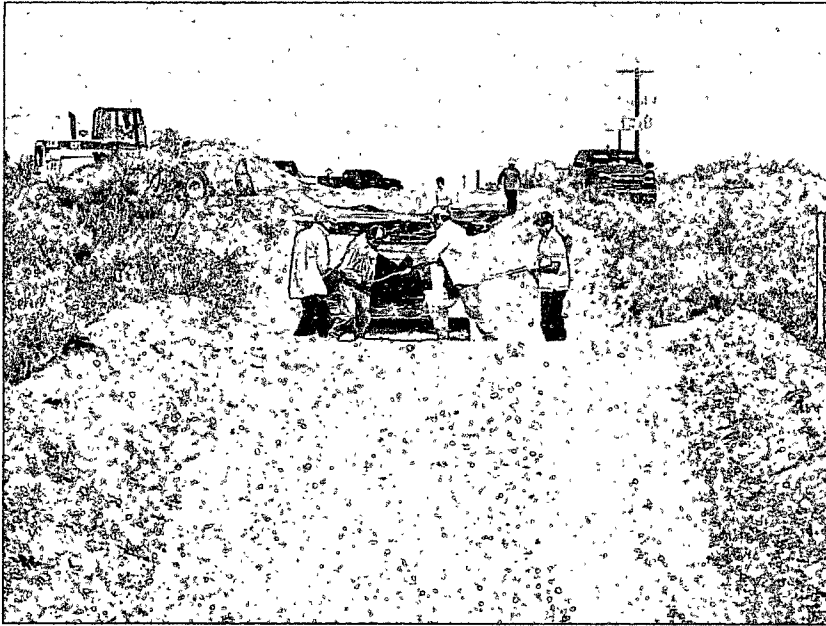
< 5/22/08 – Installing 465' X 20' liner along roadway. >

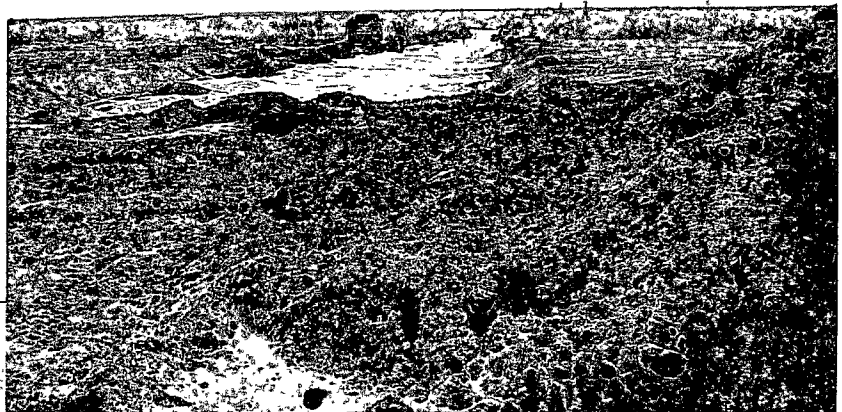
5/22/08 – Liner installed and commencing cover with topsoil. >

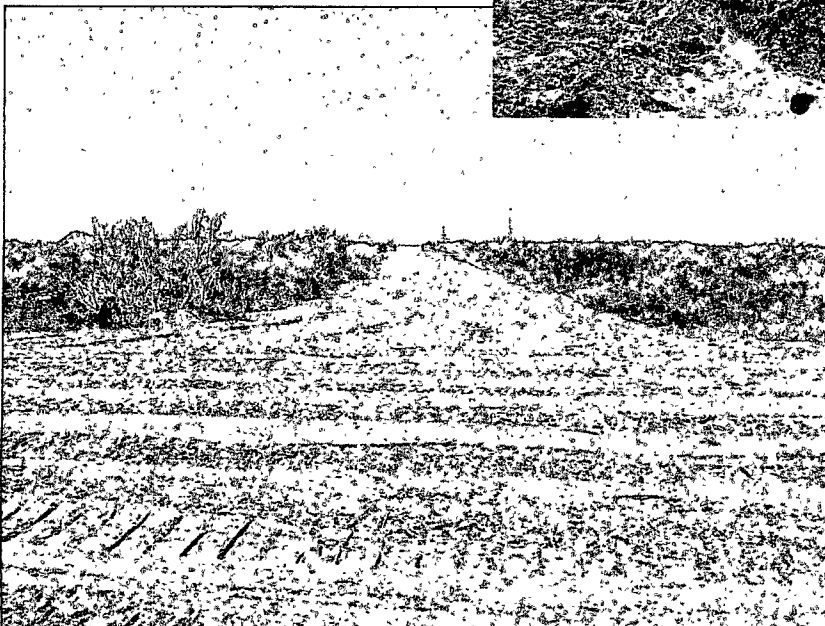
< 5/30/08 – 1000-ft + roadway remediation completed (photo from Merit well facing west. >
