SOUTH # 1 POND INVESTIGATION REPORT

Re: South (#1) Brine Pond Investigation Report Targa Midstream Services, L.P., Monument Gas Plant (GW-025) Lea County, New Mexico

South Brine Pond Investigation Report

Monument Gas Plant (GW-025) Lea County, New Mexico

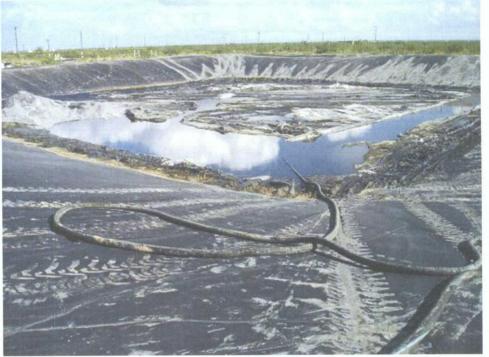
Viewing across the South (#1) Brine Pond prior to closure activities.

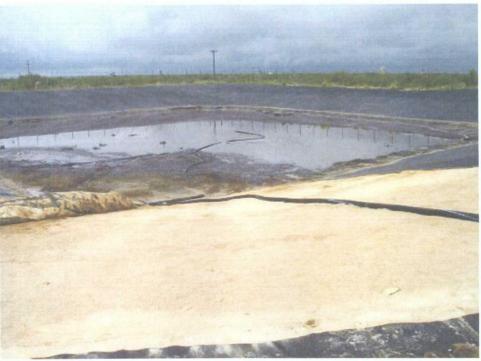
A portion of the primary (top) liner is removed to expose the intermediate cushion sand and secondary (bottom) liner.

Excavating and stockpiling progressed while great care was taken to not disturb the underlying liner system. The liner system was comprised of two geotextile materials with cushion sand separating the two liners and separating the underlying native soil. The upper, primary liner appeared to be a 60 mil linear polyethylene material, while the bottom, secondary liner appeared to be a 20 mil linear polyethylene material. A leachate collection pipe and sump was set between the two liners at the bottom of the pond.

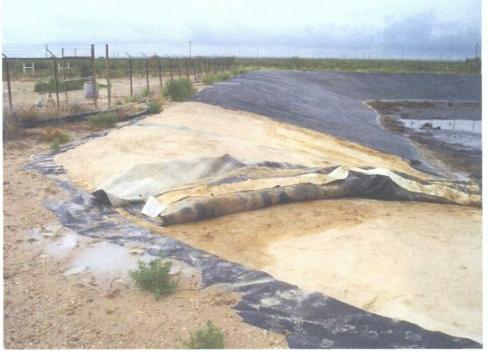
Another view of primary liner, cushion sand, and secondary liner.

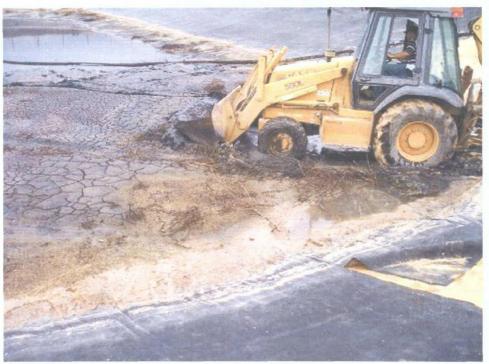
Precipitated salt and sediments are pushed towards the center to encourage decanting liquids for disposal, and to create a solid material stockpile for removal.

LAI submitted to the OCD an investigation and closure plan for the South (#1) Brine Pond on March 3, 2006; the plan was approved on August 20, 2008 (Appendix A). Closure activities began on September 2nd, 2008. LAI representative Mr. Roger Brooks directed subcontractors in the removal of excess fluids remaining in the pond. These fluids were transported to the nearby Cooper Salt Water Disposal (SWD) facility. With the fluids removed to the level of the sediment and precipitated salt, a backhoe began excavating the sediment and placing the solids into a stockpile. As the sediment was disturbed, fluids that decanted were extracted by vacuum truck and transported to the Cooper SWD for disposal.

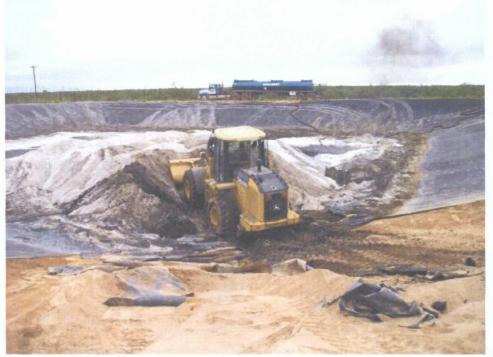
Excavated salt and sediment being stockpiled. Vacuum trucks remain onsite as liquids continue to decant from the sediment.

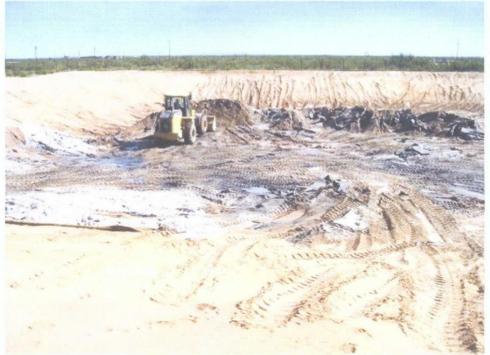
With most of the precipitated salt and sediments removed, the upper liner portion is removed from the sloped walls.

As it became apparent that the sediment had released the bulk of the interstitially-held fluids, the primary liner was removed from the sides of the pond, exposing the upper cushion sand. Upon the removal of all sediments, a chain was attached to the backhoe, and the liner was removed with the upper cushion sand. All sediments, cushion sand and liner materials were properly disposed in either Sundance or Lea Land facilities. Sundance was the preferred facility, but its road is not paved, so seasonal rains required transport to the Lea Land facilities.

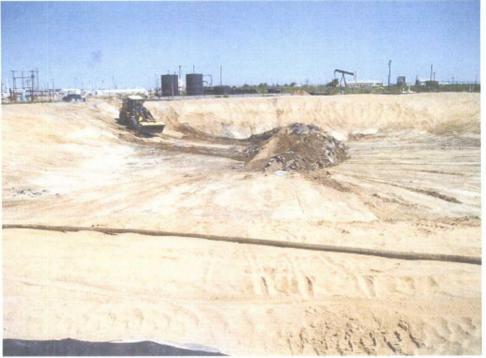
Continued progress in the upper liner removal and disposal.

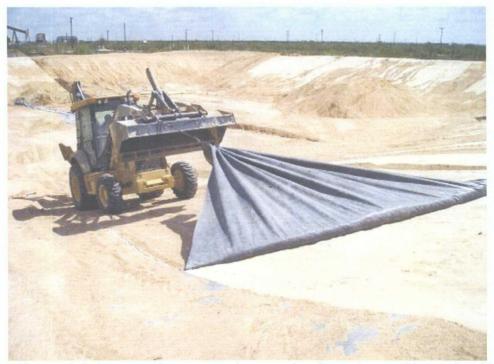
A backhoe and chain are used to remove the secondary liner. A second layer of cushion sand is between the bottom liner and native soil.

After the removal of the primary liner and upper cushion sand, the upper cushion sand and secondary liner were removed and disposed in the same manner as the primary liner. The leachate collection pipe's pea-gravel filter pack and pipe were excavated, and the secondary liner removed. Finally, the lower cushion sand was excavated, stockpiled and transported for off-site disposal. Excavation and disposal activities were concluded on September 25, 2008.

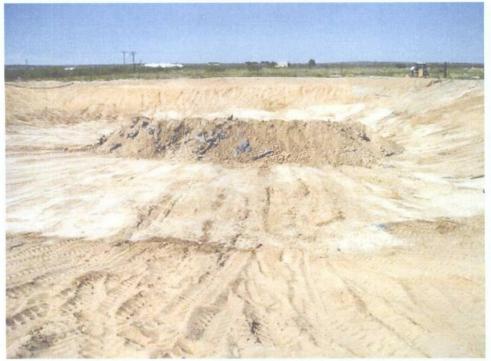
The secondary liner and cushion sand are stockpiled in the former pond pending being loaded for transport for final disposal.

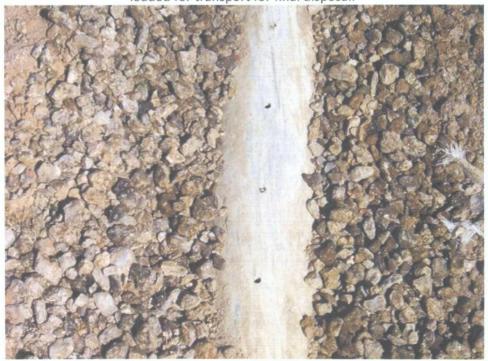
Close up of sump collection system and pea gravel filter pack.

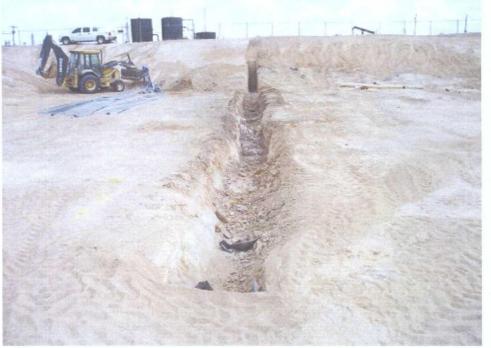
Viewing east along the trench which formerly contained the leachate collection pipe.

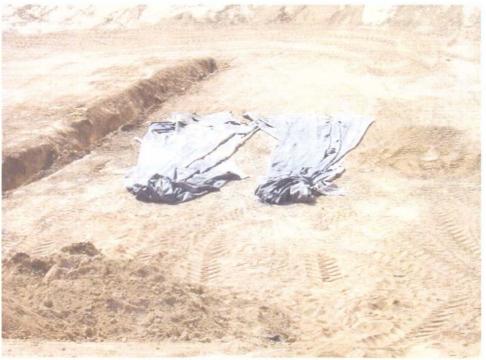
Bottom liner removed from the leachate collection system.

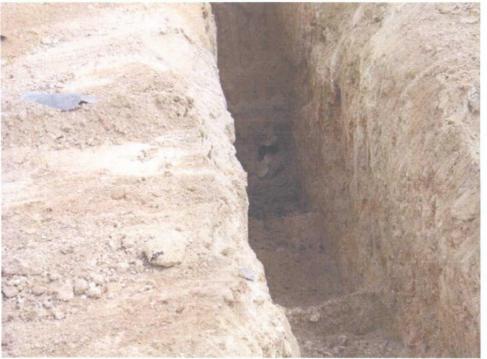
Viewing east, at the former leachate collection sump.

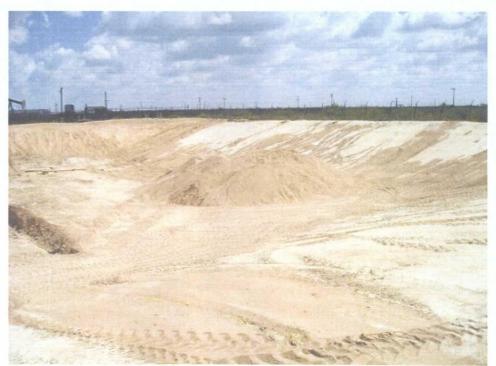
View of the former pond with both liners removed. The stock pile of sand is from layer between the secondary liner and native soil.
