Justis Jct C-1 Vent
(2 Boxes)

**RICE OPERATING COMPANY
JUNCTION BOX DISCLOSURE* REPORT**

Justis Jct. C-1 vent

Unit C, Section 1, T26S, R37E

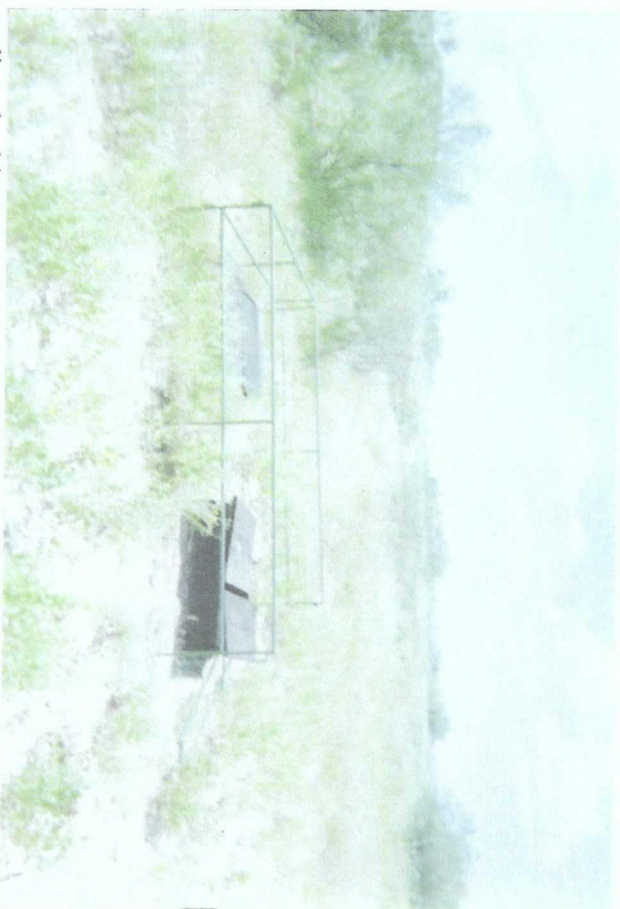
8/08/2007

undisturbed junction boxes, facing west

General Description of Remedial Action: These junction boxes were eliminated during

the pipeline replacement/upgrade program. After the boxes were removed, an investigation was

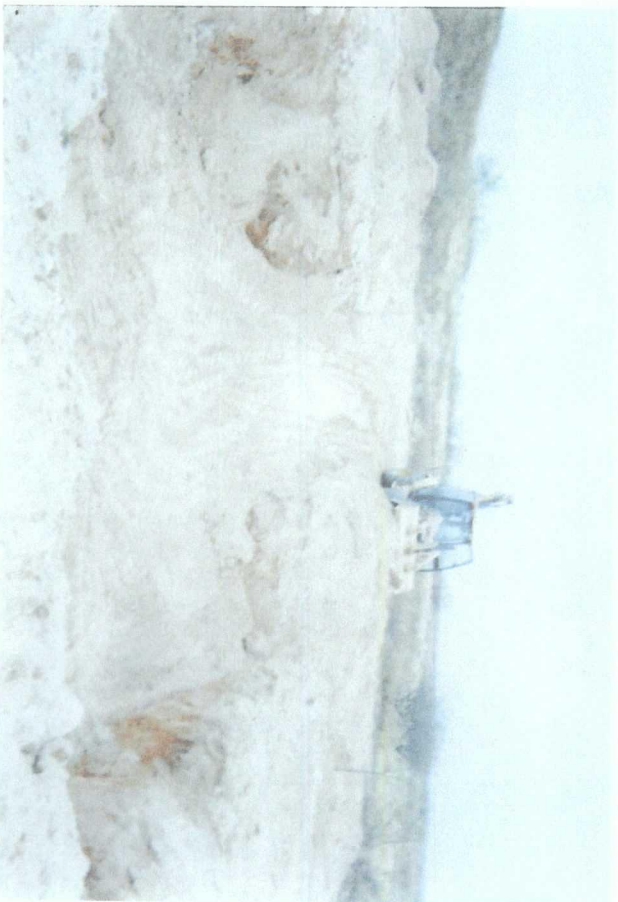
11/16/2007

backfilling excavation site

Representative composite samples were sent to a commercial laboratory for analysis. The

excavated soil was then blended on site and returned to the excavation up to 6 ft below ground

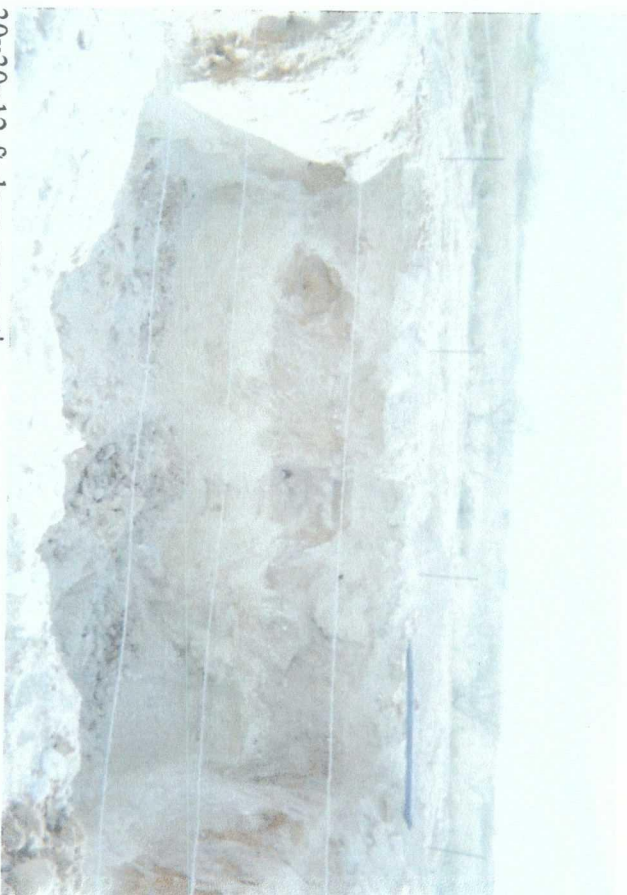
11/14/2007

30x30x12-ft-deep excavation

conducted using a backhoe to collect soil samples at regular intervals, producing a 30x30x12-ft

deep hole. Chloride field tests were performed on each sample, yielding elevated levels that did not

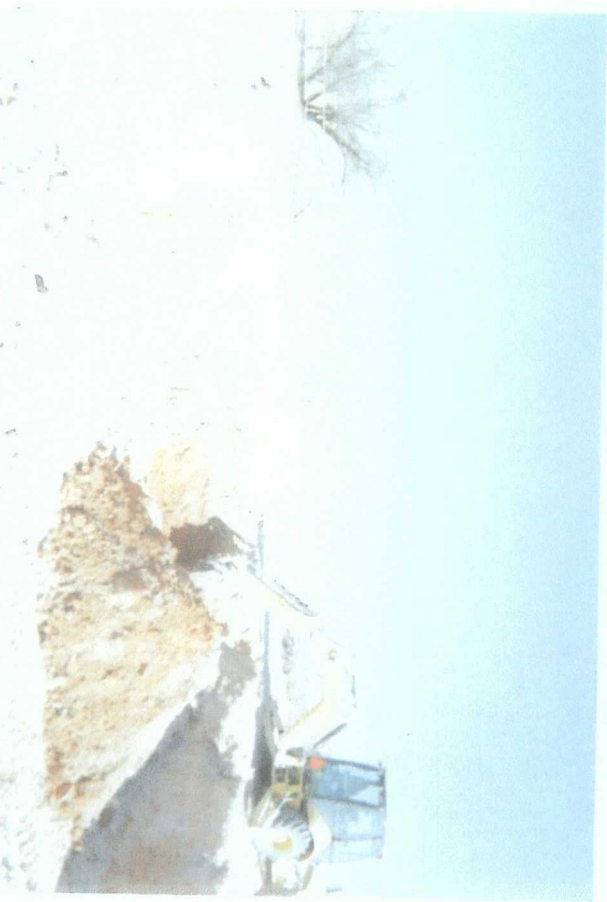
2/08/2008

5 ft north shelf being excavated, facing north

surface. A 6-ft-deep shelf was excavated extending 5 ft out from the north, south, east, and west

walls to prepare for the clay barrier. At 6-5 ft BGS, a 1-ft-thick clay barrier was installed. A portion

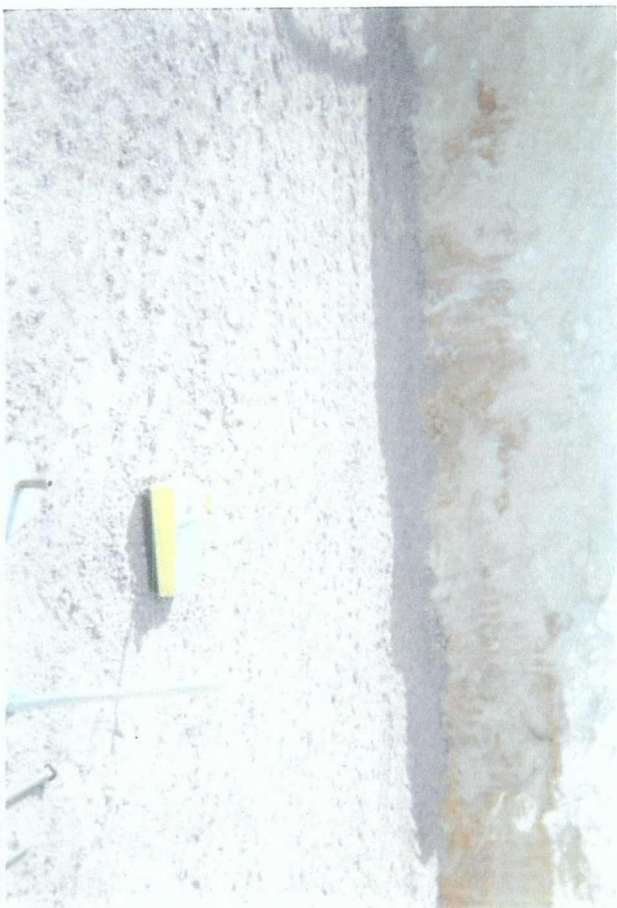
2/14/2008

compaction test on clay barrier

Control Density: 102.8
ASTM: D 698

Optimum Moisture: 22.6%

Required Compaction: *90-95%

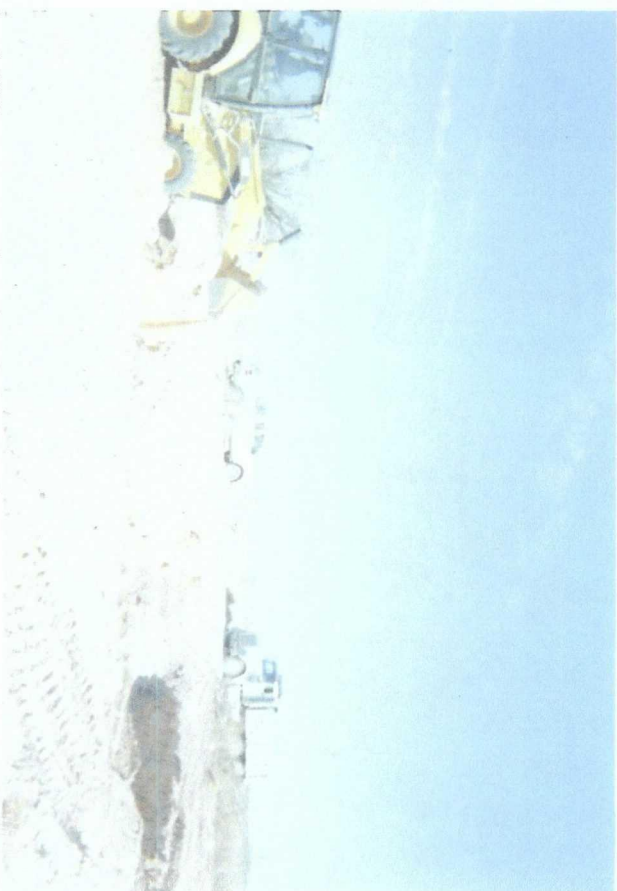
2/14/2008

backfilling excavation site, facing north

of the remaining backfill was then disposed of and the remaining soil was blended with clean,

imported soil and returned to the excavation. An identification plate was placed on the surface at

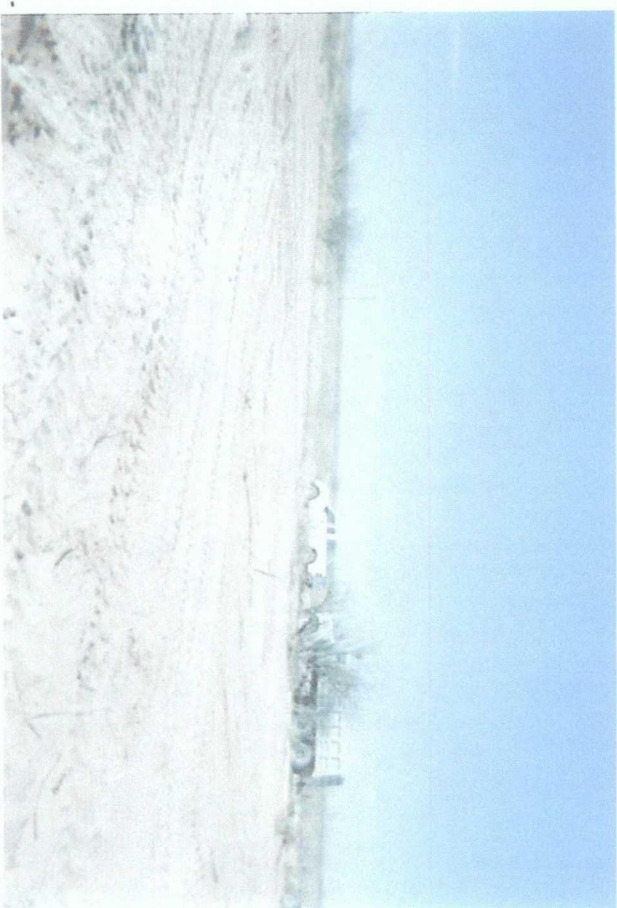
2/20/2008

completed excavation site, facing northeast

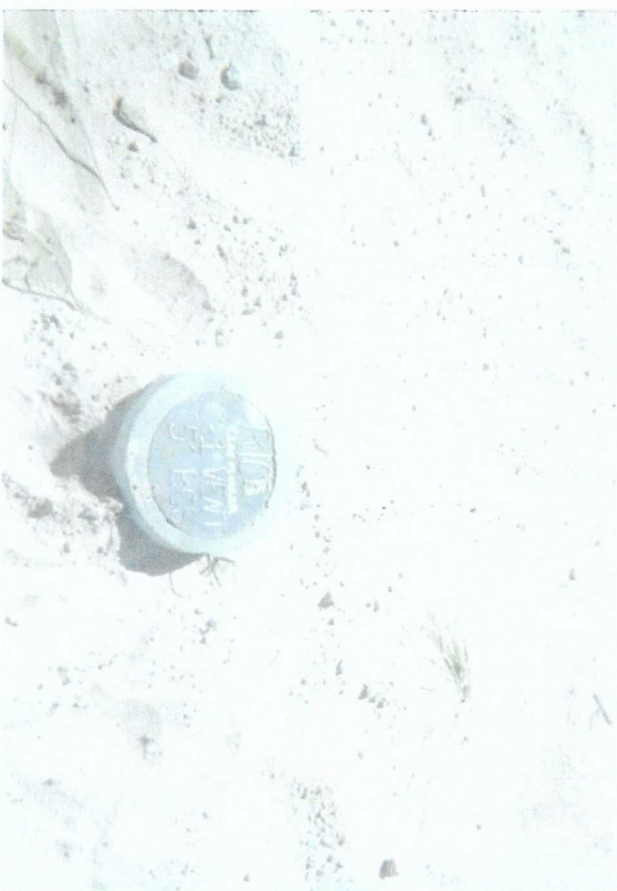
2/29/2008

clay marker

the former junction site to mark the presence of the clay below. NMOCD was notified of the
