Vacuum Chevron 6-34 EOL

1R425-59

**RICE OPERATING COMPANY
JUNCTION BOX FINAL REPORT**

Unit K, Section 34, T17S, R35E

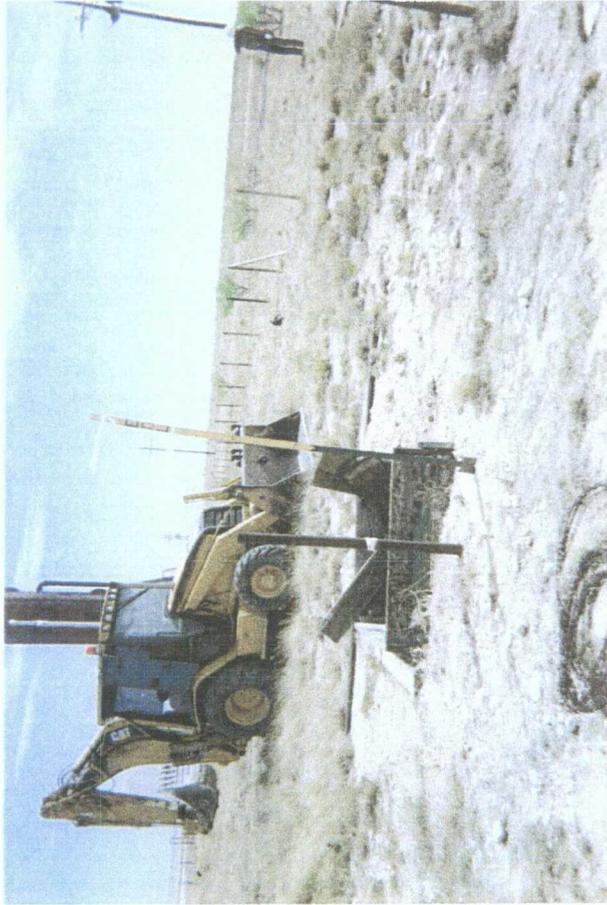
4/30/2008

former junction box, facing south

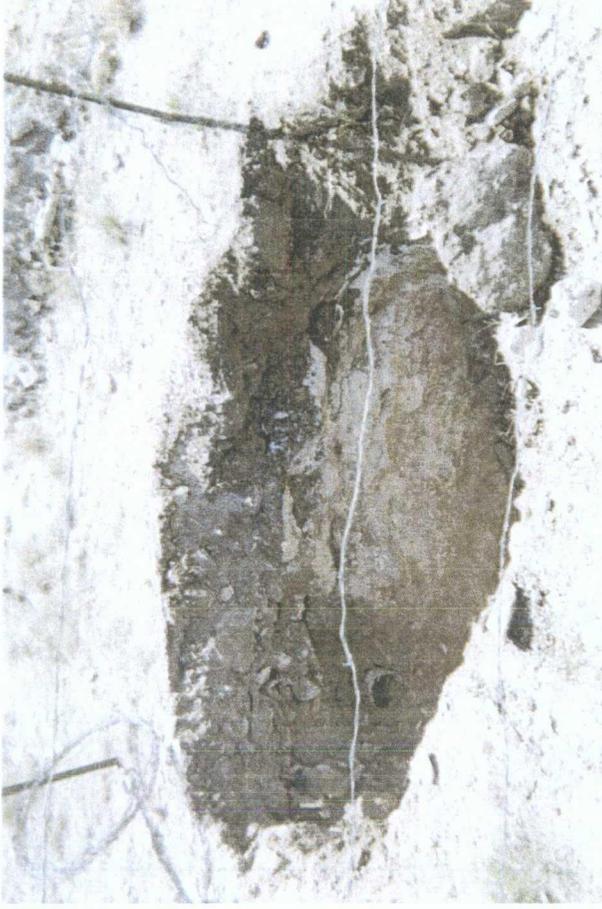
5/2/2008

delineation trench at former junction site, facing east

General Description of Remedial Action: This junction was addressed under the Vacuum SWD System abandonment. After the junction was removed, an investigation was conducted using a backhoe to collect soil samples at regular intervals producing a 5x3x6-ft-deep hole. Chloride field tests were performed on each sample, which yielded low concentrations. Organic vapors were measured using a PID, which also yielded low concentrations. The deepest sample, 6 ft BGS, was sent to a commercial laboratory for analysis of chloride and TPH, confirming low concentrations. The excavated soil was returned to the excavation and clean, imported soil was used as a top cap and to contour the site to the surrounding area. On 5/20/2008, the site was seeded with a blend of native vegetation and is expected to return to a productive capacity at a normal rate.

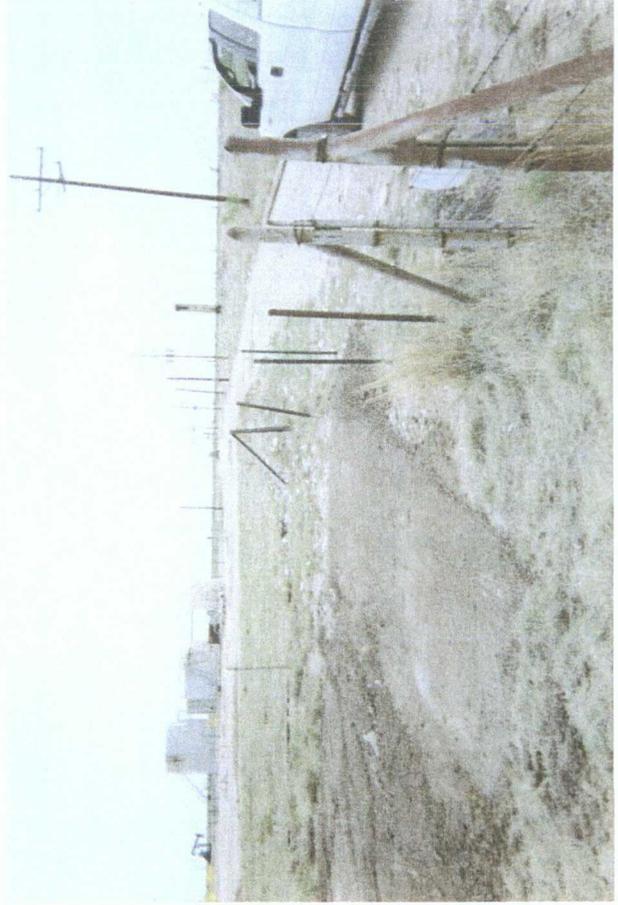
5/15/2008

backfilled site, facing west

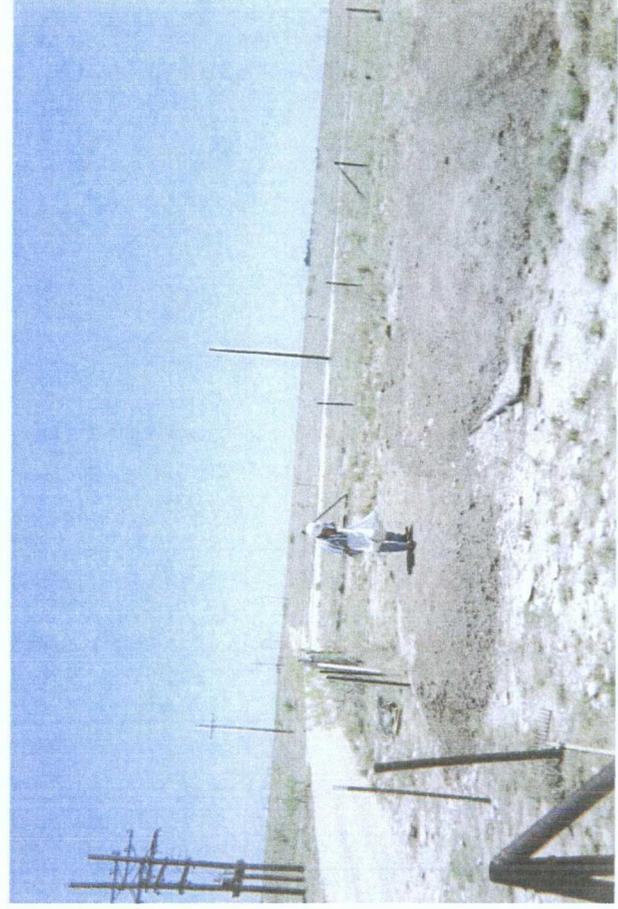
5/20/2008

seeding backfilled site, facing east

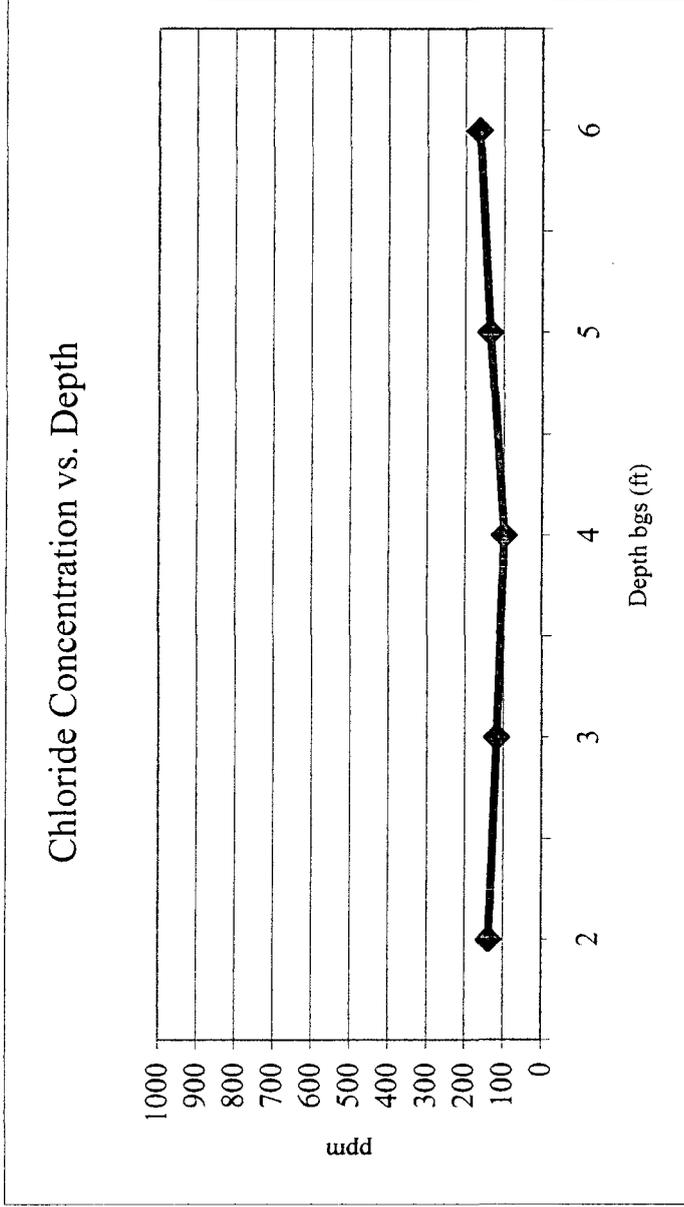
CHLORIDE CONCENTRATION CURVE

Backhoe samples at junction (source)

Depth bgs (ft)	Cl ⁻ ppm
2	137
3	117
4	98
5	135
6	163

Groundwater = 65 ft
