EME Jct M-6

**RICE OPERATING COMPANY
JUNCTION BOX FINAL REPORT**

EME Jct. M-6

Unit M, Section 6, T20S, R38E

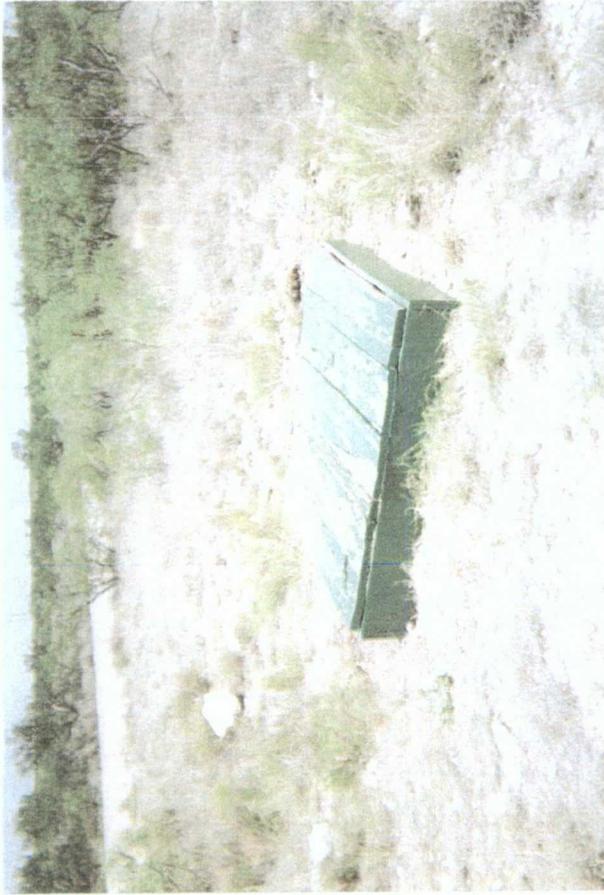
undisturbed junction box, facing northeast

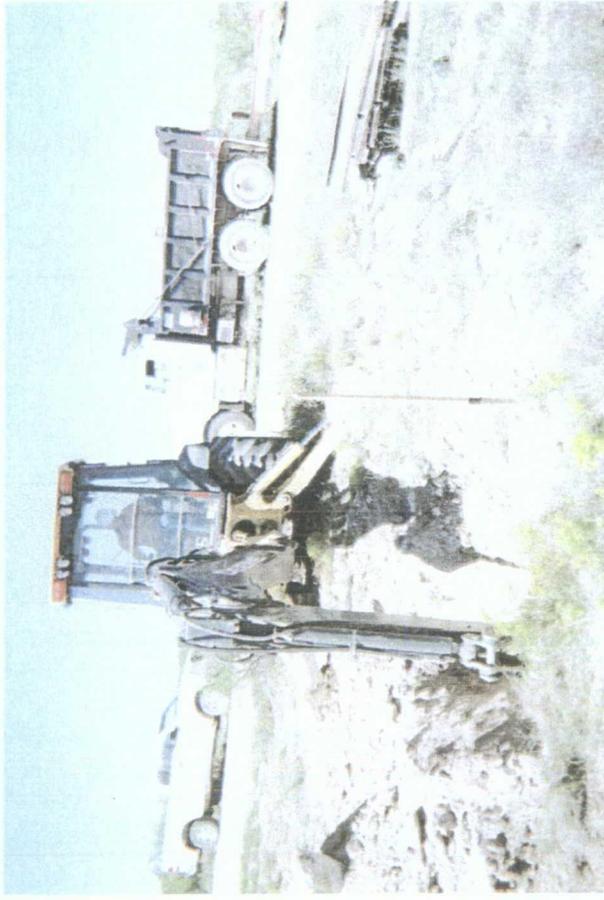
excavating at former junction site, facing west

General Description of Remedial Action: This junction was eliminated during the pipeline replacement/upgrade program. After the former junction box was removed, an investigation was conducted using a backhoe to collect soil samples at regular intervals producing a 5x3x9-ft-deep excavation. Chloride field tests performed on each sample yielded low concentrations similar to that of the background sample. Organic vapors measured with a PID also yielded low concentrations. The deepest sample, 9 ft BGS, was sent to a commercial laboratory for analysis of chloride and TPH, which confirmed low concentrations. The excavated soil was returned to the excavation to ground surface. Clean, imported blow sand was used to top cap and to contour to the surrounding area. On 9/29/2008, the site was seeded with a blend of native vegetation and is expected to return to a productive capacity at a normal rate.

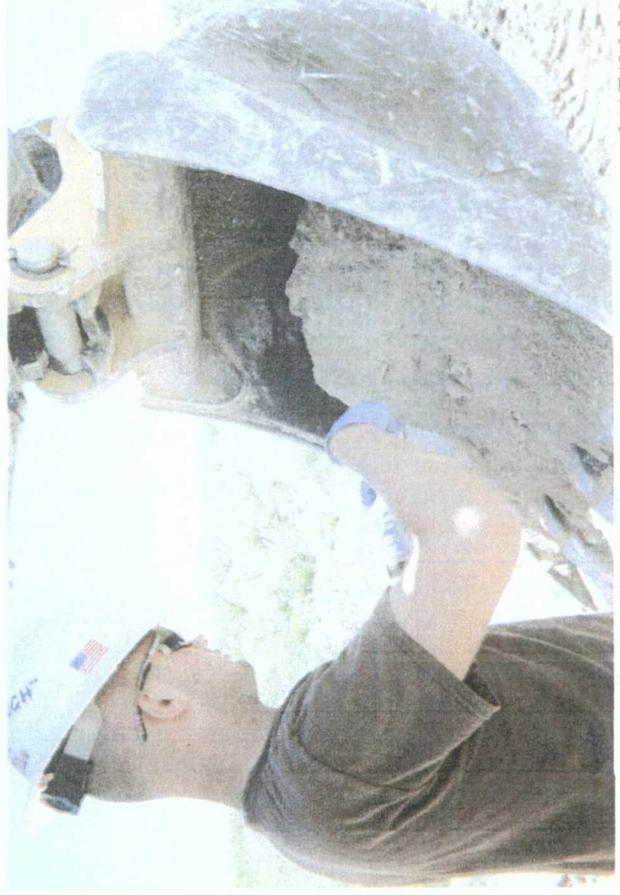
collecting a soil sample, facing east

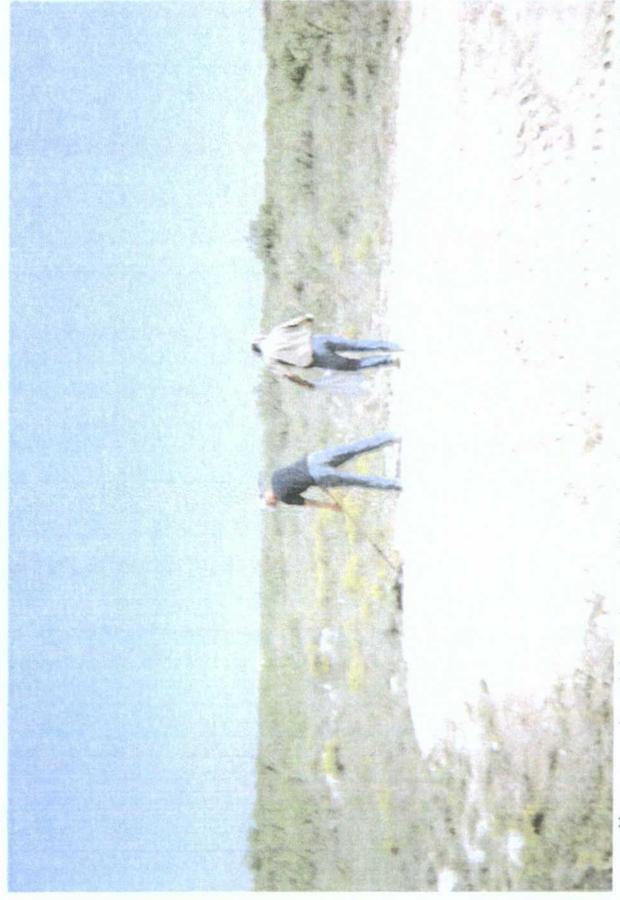
seeding and raking backfilled site, facing east

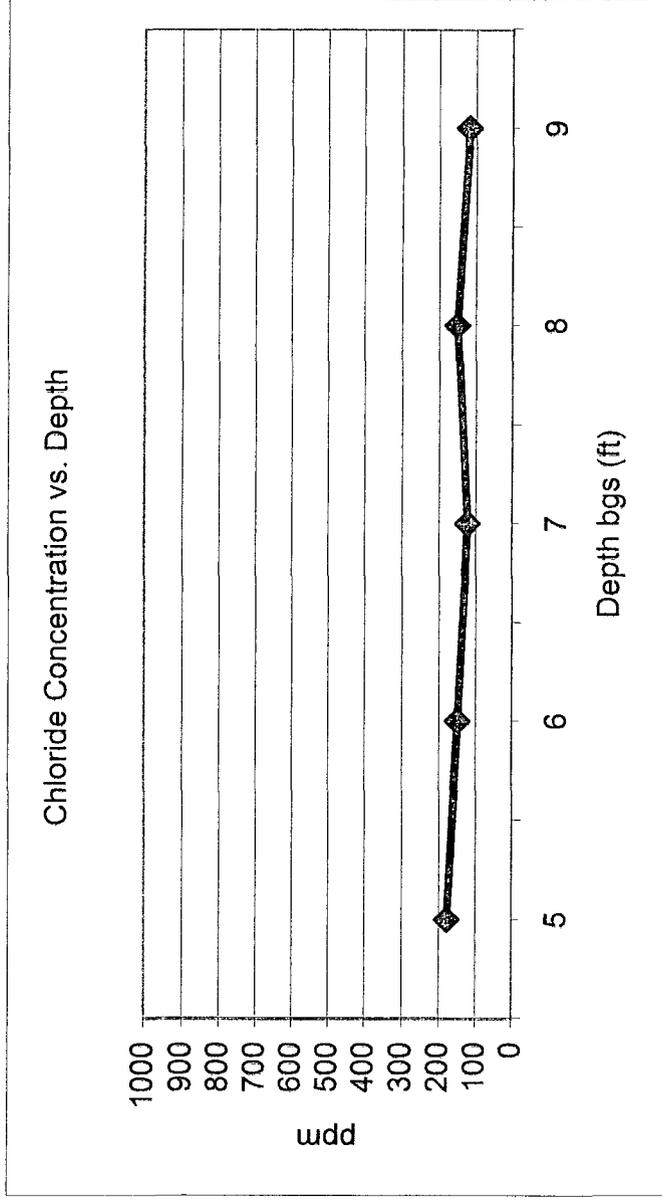
CHLORIDE CONCENTRATION CURVE

Backhoe samples at the junction (source)

Depth bgs (ft)	Cl ppm
5	178
6	149
7	122
8	150
9	118

Groundwater = 57 ft
