EME Jct O-16

RICE OPERATING COMPANY
JUNCTION BOX FINAL REPORT

SWD SYSTEM	JUNCTION	UNIT	SECTION	TOWNSHIP	RANGE	COUNTY	BOX DIMENSIONS - FEET		
							Length	Width	Depth
Eunice Monument Eumont (EME)	Jct. O-16	O	16	21S	36E	Lea	eliminated

EME Jct. O-16

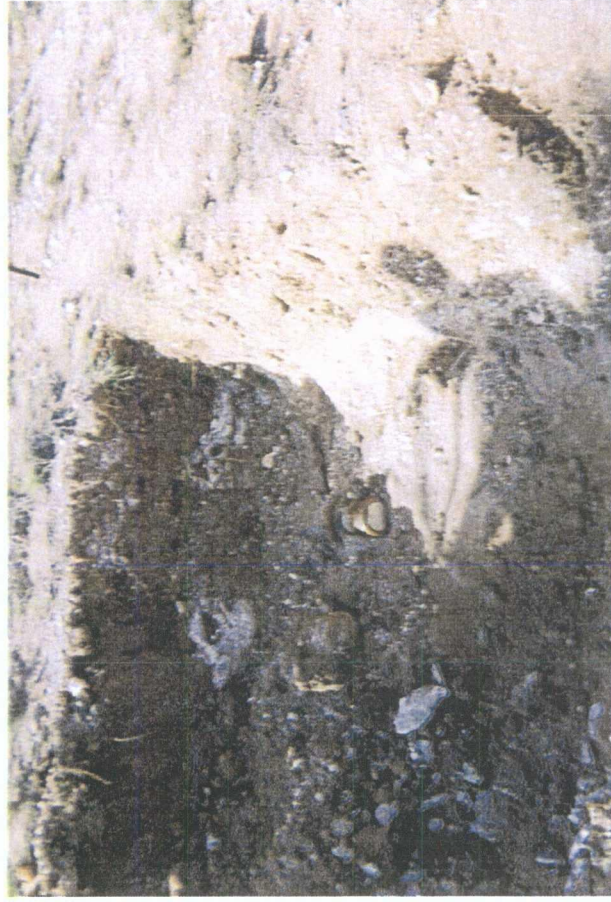
10/21/2008

site prior to excavation, facing north

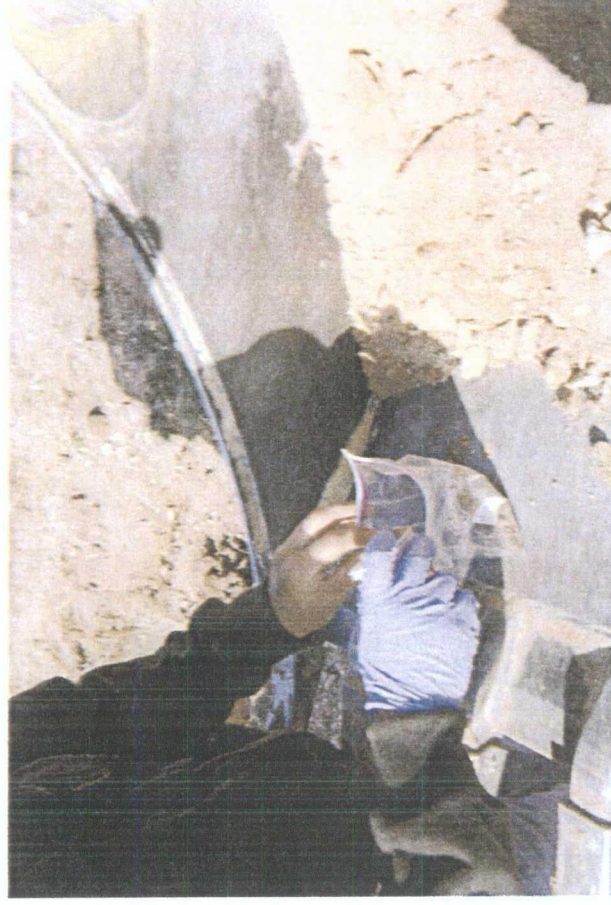
10/21/2008

collecting a soil sample, facing west

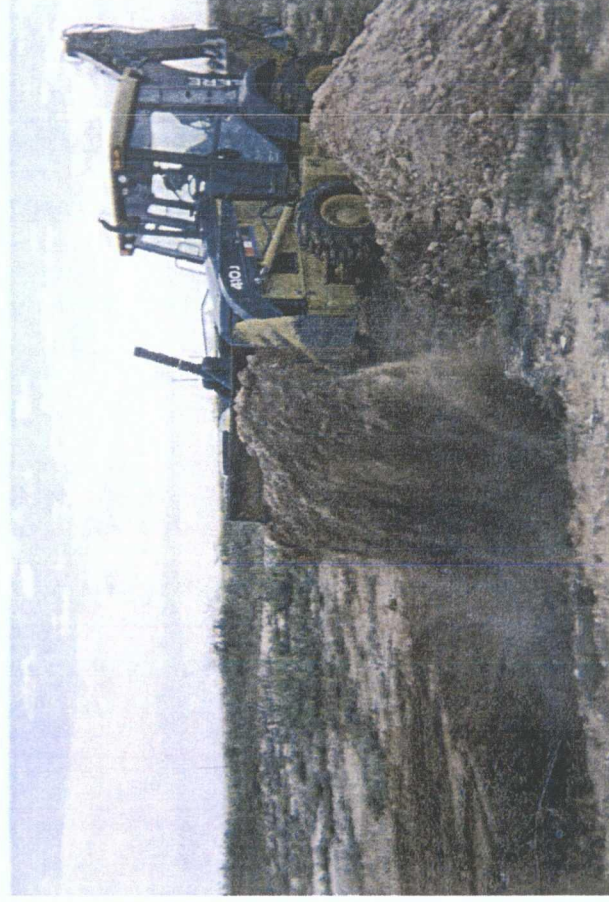
10/21/2008

backfilling excavation, facing east

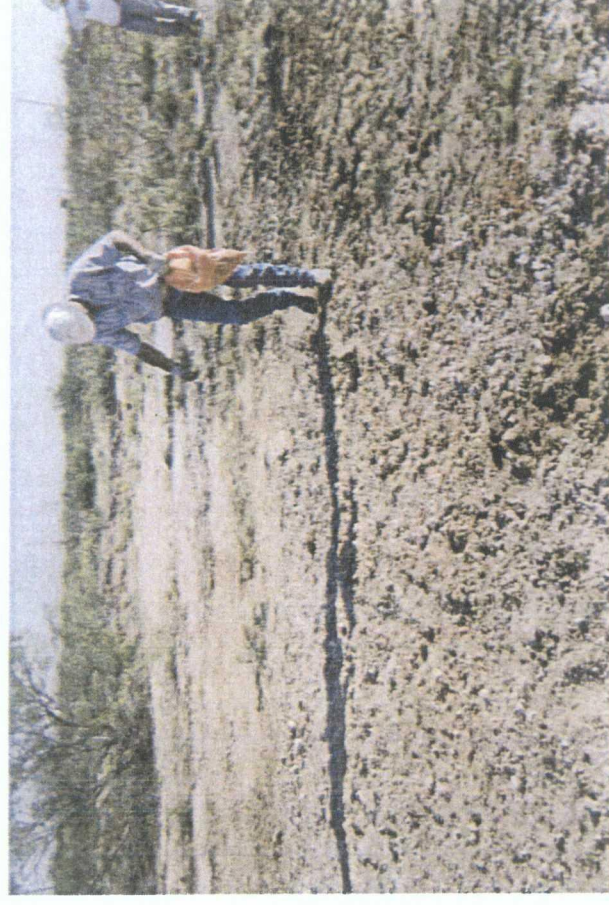
10/31/2008

seeding backfilled site, facing north
