EME Jct A-19-1

**RICE OPERATING COMPANY  
JUNCTION BOX FINAL REPORT**

# EME Jct. A-19-1

Unit A, Section 19, T21S, R36E

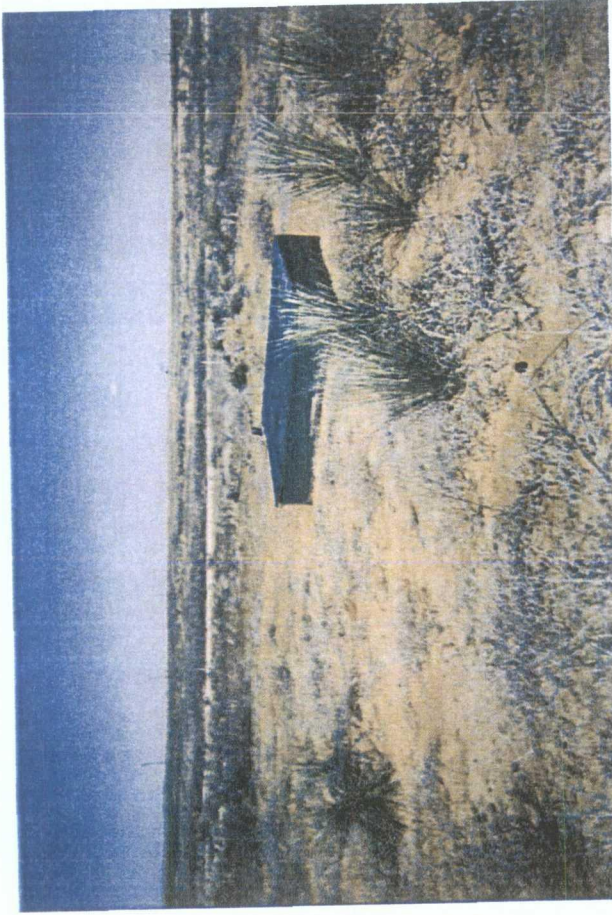
1/28/2005

undisturbed junction box, facing north

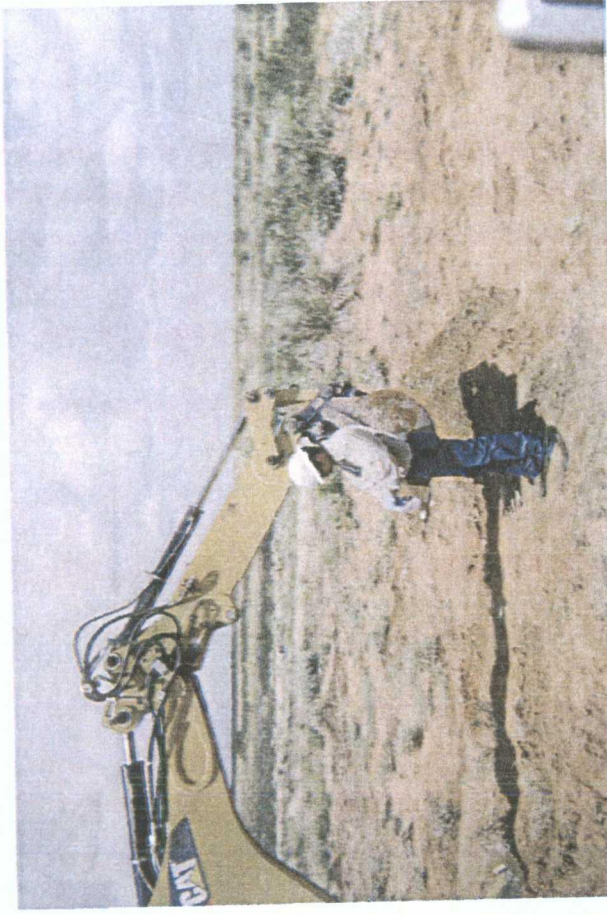
8/27/2008

collecting a soil sample, facing north

pipeline replacement/upgrade program. After the former junction box was removed, an investigation was conducted using a backhoe to collect soil samples at regular intervals producing a 15x15x12-ft-deep excavation. Chloride field tests performed on each sample yielded generally low concentrations. Organic vapors were measured using a PID, which yielded some elevated concentrations. Representative composite samples were collected and sent to a commercial laboratory for analysis of chloride, TPH, and BTEX. Lab analysis confirmed that chloride, TPH, and BTEX were all within limits. The excavated soil was blended on-site and returned to the excavation to ground surface and contoured to the surrounding area. On 9/24/2008, the site was seeded with a blend of native vegetation and is expected to return to a productive capacity at a normal rate.

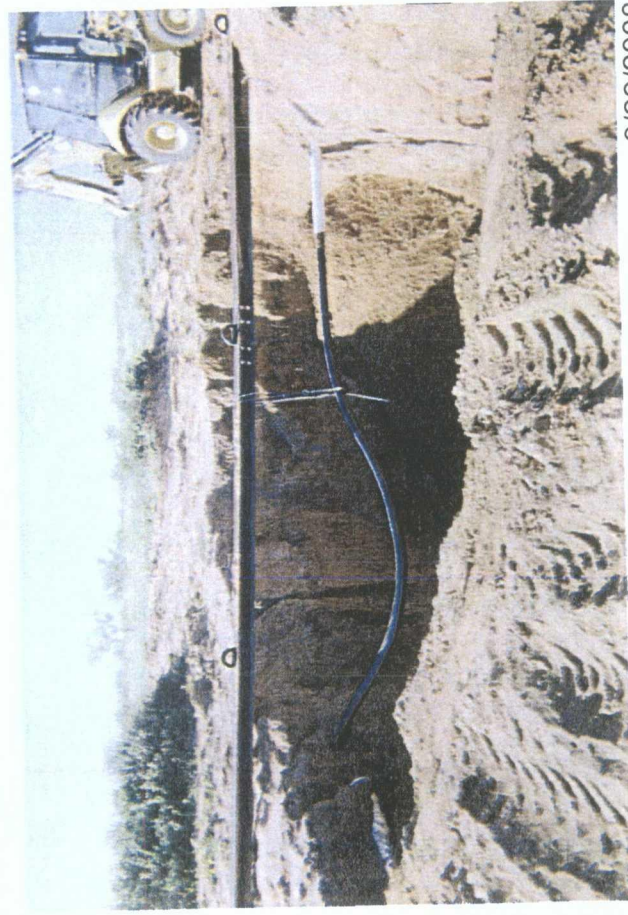
9/22/2008

final excavation

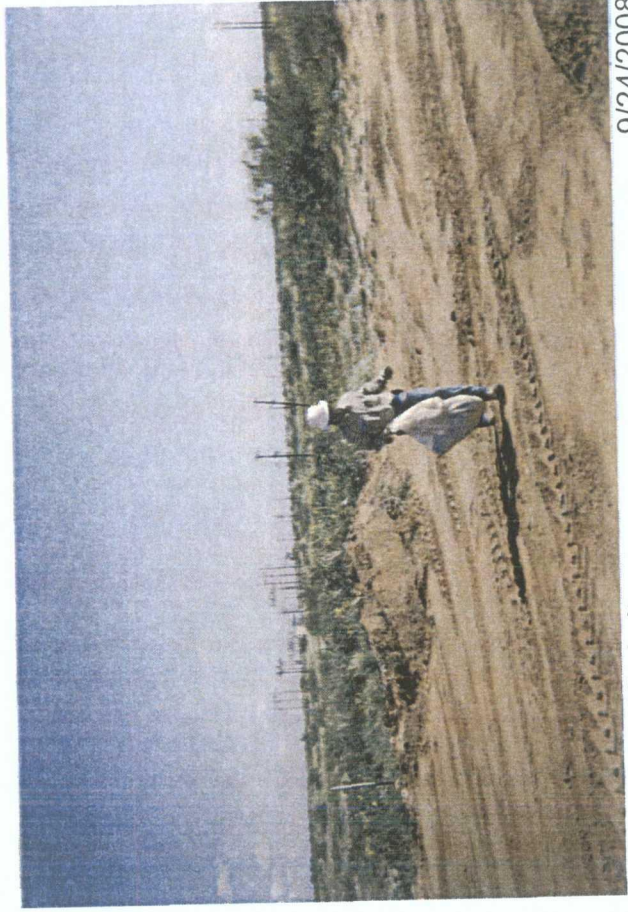
9/24/2008

seeding backfilled site

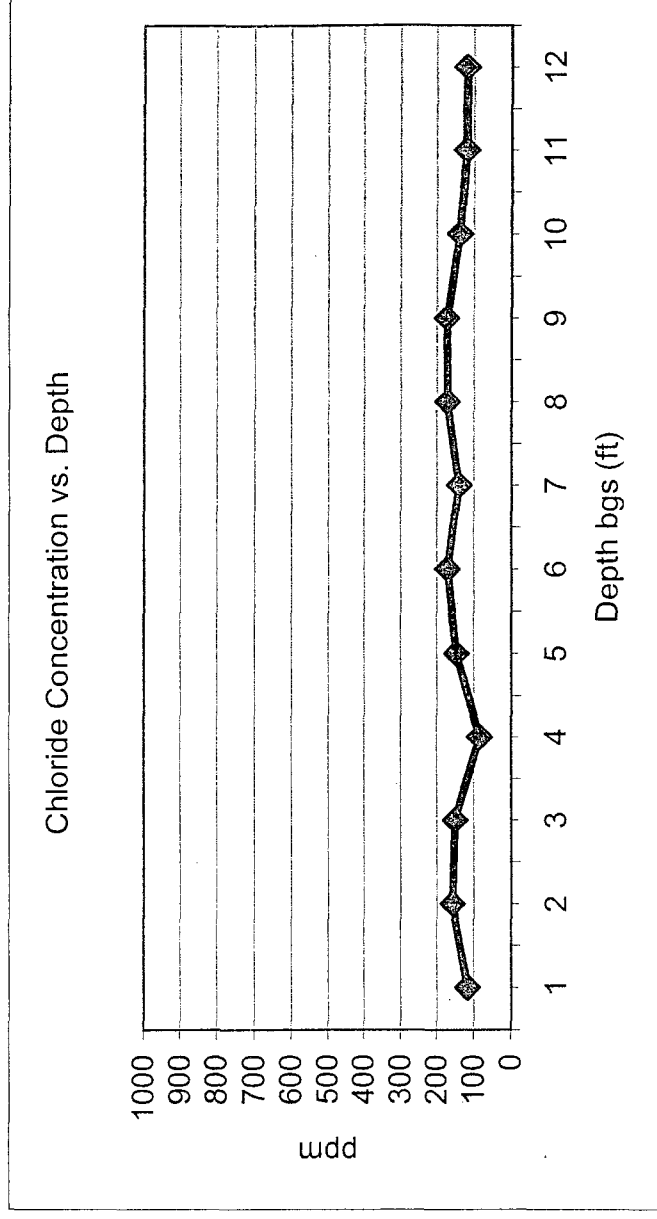
# EME Jct. A-19-1

Backhoe samples at 15 ft south of the junction (source)

Depth bgs (ft)	[Cl] ppm
1	116
2	157
3	150
4	84
5	147
6	171
7	140
8	172
9	173
10	138
11	120
12	120

Groundwater = 170 ft

LOCATION	DEPTH	mg/kg
4-wall comp.	n/a	142
bottom comp.	12'	199
blended backfill	n/a	243
background	6"	150
vertical delineation trench at 15 ft south of the junction (source)	1'	116
	2'	157
	3'	150
	4'	84
	5'	147
	6'	171
	7'	140
	8'	172
	9'	173
	10'	138
	11'	120
	12'	120
