**Release Notification and Corrective Action**

1RP-2012

**Soil Closure Compliance Report**

Plains Pipeline, L.P.  
 Hugh Gathering Eubanks Discharge 4"  
 SE 1/4 of NE 1/4 Section 22, Township 21S, Range 37E  
 2.5 Miles North of Eunice, Lea County, New Mexico  
 New Mexico Oil Conservation Division Number 1RP-2012  
 Plains All American Pipeline Leak Number 2008-311  
 Terracon Project Number A4087125

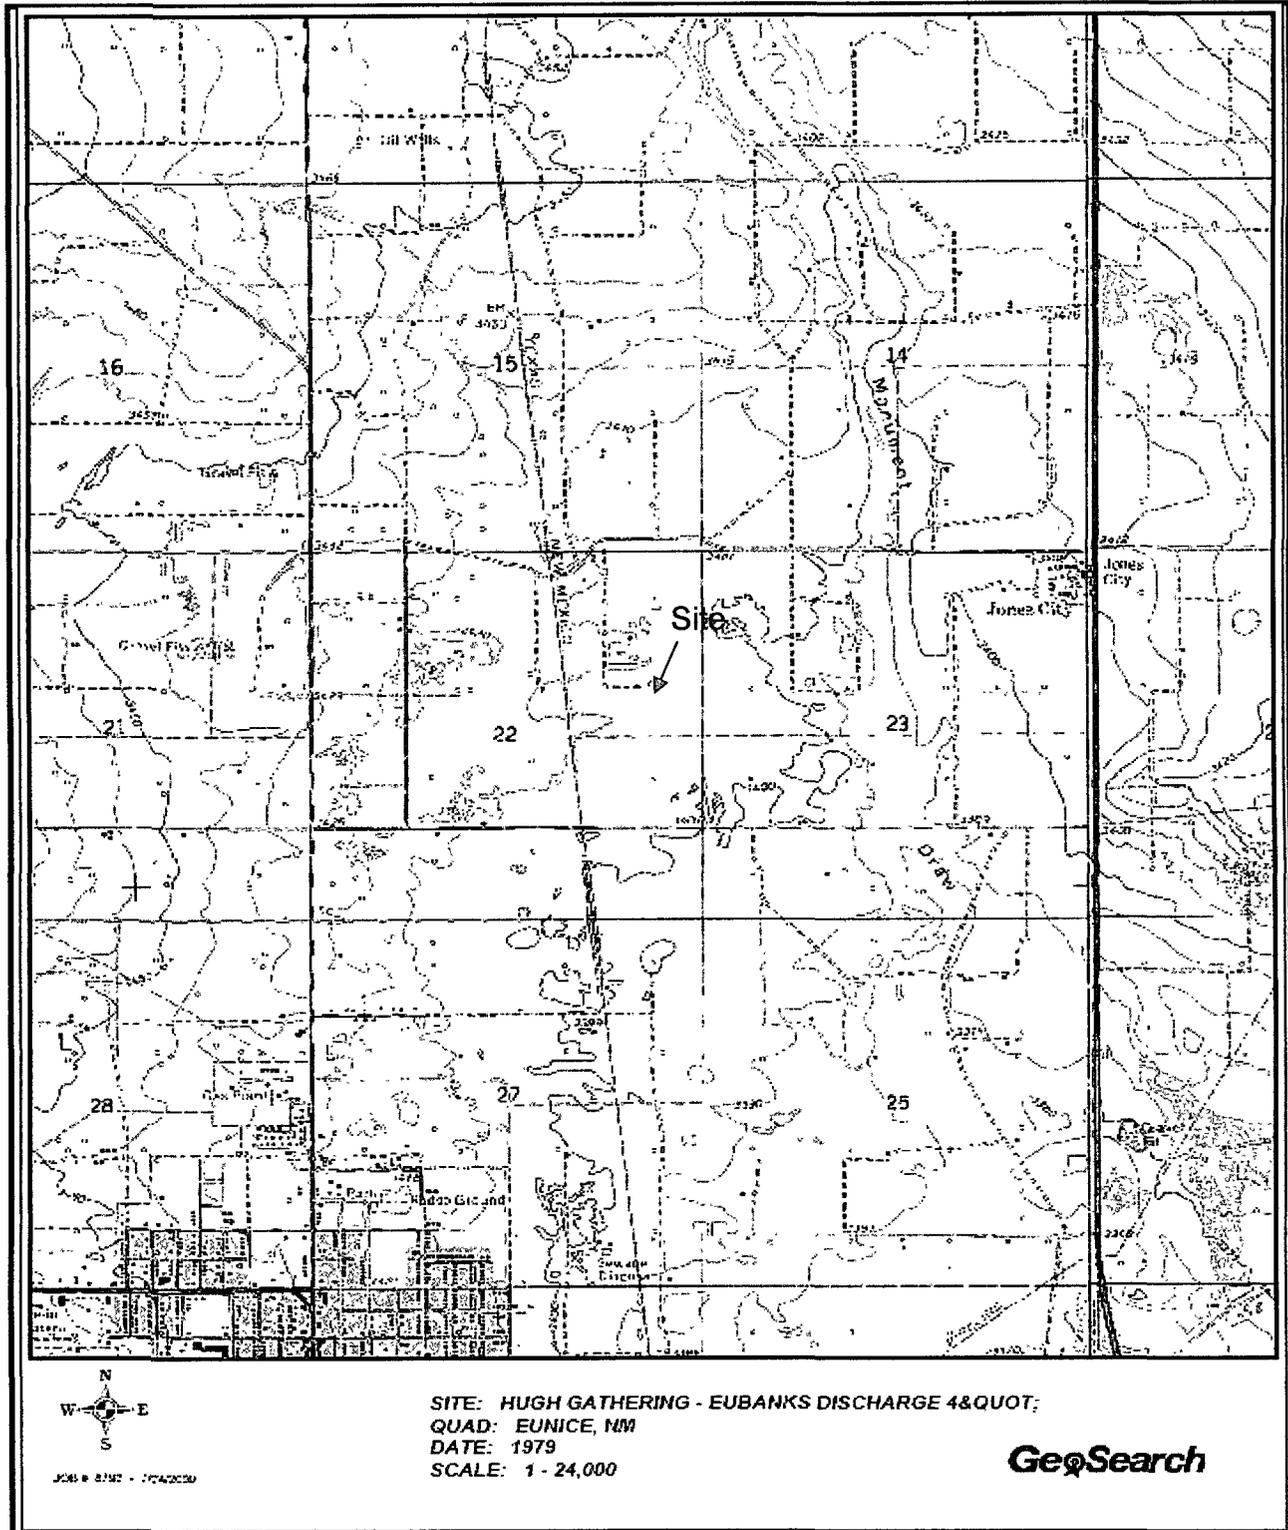
**USGS TOPOGRAPHIC QUADRANGLE MAP**  
 Eunice, New Mexico  
 Dated: 1979  
 SCALE: 1" = 1,600'  
 PROJECT NO. A4087125

**Hugh Gathering Eubanks Discharge 4"**  
 Unit Letter H, Section 22, T21S-R37E  
 Plains SRS Number 1RP-2012  
 Lea County, New Mexico  
**FIGURE 1: TOPOGRAPHIC MAP**

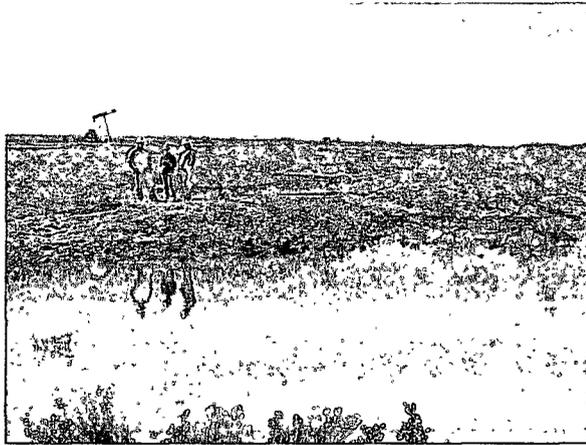
**Photo #1** View of oil-filled depressions, looking northwest.

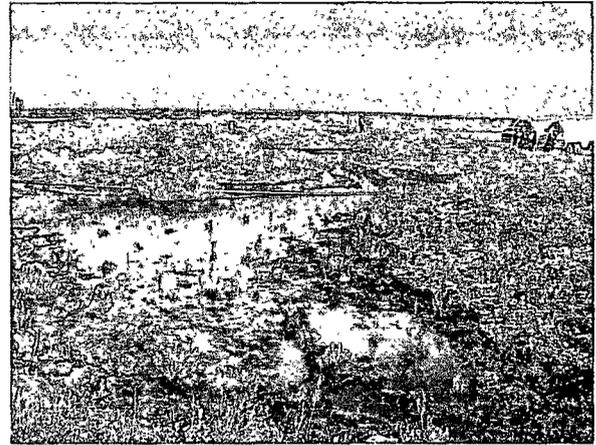
**Photo #2** View of oil recovery efforts, looking easterly.

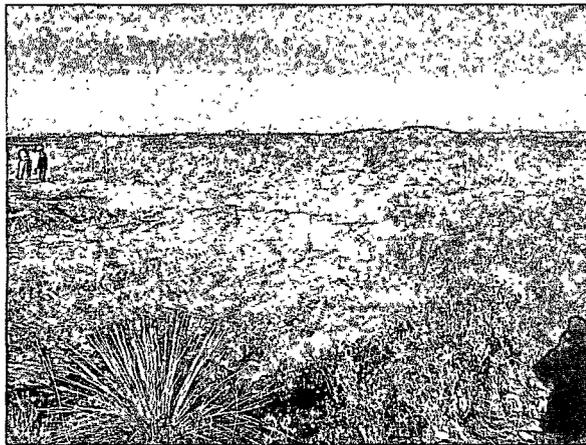
**Photo #3** View of depression following removal of free oil, looking northwest.

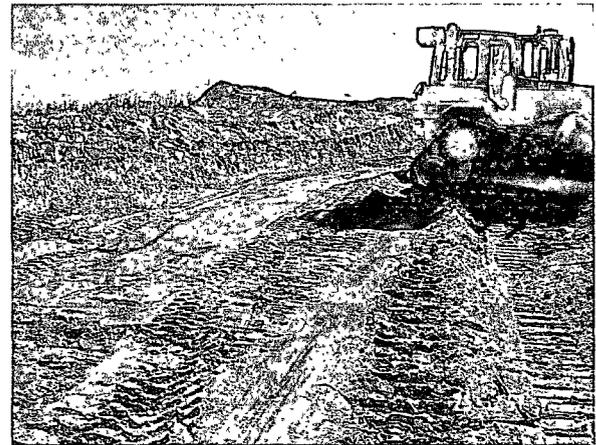
**Photo #4** Soil removal activities.

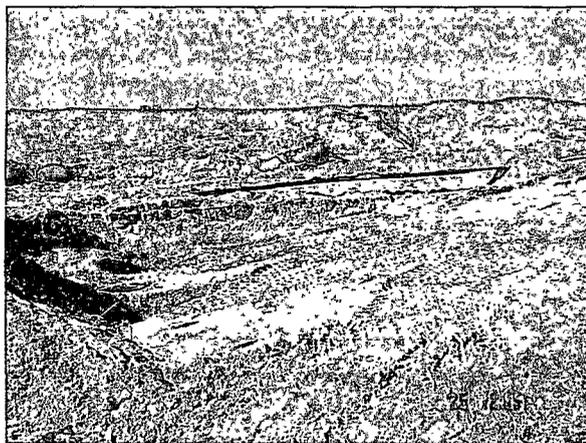
**Photo #5** Soil removal activities.

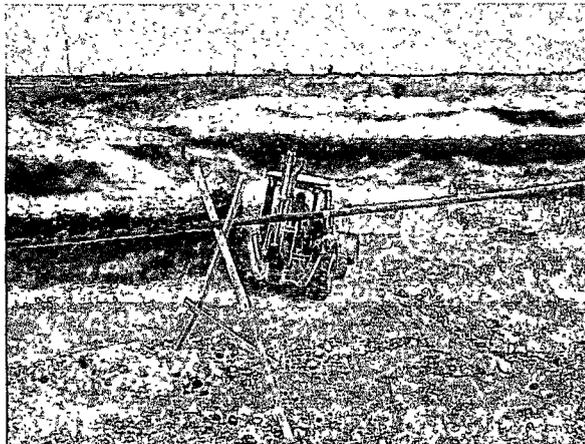
Photo #9 Continued excavation.

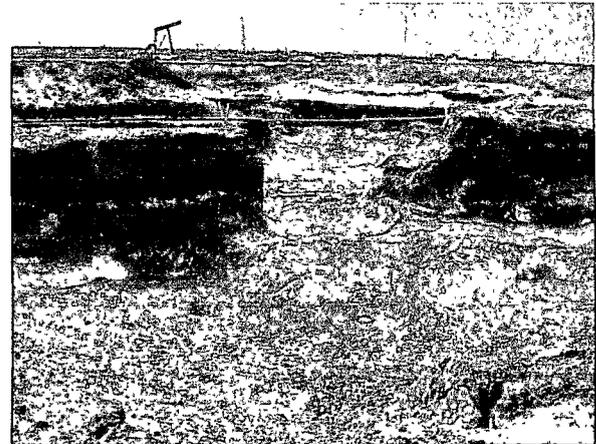
Photo #10 Continued excavation. Red circles denote sample collection locations.

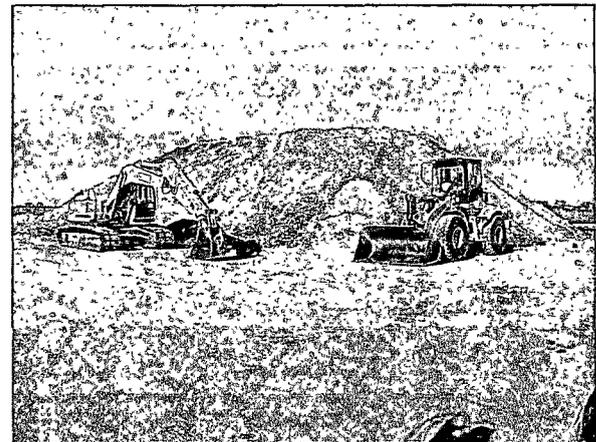
Photo #12 View of stockpile.

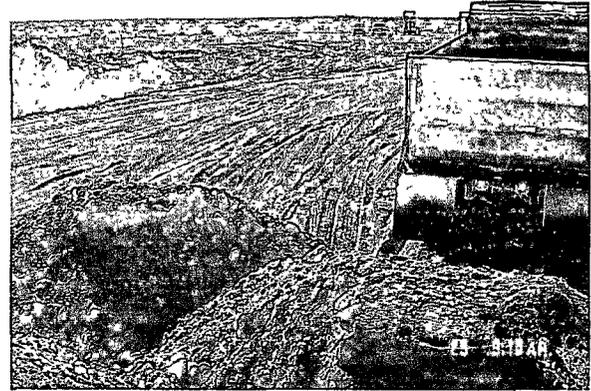
**Photo #14** View of backfill (topsoil) being delivered.

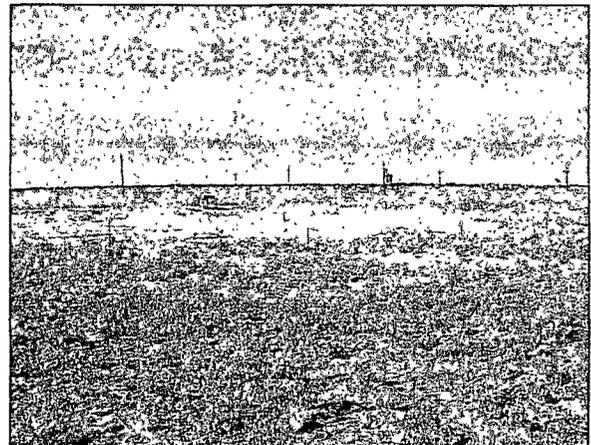
**Photo #16** Final site restoration view.

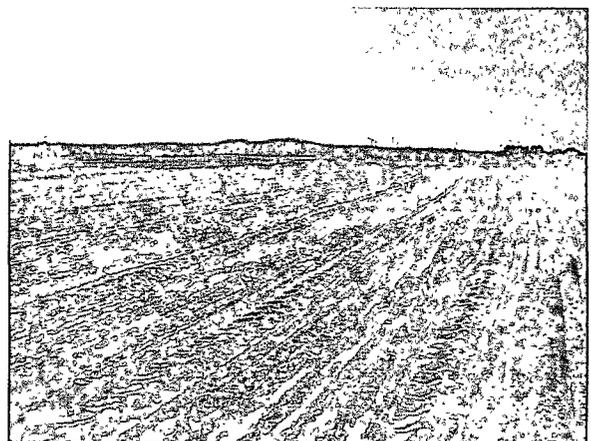
**Photo #18** Final site restoration view.
