Release Notification and Corrective Action

Name of Company: Whiting Oil and Gas Corporation	Contact: Brian Ashburn	
Address: 400 W. Illinois, Suite 1300, Midland, TX 79701	Telephone No.: 432-686-6745	
Facility Name: Flying M, NM # 4, Lease K-2859	Facility Type: Oil & Gas Tank Battery	
Surface Owner: Flying M	Mineral Owner:	Lease No.: 30-025-23187

Subject: Remediation of Hydrocarbon Impacted Soil
Flying M, NM #4 Tank Battery (K-2859)
Lea County, New Mexico

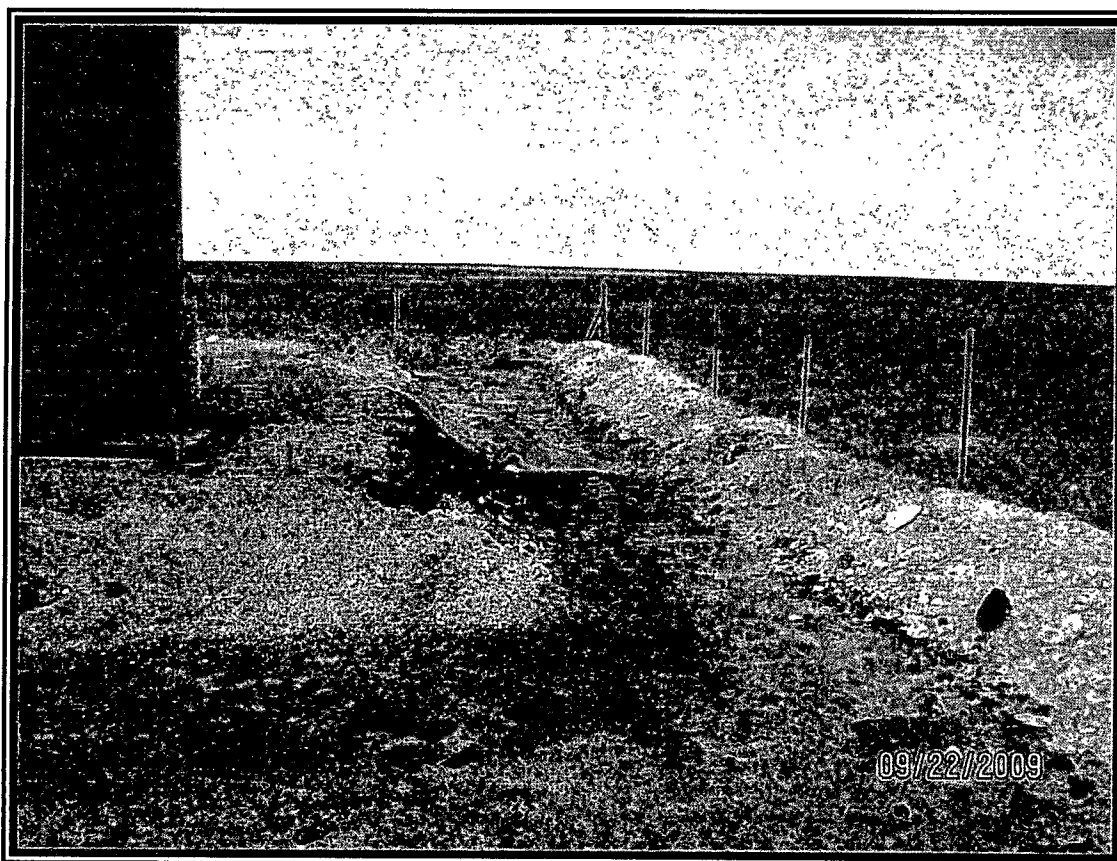
Photo 2 – Flying M Tank Battery prior to start of remediation.

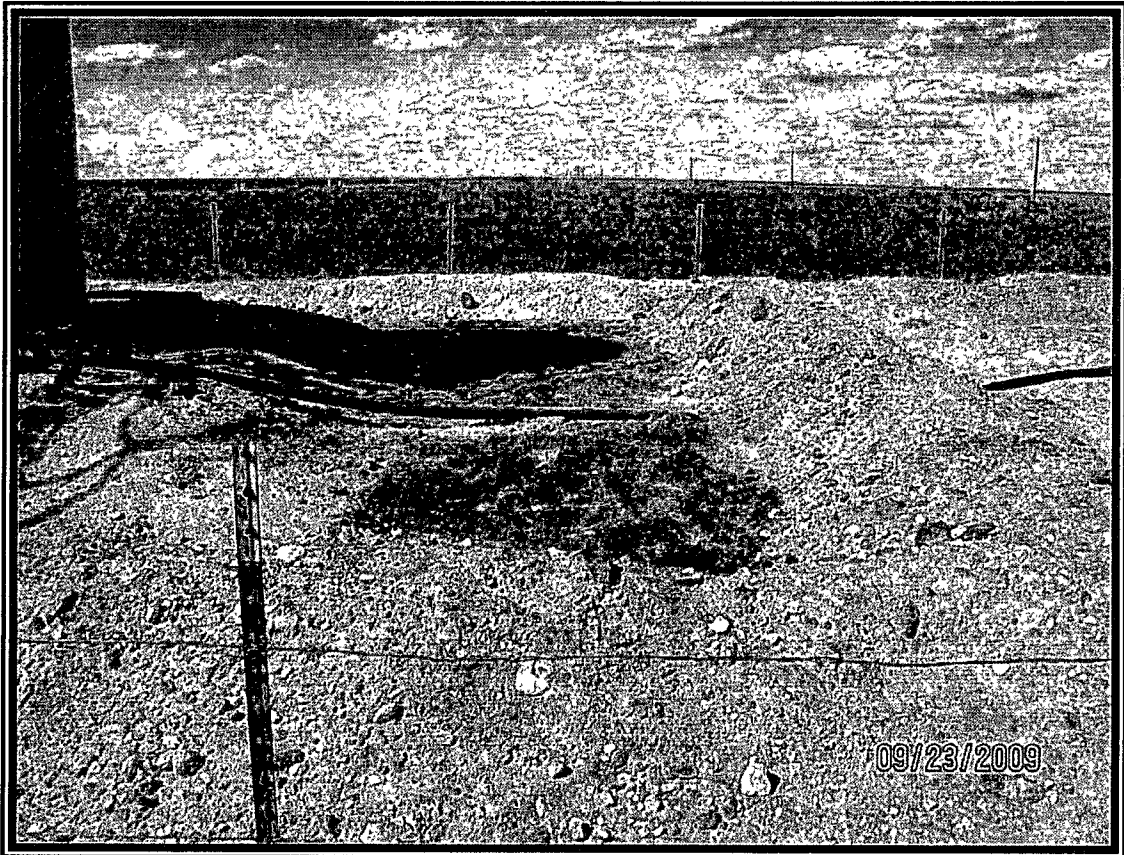
Photo 3 – After initial remedial activities.

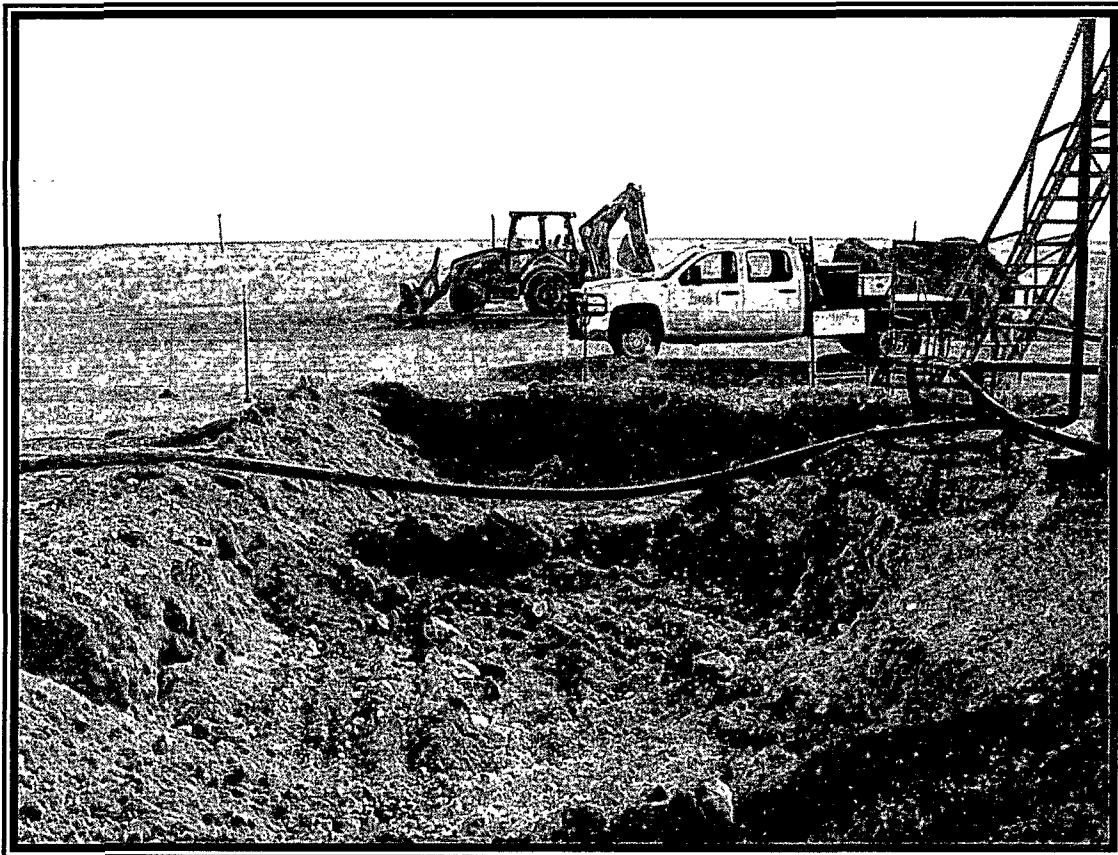
Photo 5 – Tank battery during secondary remediation activities.
