RICE OPERATING COMPANY

JUNCTION BOX FINAL REPORT

EME Jct. L-19-1 EOL

Unit L, Section 19, T20S, R37E

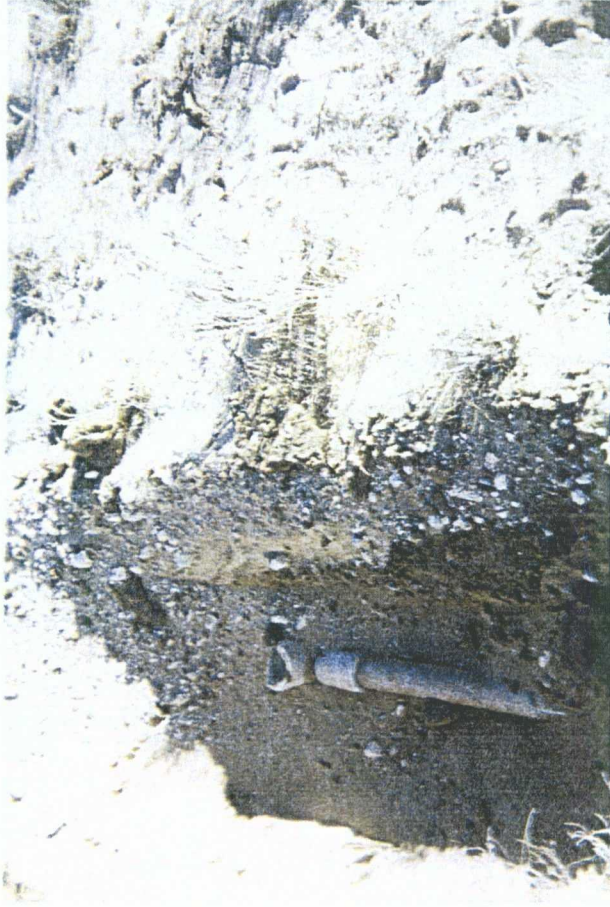
1/7/2009

capped lines at former junction box, facing north

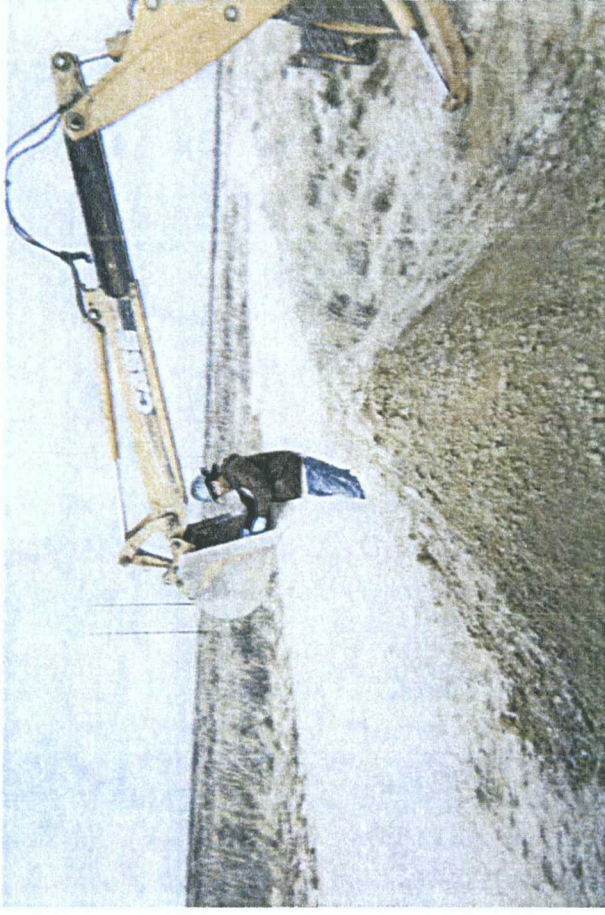
1/7/2009

collecting a soil sample, facing northwest

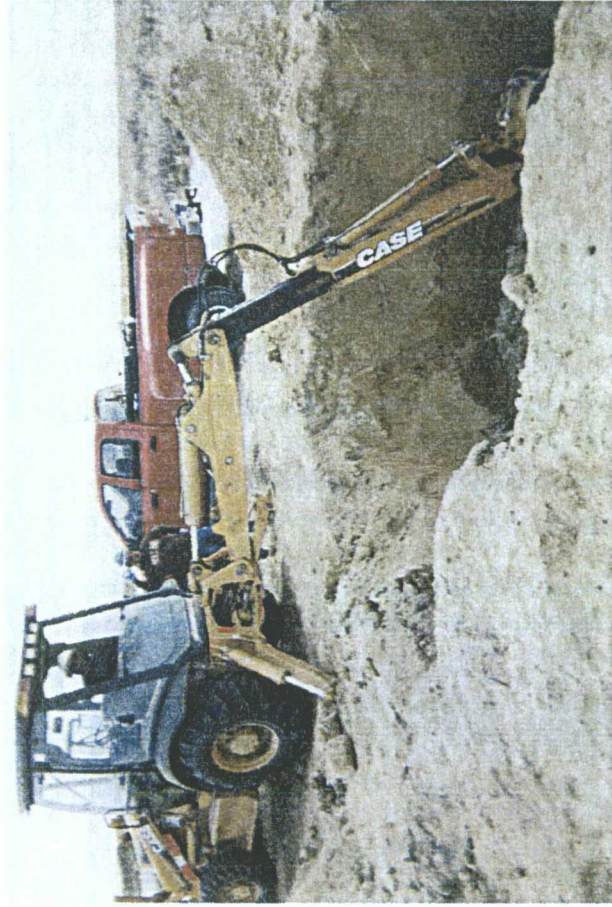
1/7/2009

excavation at former junction box, facing southwest

General Description of Remedial Action: This junction box was eliminated during the pipeline replacement/upgrade program. After the former junction box was removed, an investigation was conducted using a backhoe to collect soil samples at regular intervals producing a 10x10x12-ft-deep excavation. Chloride field tests performed on each sample yielded low concentrations similar to that of the background. Organic vapors were measured using a PID which also yielded low concentrations. A 5-point bottom composite and a backfill composite sample was analyzed by a commercial laboratory which confirmed low concentrations. A 4-wall composite sample was not taken due to the safety concern of unstable walls. The excavated soil was returned to the excavation to ground surface and contoured to the surrounding area. On 2/13/2009, the site was seeded with a blend of native vegetation and is expected to return to a productive capacity at a normal rate.

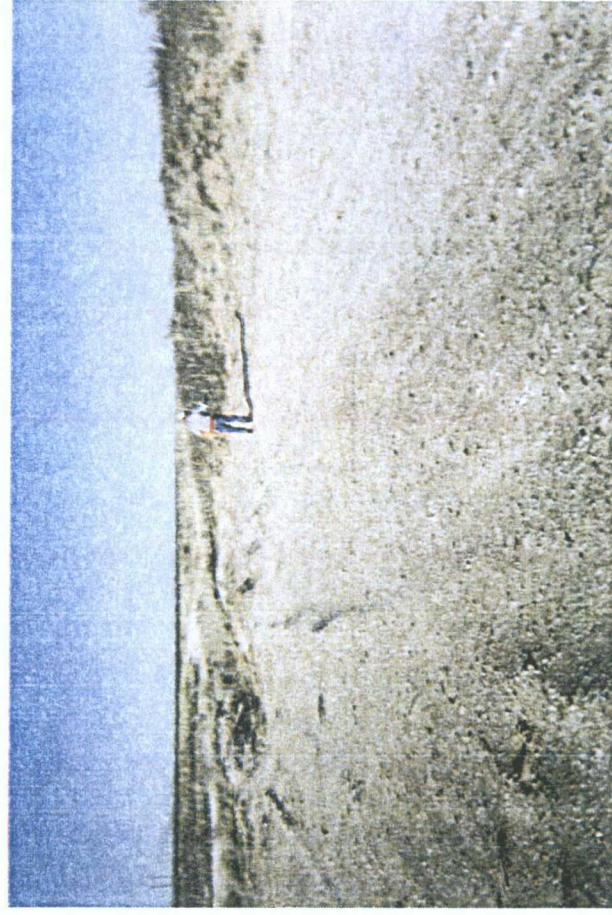
2/13/2009

seeding backfilled site, facing north

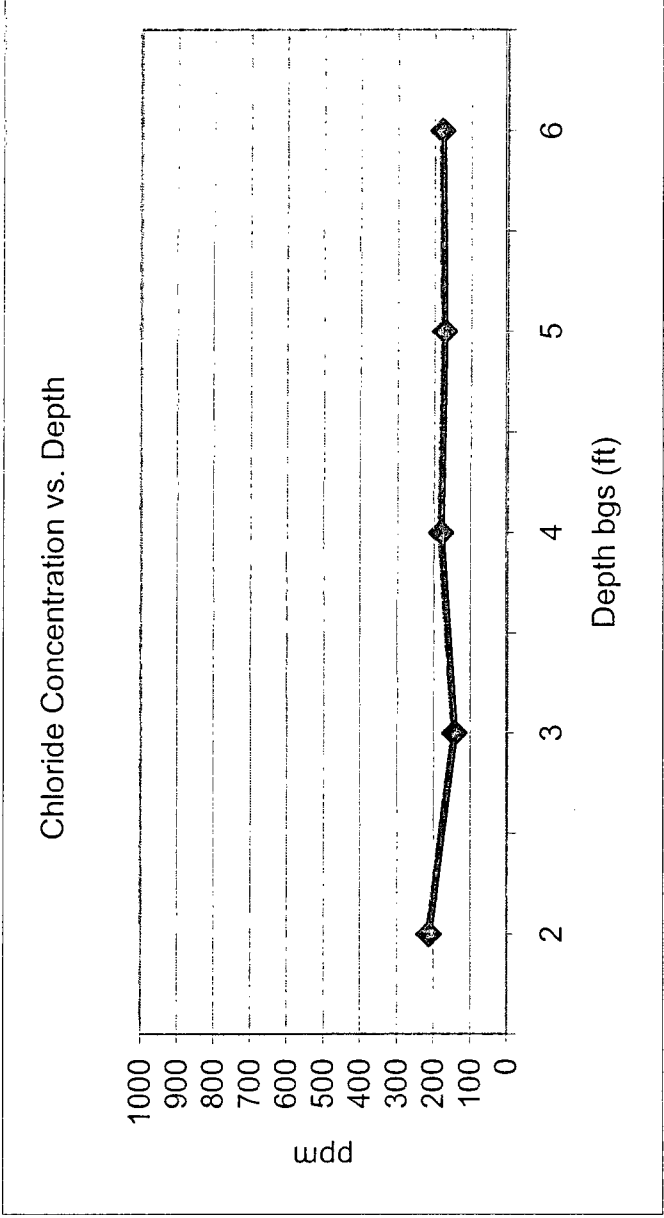
Backhoe samples at the junction (source)

Depth bgs (ft)	[Cl ⁻] ppm
2	212
3	142
4	179
5	169
6	175
7	196
8	182
9	141
10	198
11	198
12	143

Groundwater = 32 ft
