RICE OPERATING COMPANY  
JUNCTION BOX FINAL REPORT

| SWD SYSTEM | JUNCTION | UNIT | SECTION | TOWNSHIP | RANGE | COUNTY | BOX DIMENSIONS - FEET | | |
|---|---|---|---|---|---|---|---|---|---|
| Blinebry-Drinkard (BD) | Jct. A-1 | A | 1 | 22S | 36E | Lea | Length 4' | Width 5' | Depth 6'6" |

## BD Jct. A-1

Unit A, Section 1, T22S, R36E

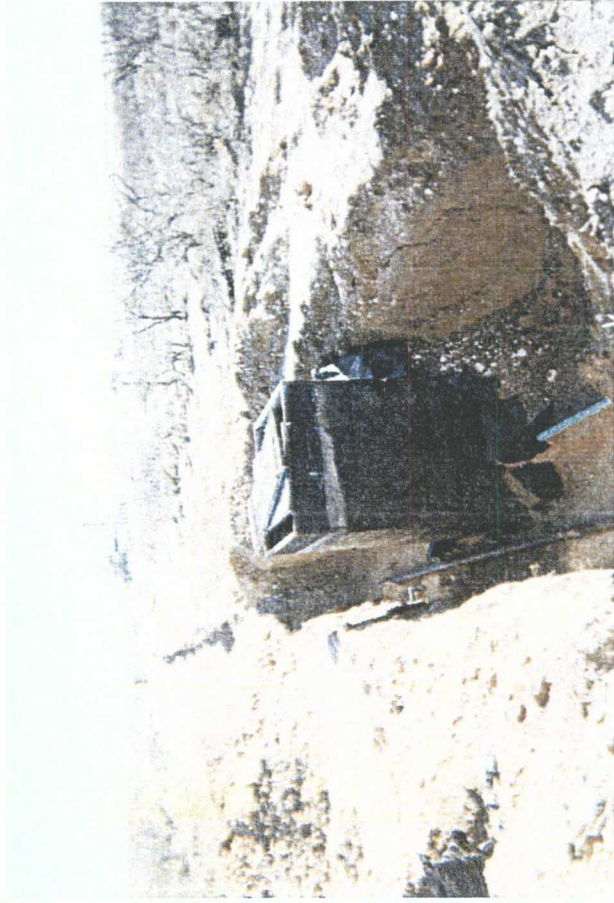
former junction box, facing northeast

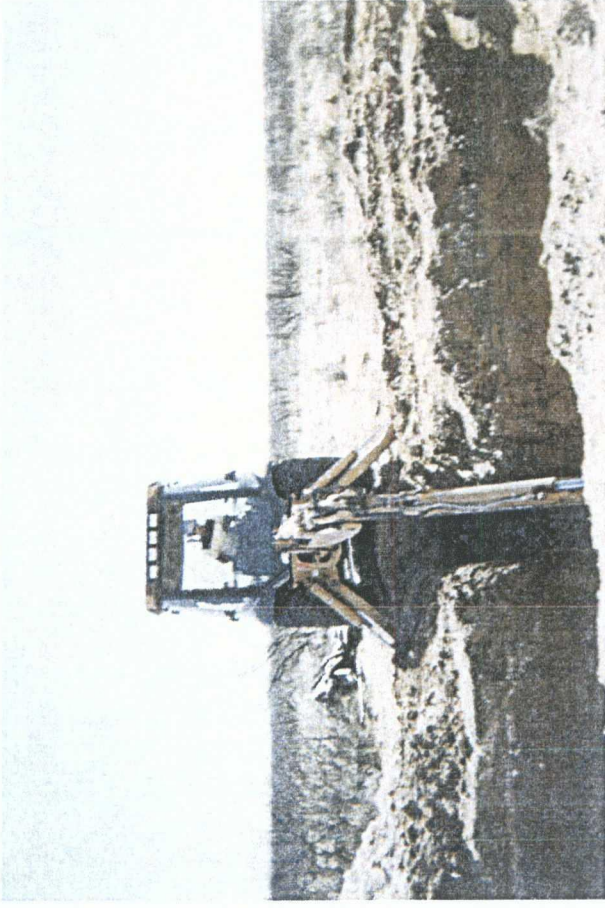
excavating at former junction site, facing east

**General Description of Remedial Action:** This junction box was eliminated during the pipeline replacement/upgrade program. After the former junction box was removed, an investigation was conducted using a backhoe to collect soil samples at regular intervals producing a 3x6x12-ft-deep excavation. Field data suggests the site is low in chlorides and organic vapors are similar to background concentrations. The deepest sample, 12-ft BGS, was sent to a commercial laboratory for analysis of chloride and TPH which confirmed low concentrations. The excavated soil was returned to the excavation and clean, imported soil was used as a top cap and to contour the site to the surrounding area. On 3/26/2009, the site was seeded with a blend of native vegetation and is expected to return to a productive capacity at a normal rate.

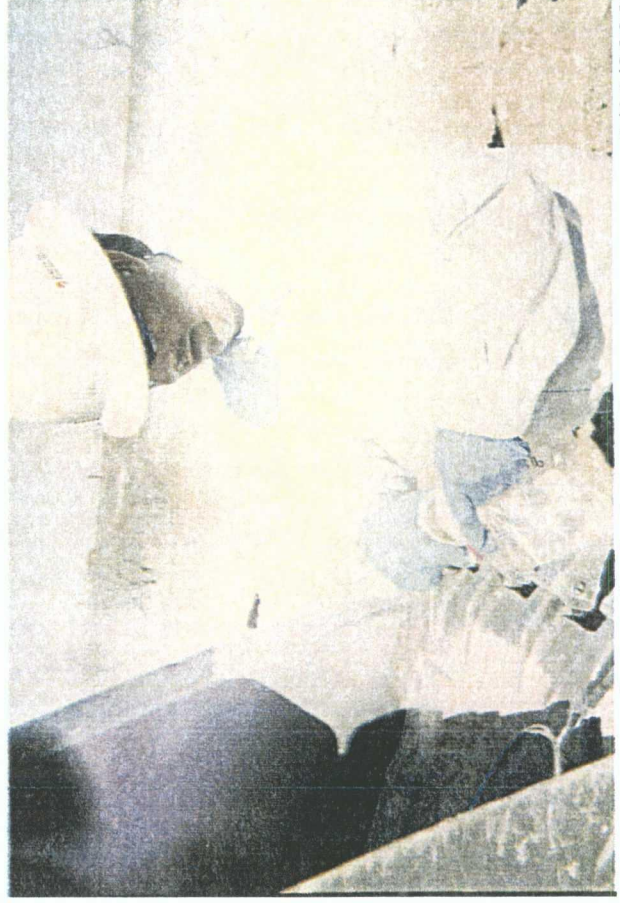
collecting a soil sample, facing east

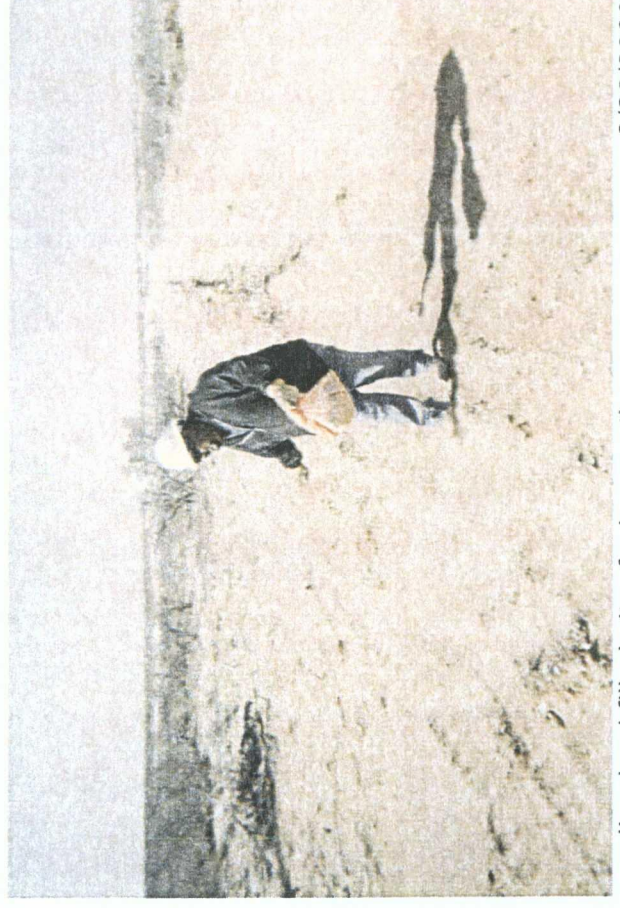
seeding backfilled site, facing south
