RICE OPERATING COMPANY
JUNCTION BOX FINAL REPORTAPP - 6 2010
Environmental Bureau
Oil Conservation Division

BD K-2 EOL

Unit K, Section 2, T22S, R36E

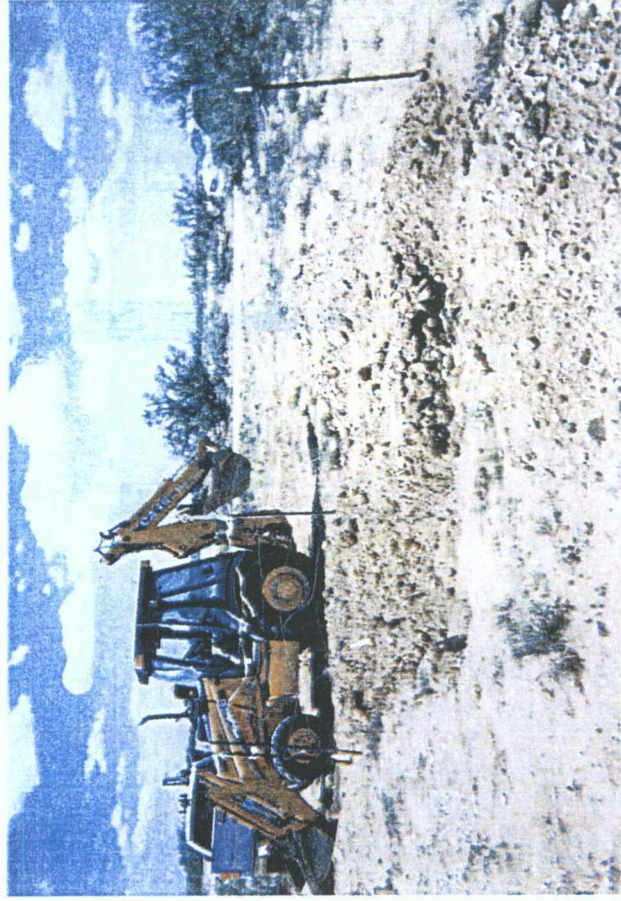
7/24/2009

site prior to excavation, facing west

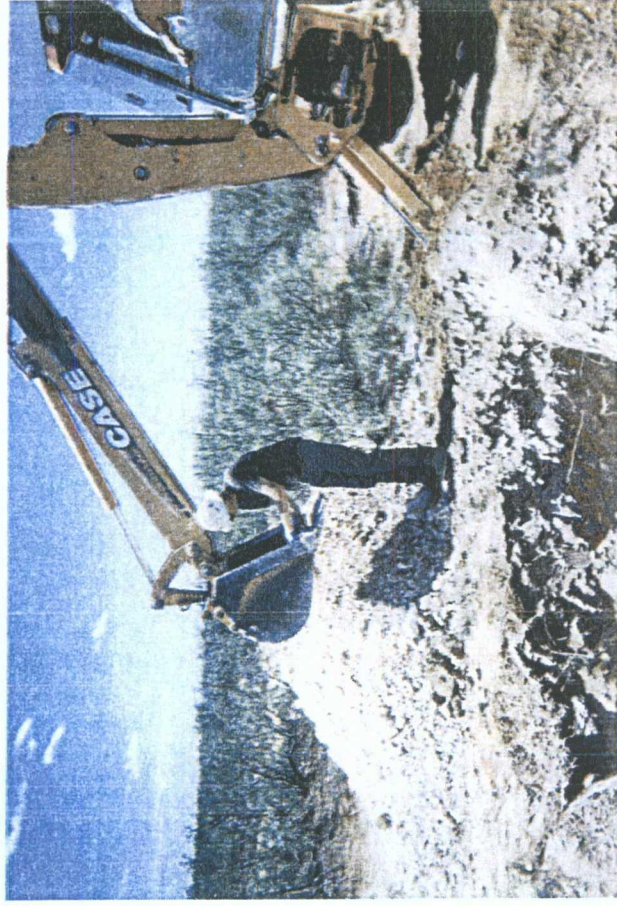
7/29/2009

collecting a soil sample, facing south

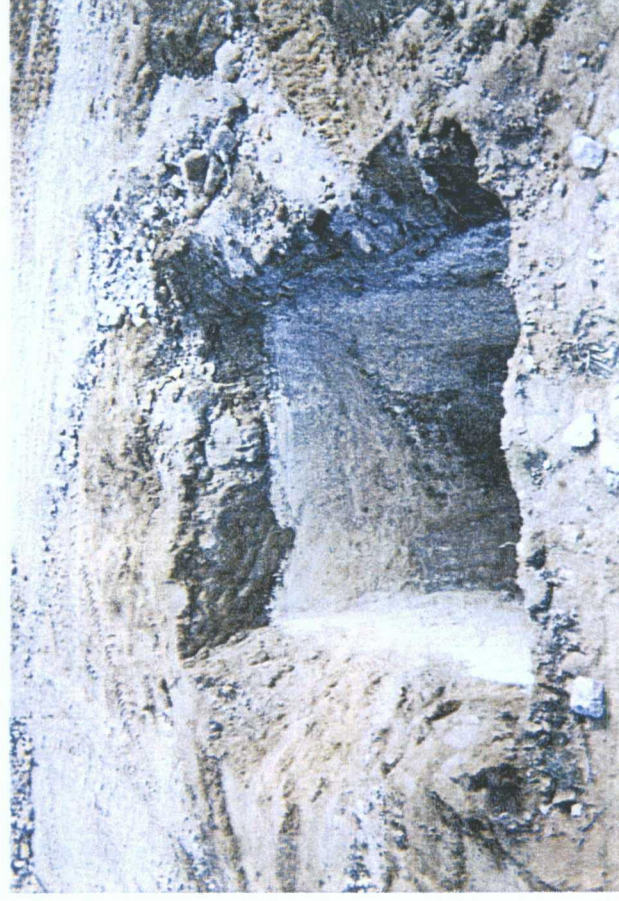
7/30/2009

final 10x10x12-ft excavation, facing north

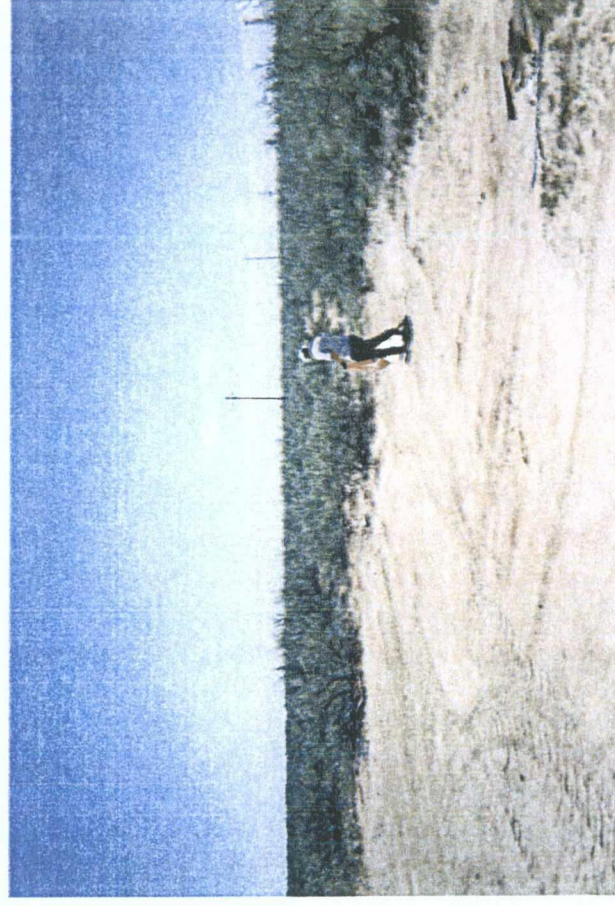
8/7/2009

seeding backfilled site, facing southeast

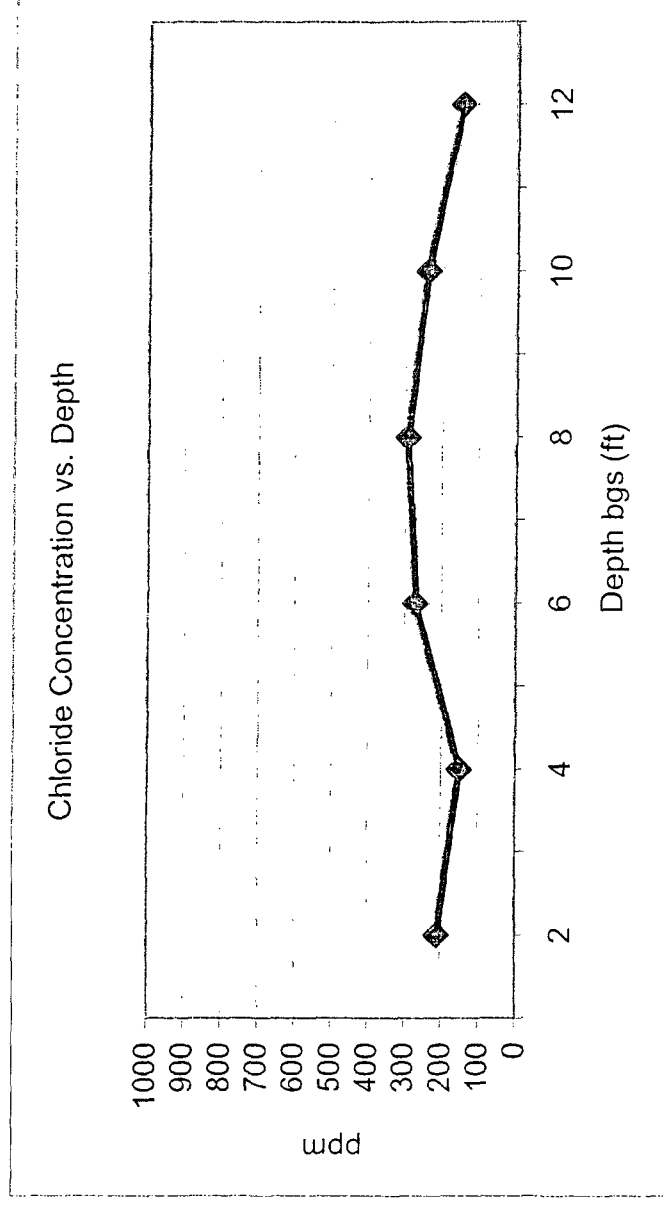
CHLORIDE CONCENTRATION CURVE

Backhoe samples at 5 ft west of the junction (source)

Depth bgs (ft)	[Cl] ppm
2	211
4	150
6	270
8	291
10	238
12	144

Groundwater = 130 ft
