**RE: Corrective Action Plan Report & Termination Request  
NMOCD Case No. 1R427-15  
EME State H EOL  
Rice Operating Company – EME SWD System**

**Rice Operating Company – EME State H EOL**

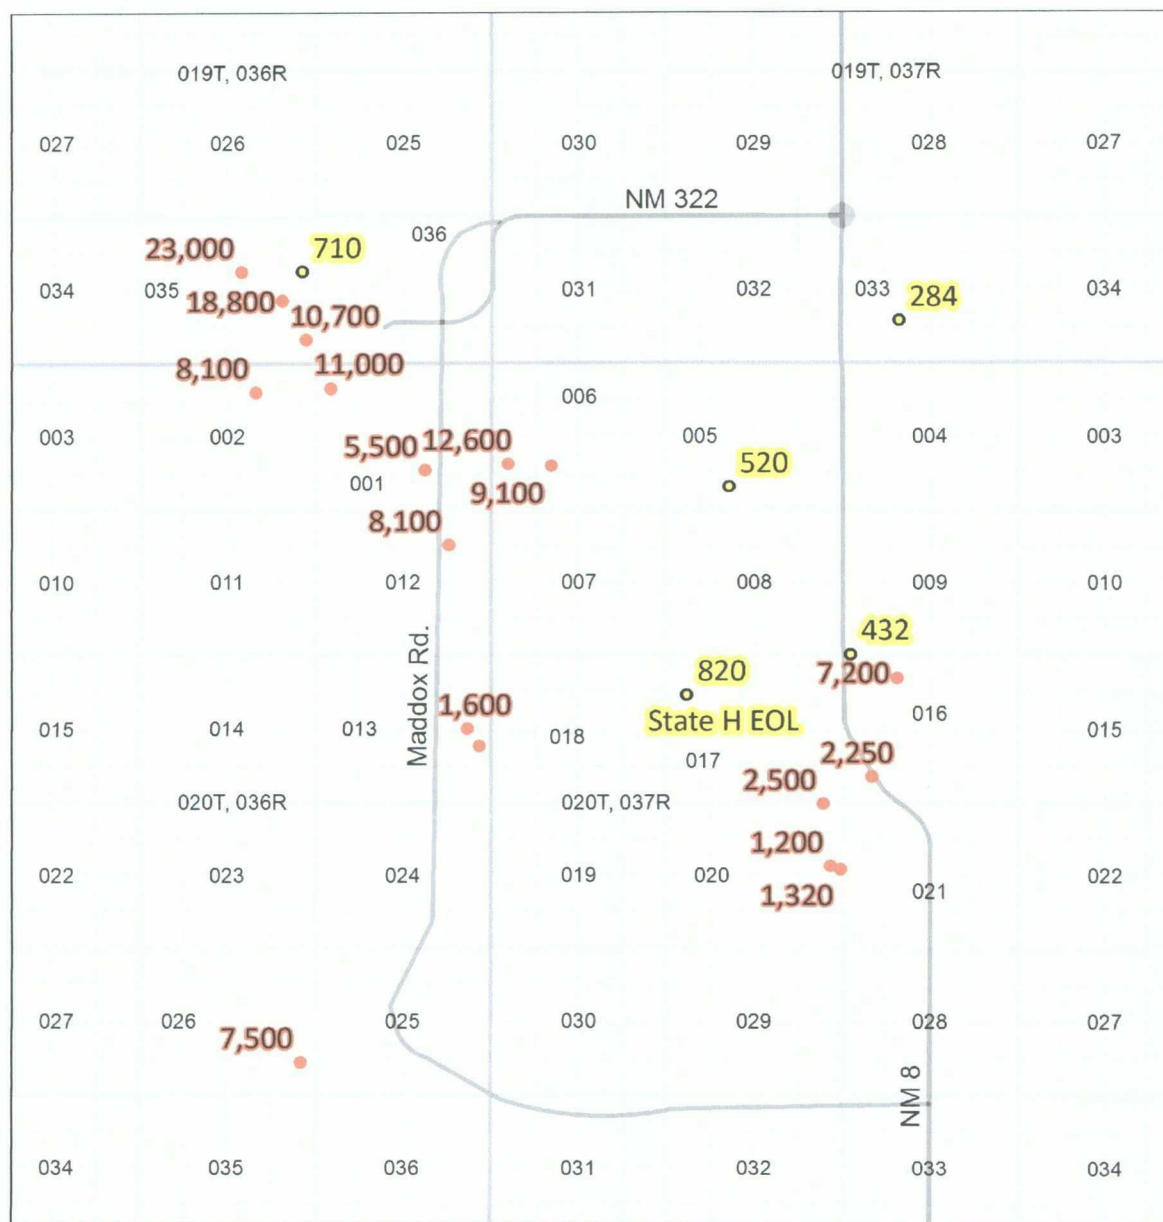
**Figure 1** – Regional groundwater chloride concentrations (in ppm) within the EME field from “up-gradient” monitor wells for various open NMOCD projects. Red font indicates groundwater chloride concentrations greater than 1,000 ppm. The EME State H EOL site is located near the center of the map in Section 017.

Rice Operating Company (ROC) has removed 1,023 lbs of chloride from a recovery well at the EME L-6 location per the NMOCD approved Corrective Action Plan (CAP) for the EME State H EOL site, which is located within a regionally impacted area (Figure 1). This value was estimated per the following calculations:

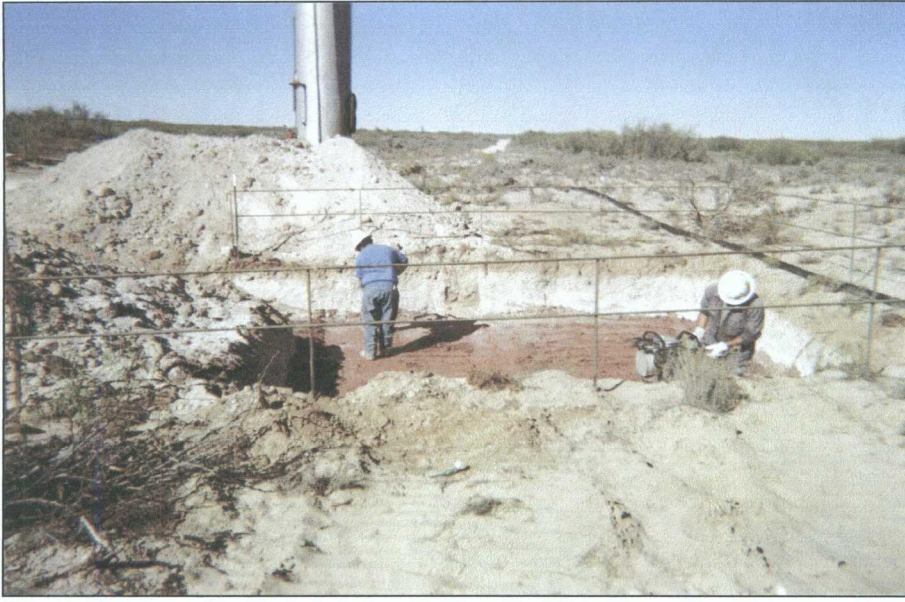
**Figure 3 – Installation of a clay infiltration barrier following removal of the junction box at EMS State H EOL.**

The removal of this mass of chlorides from groundwater at L-6 location was intended to compensate for the potential groundwater impact of residual chlorides at the EME State H EOL site. This was a conservative measure since the State H EOL site is underlain by an installed clay barrier (Figure 3). Additionally, the subsequent restoration of vegetation at the ground surface will enhance evapotranspiration and further limit the downward migration of residual chlorides (Figure 4).

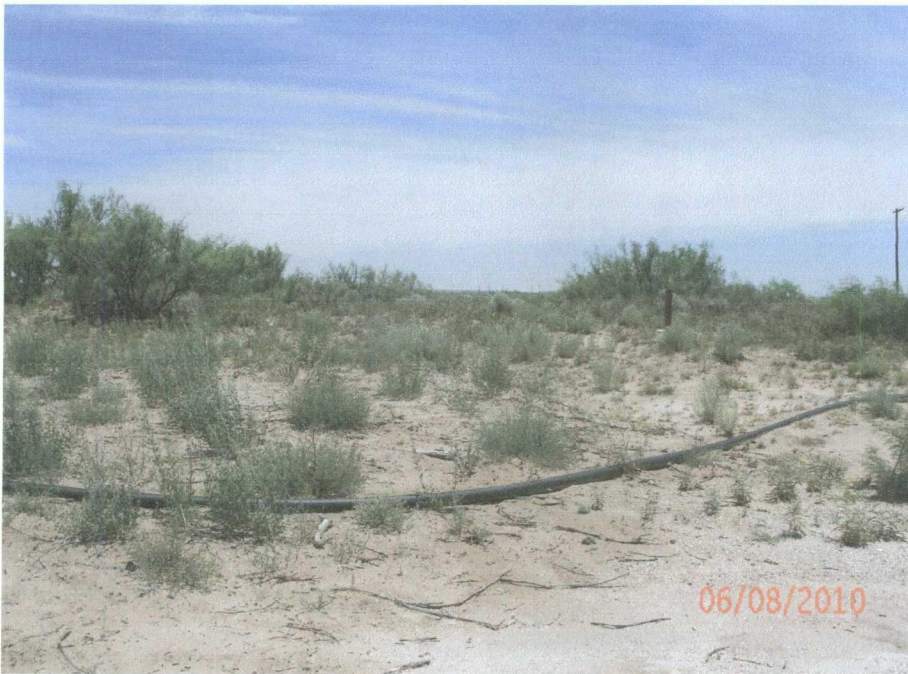
**Figure 4 – Recent photograph (June 2010) of ground surface at EME State H EOL.**
