Release Notification and Corrective Action

**REMEDIATION REPORT**  
**Produced Water Flow Line Leak**  
C.S. Caylor Lease  
1RP-2557  
Lea County, New Mexico

Project No. 10-0112

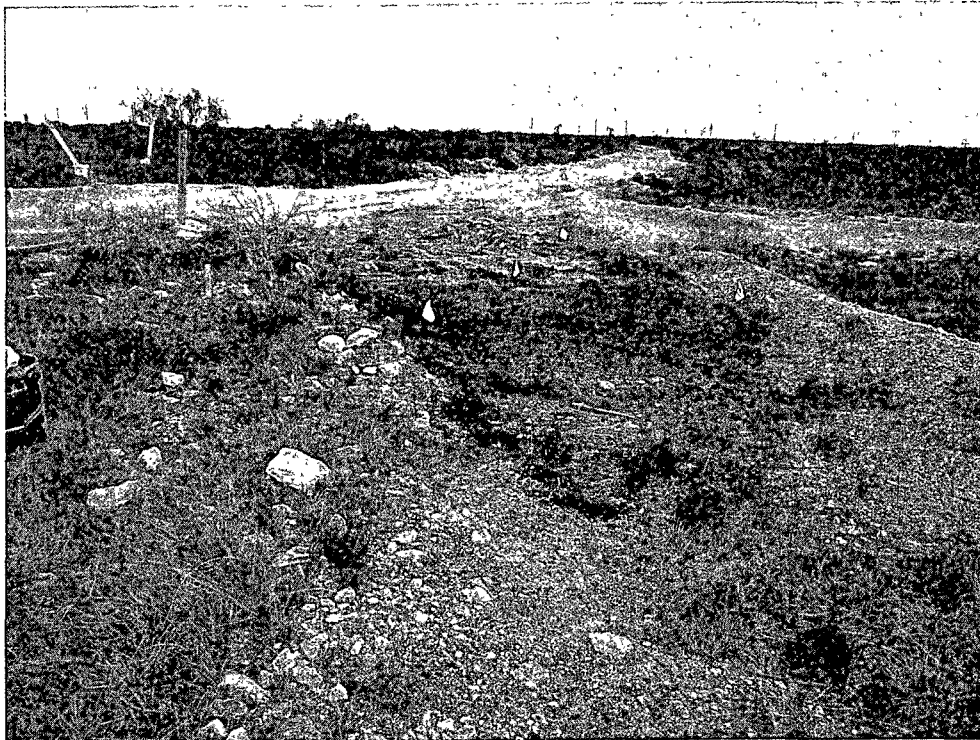
June 3, 2010 - Leak area viewing south.

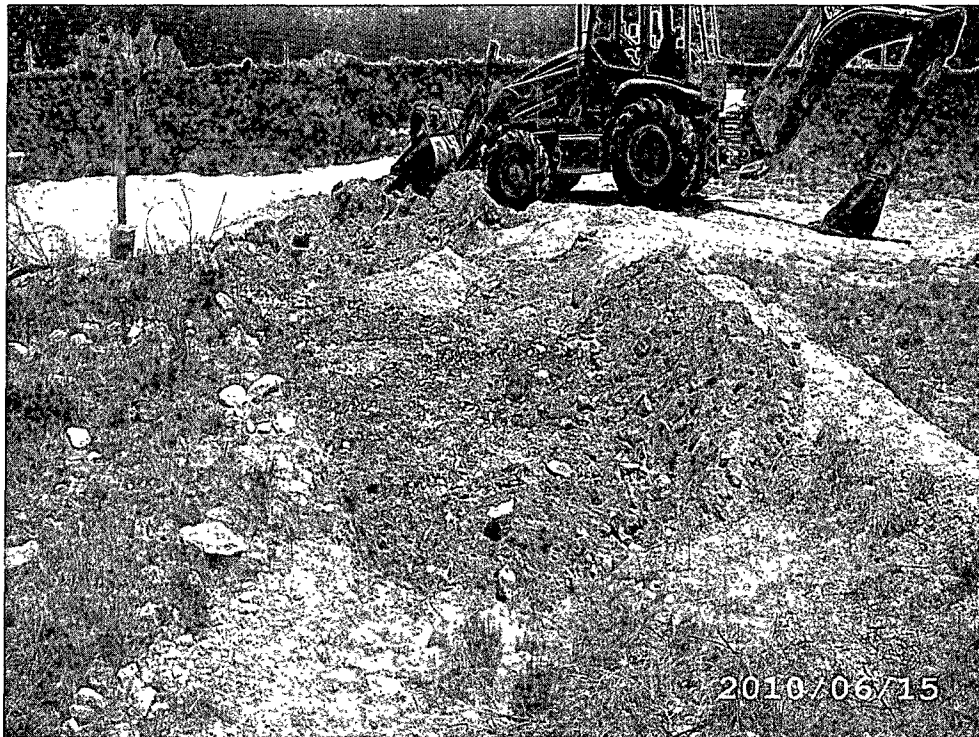
June 15, 2010 - Excavated leak location viewing south.

On June 14, 2010, Samson contracted Banta Oilfield Services, Inc. (Banta) to excavate soil from the release area. Soil was excavated to approximately 1 foot bgs where caliche was encountered and prohibited further excavating using the backhoe. Banta mobilized a track and hammer hoe, on June 15, 2010, to excavate soil to approximately 6 feet bgs. The soil was disposed at Sundance Services located east of Eunice, New Mexico.

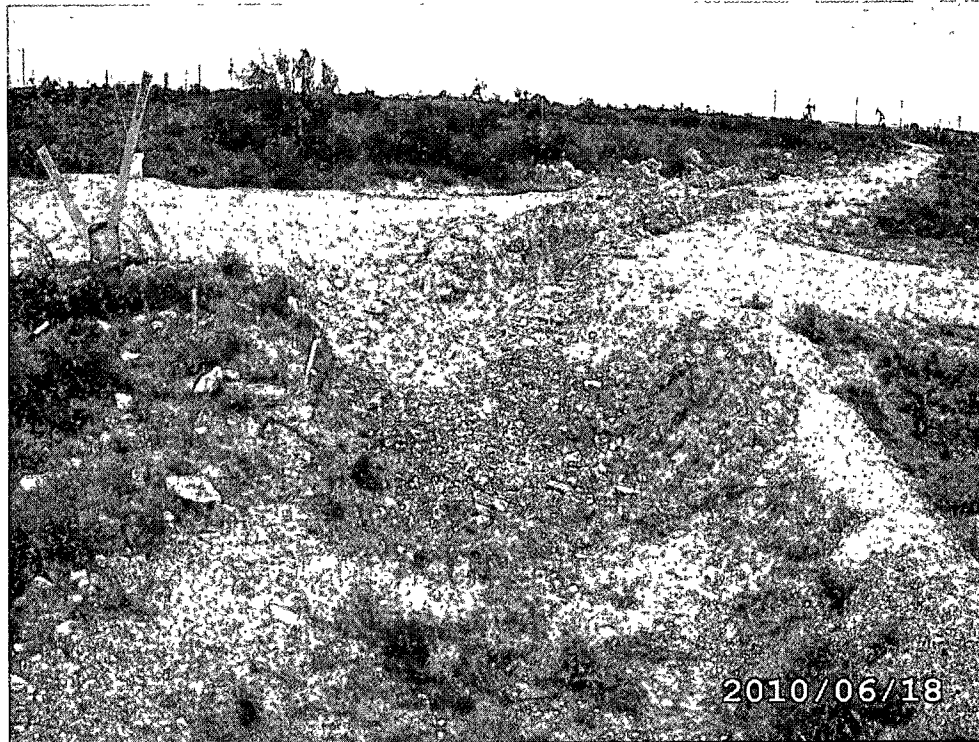
June 18, 2010 - Excavated leak area viewing south.

On June 14, 16 and 23, 2010, LAI personnel collected 5-spot composite samples from the bottom of the excavation at approximately 3, 5 and 6 feet bgs, respectively. The samples were analyzed by the laboratory for chloride which reported chloride at 3,090 mg/Kg (1 foot), 413 mg/Kg (5 foot) and 352 mg/Kg (6 foot).
