# STAGE 1 & 2 REPORTS

**RE: STAGE 2 PROGRESS REPORT  
BD SANTA RITA EOL RELEASE SITE (AP-58)  
T22S, R37E, SECTION 27, UNIT LETTER A  
LEA COUNTY, NEW MEXICO**

### EXCAVATION, BACKFILLING, CLAY/PLASTIC LAYERS, SEEDING

### INSTALLATION OF MW-4 AND RW-1

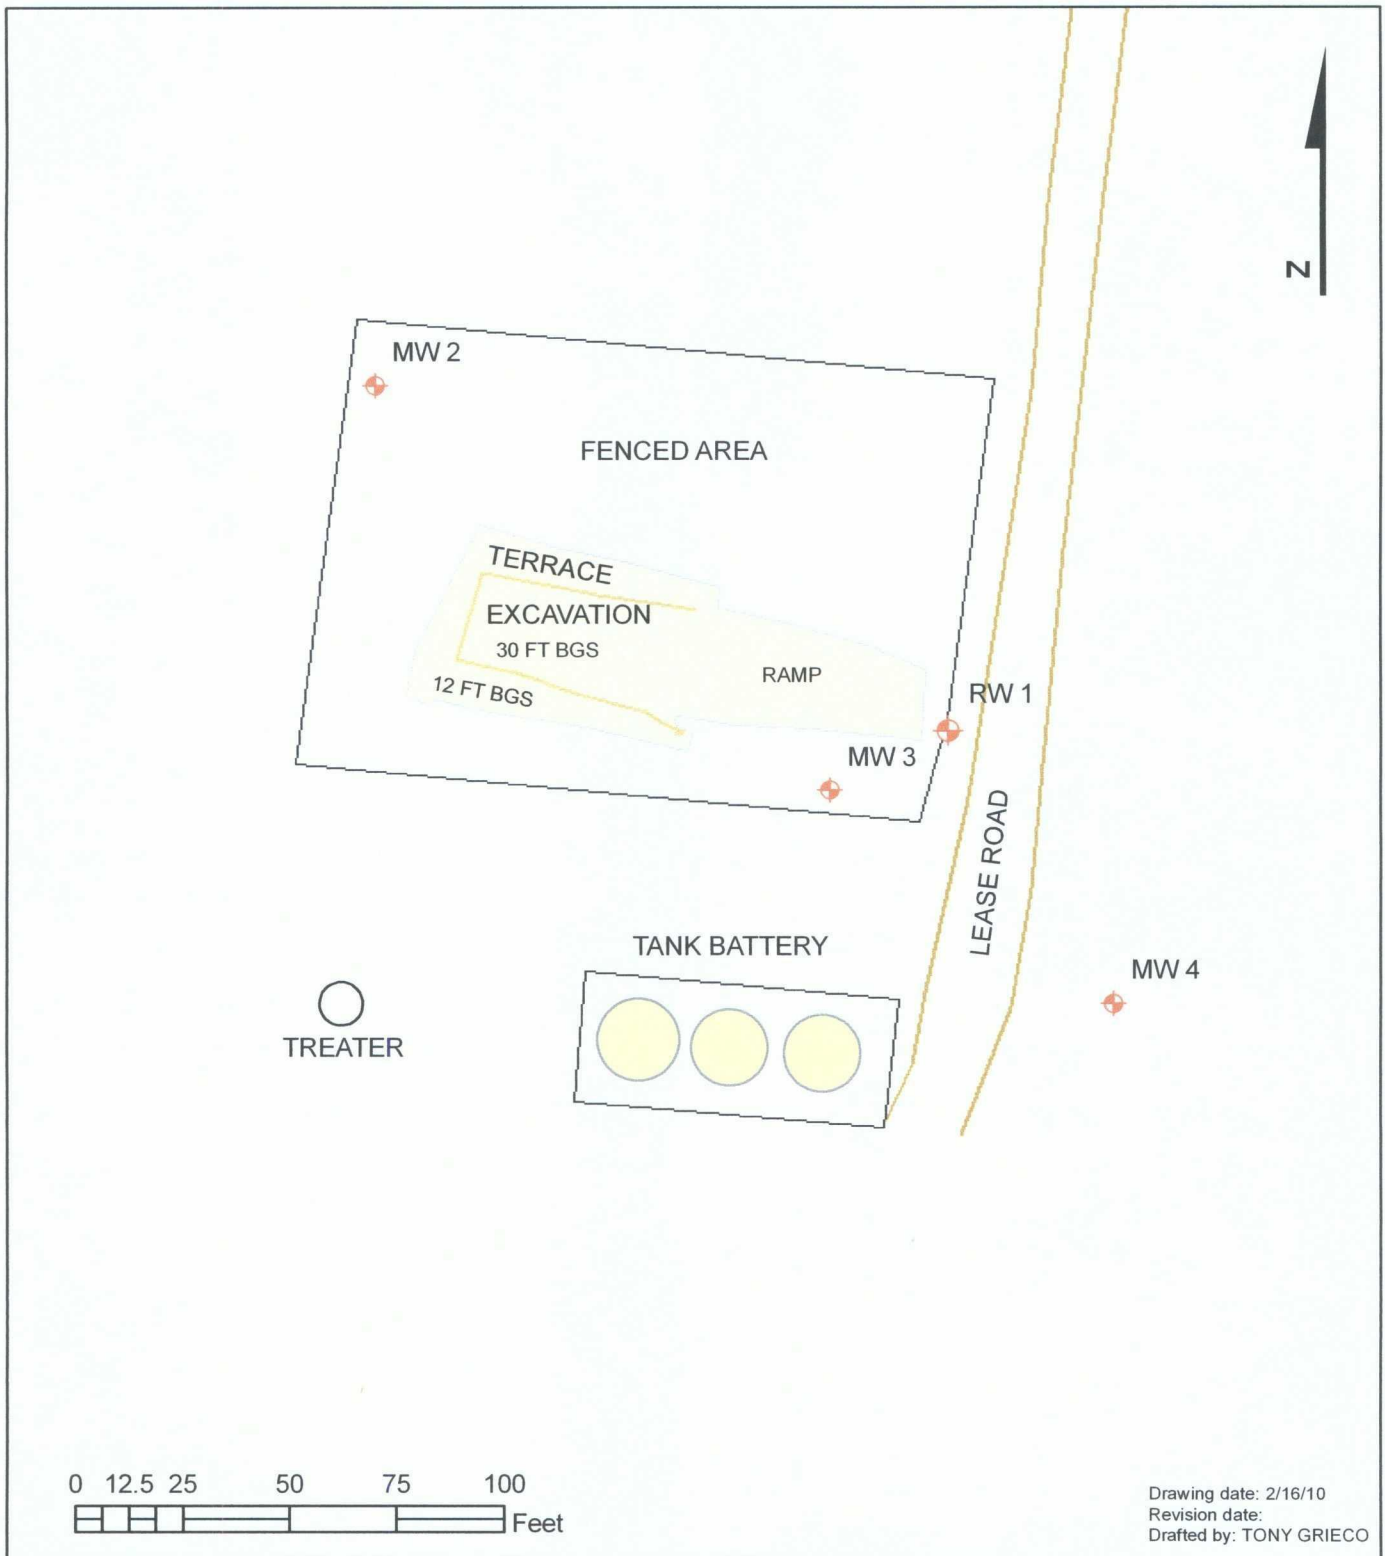
**Figure 1**  
**SITE MAP**

**Blinebry Drinkard (BD)**  
**SANTA RITA EOL (AP-58)**  
UL/A , SEC 27, T-22-S, R-37-E  
GW: 54 FT

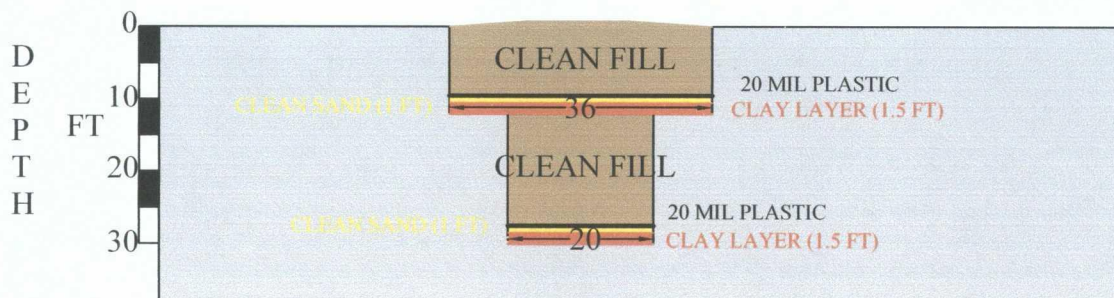
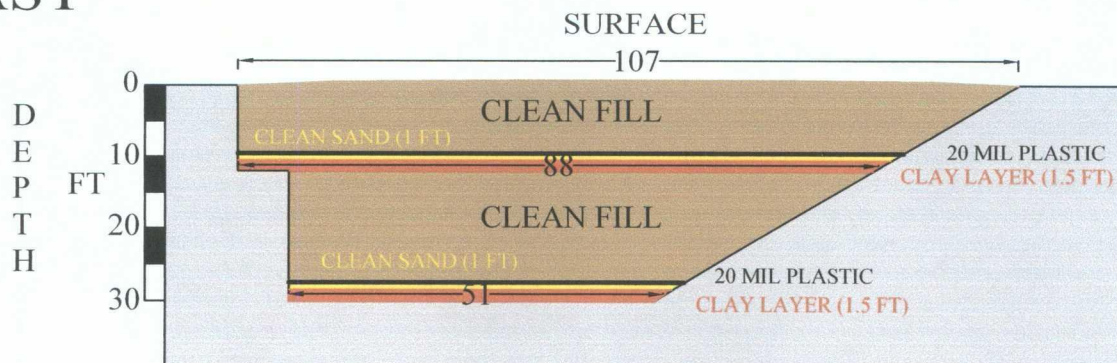
# SANTA RITA LEAK CROSS SECTIONS

Surface excavation size: 36' x 107'

Top shelf excavation size: 36' x 88' x 12'

Bottom shelf excavation size: 20' x 51' x 30'

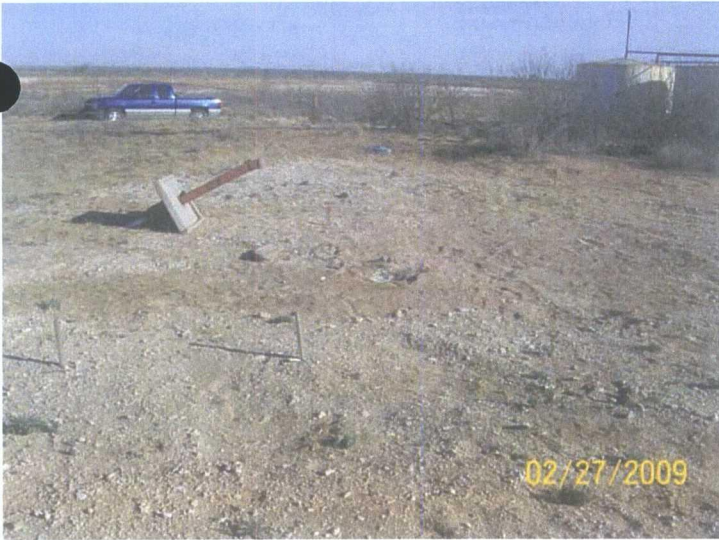
Facing SE: Source area and MW-1 after plugging

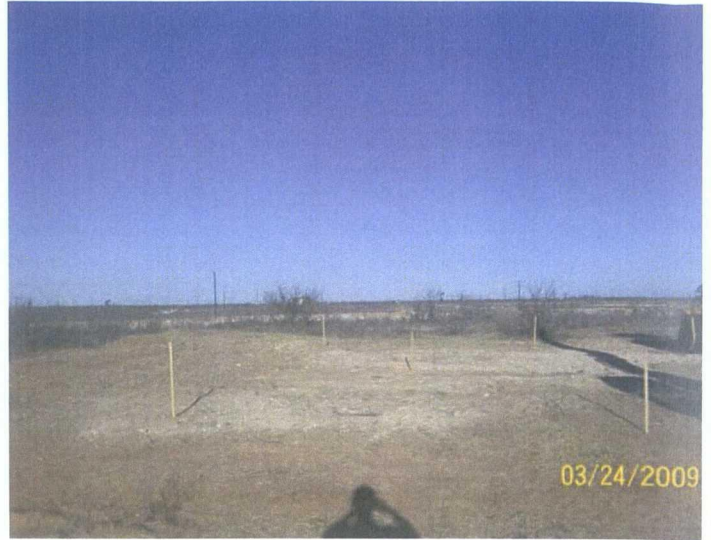
Facing WNW: Source area just prior to excavation

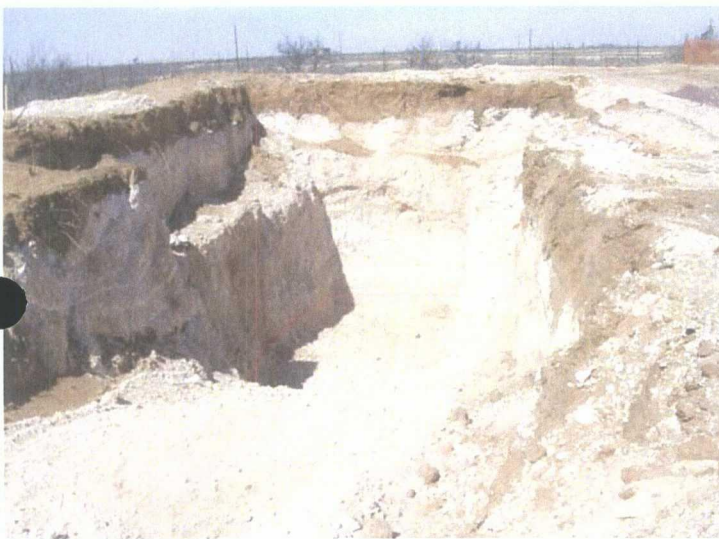
Facing WNW: Excavation completed to 30 ft bgs (3-30-09)

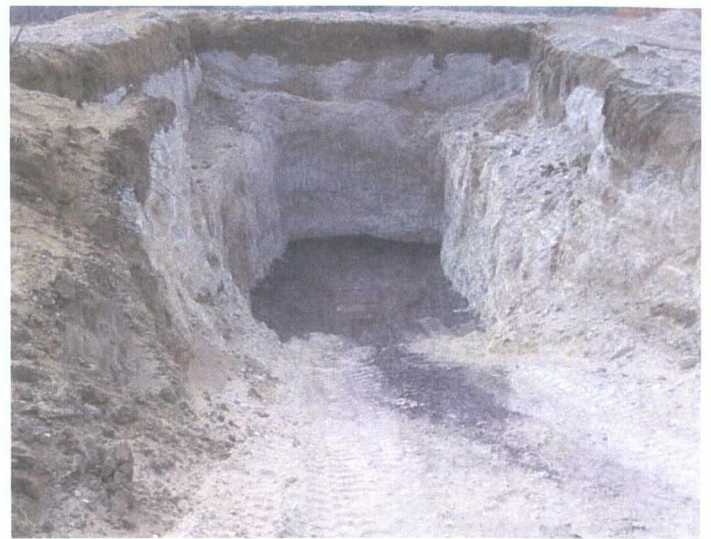
First clay layer (20 ft by 40 ft) at 30 ft bgs (04-01-09)

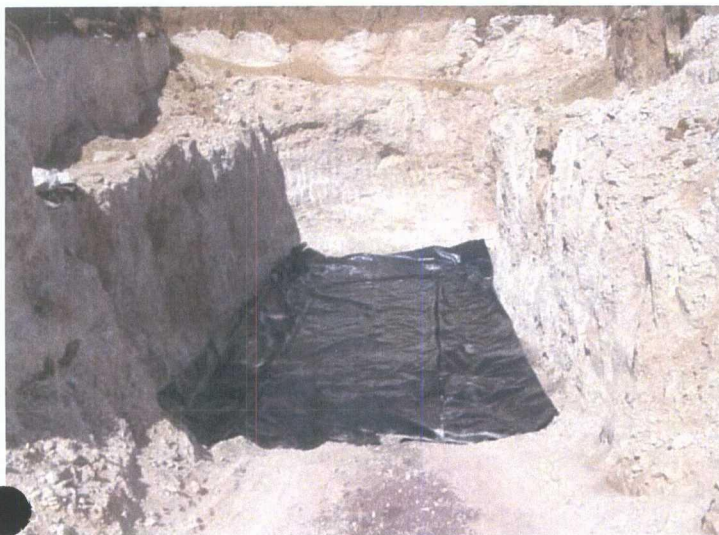
Plastic liner above first clay layer at 29 ft bgs (04-06-09)

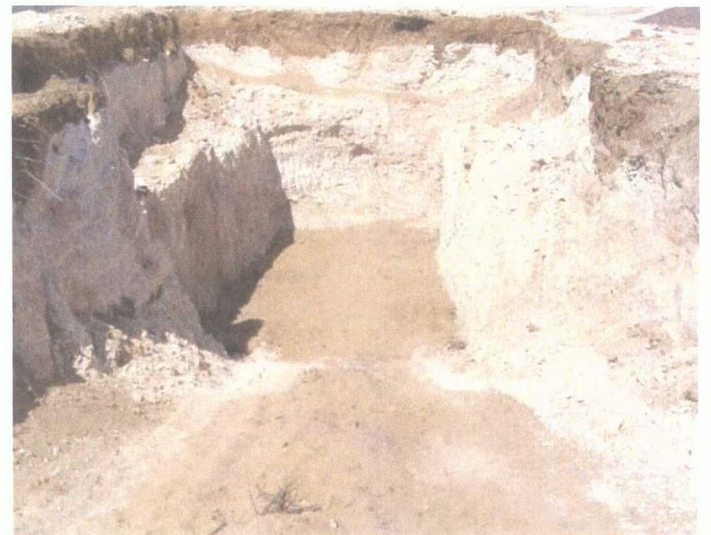
Sand layer above first plastic layer (04-06-09)

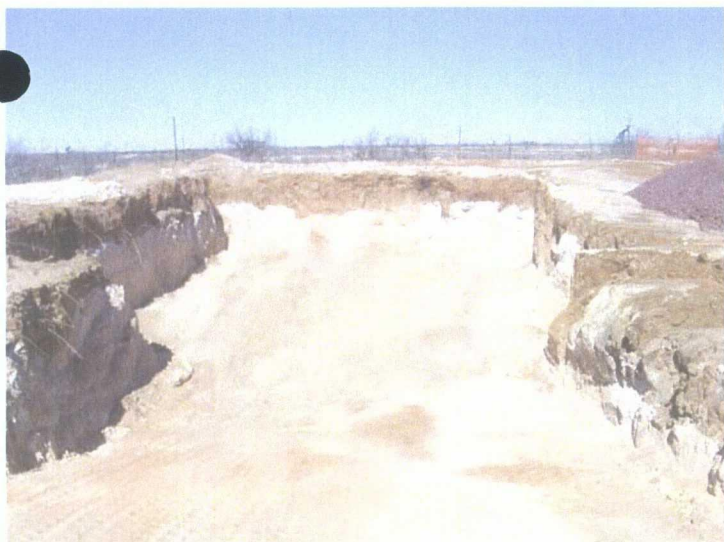
Caliche backfill up to ~12 ft bgs (04-07-09)

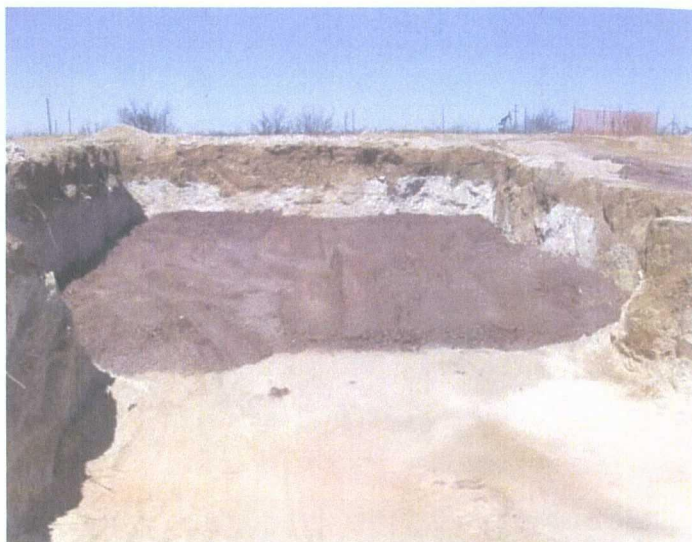
Second clay layer (40 ft by 50 ft) at 12 ft bgs (04-07-09)

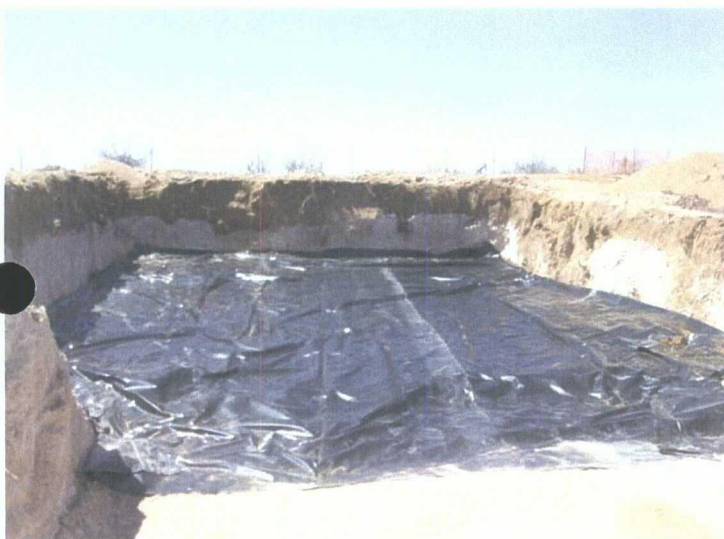
Plastic liner above second clay layer at 11 ft bgs (04-07-09)

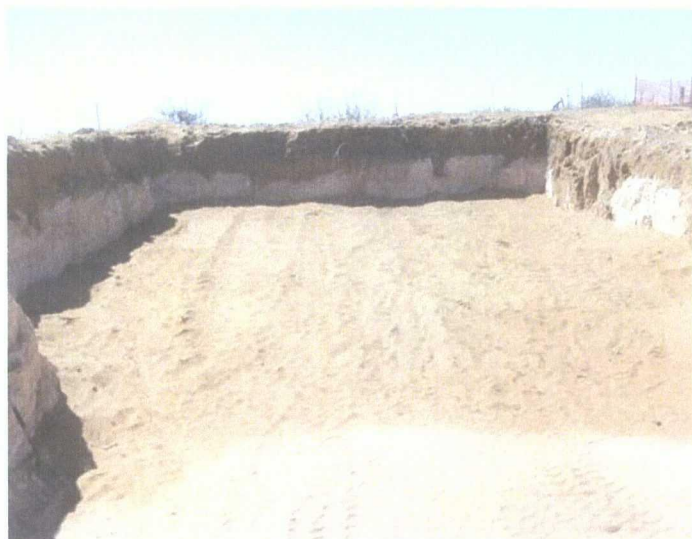
Sand layer above second plastic layer (04-07-09)

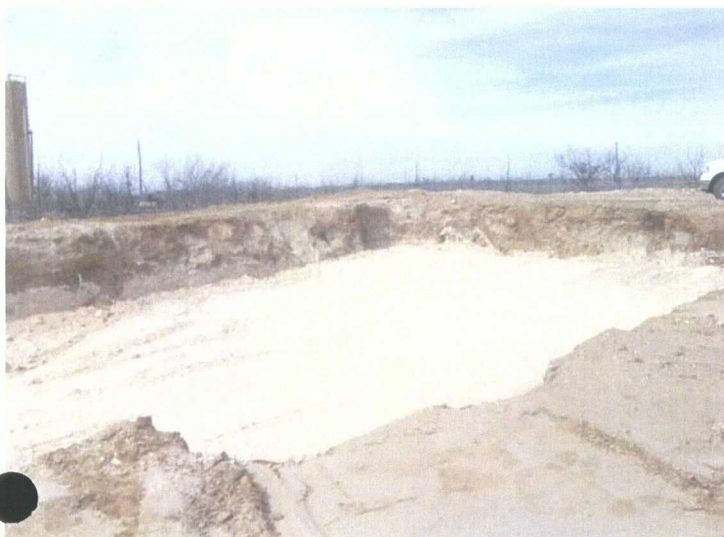
Caliche backfill up to ~5 ft bgs (04-08-09)

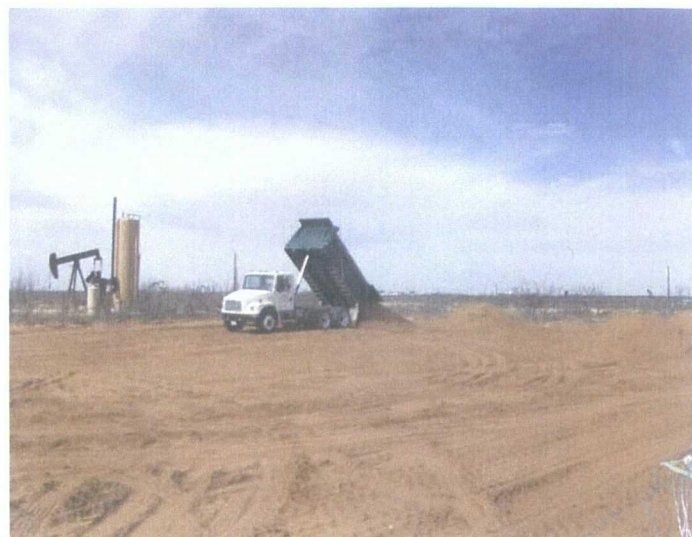
Sand layer up to surface grade (04-14-09)

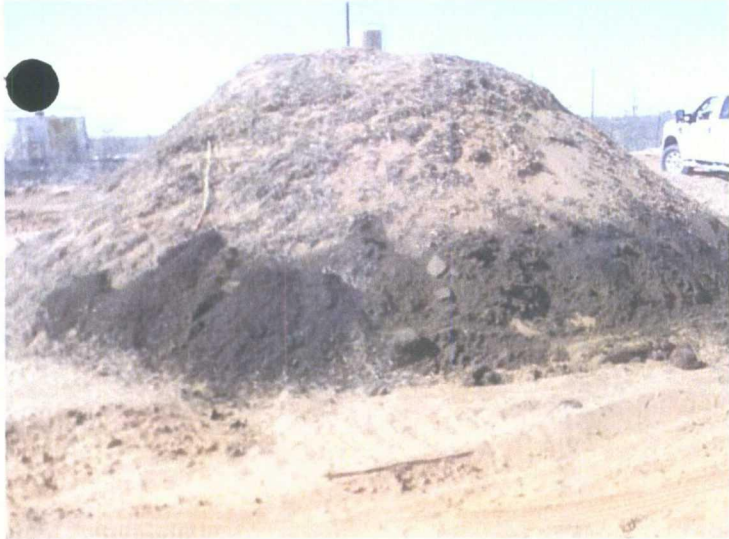
Peanut hay, peat moss, and soil conditioner (04-16-09)

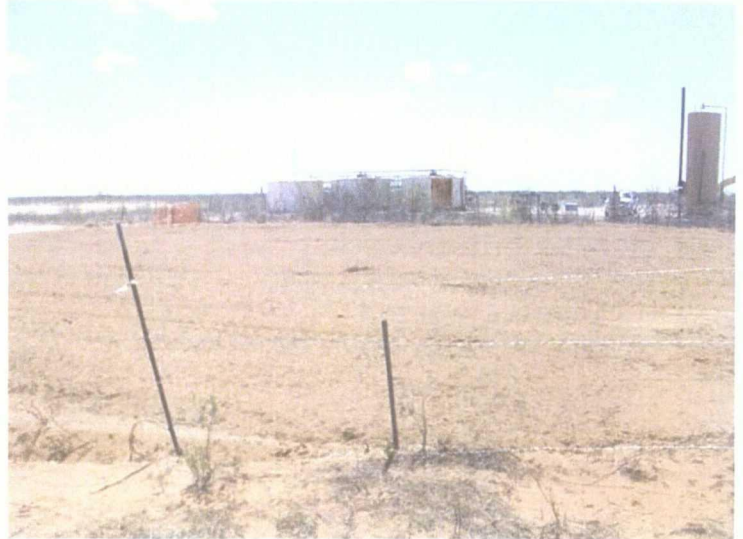
Final cover (04-16-09)

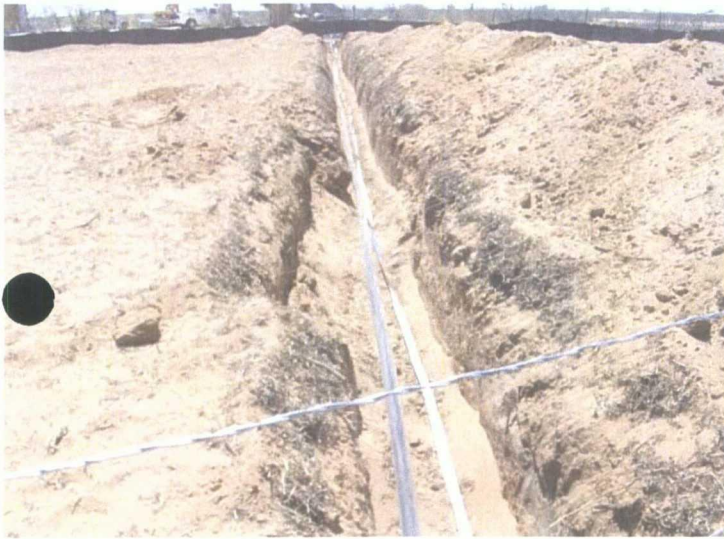
New poly line across site (04-17-09)

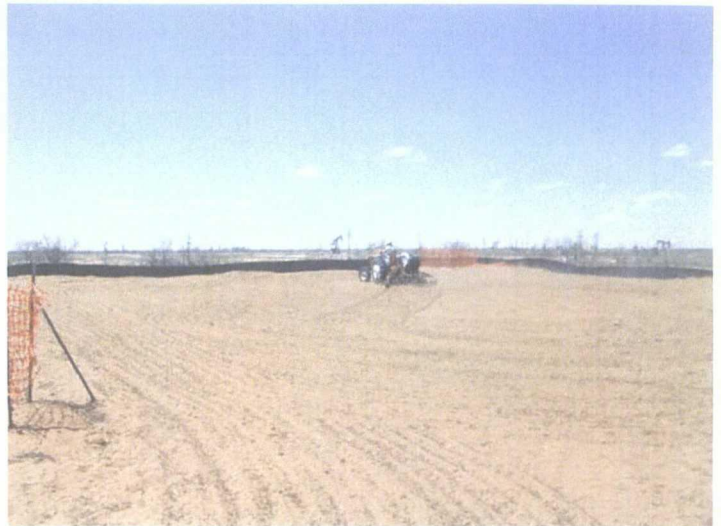
Disking and seeding site (04-17-09)

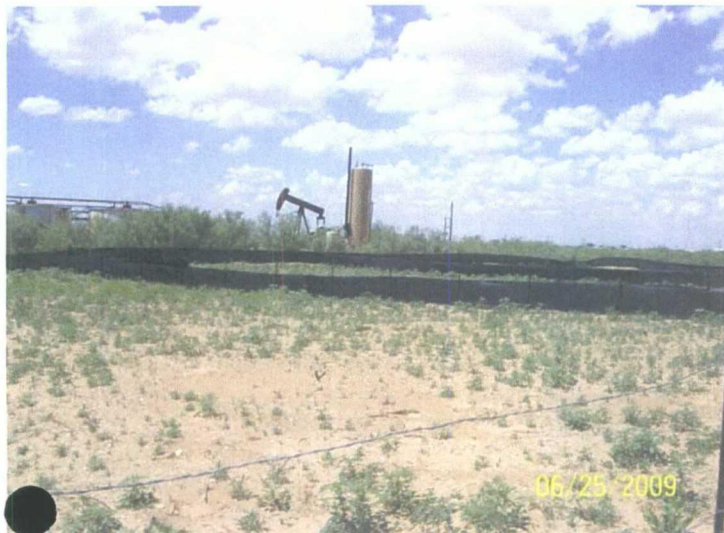
Healthy vegetation growth established soon after seeding  
(06/25/09)

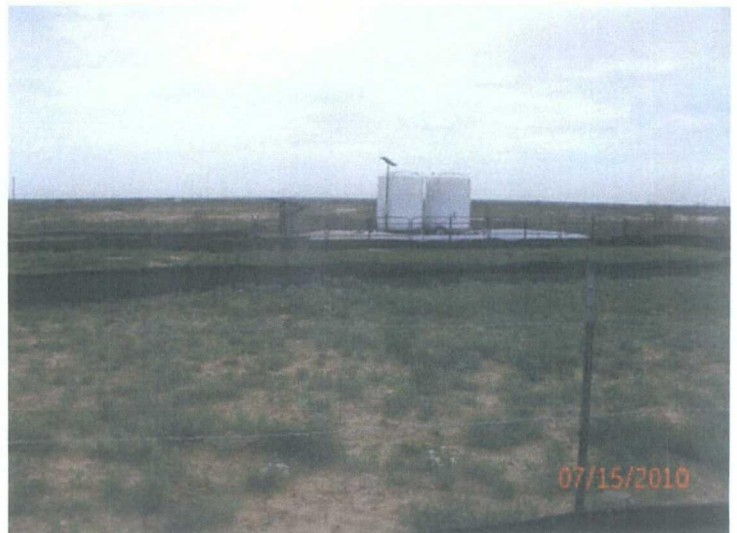
Recent photo (07/15/10) showing healthy vegetation growth  
(foreground) and groundwater recovery system (background)

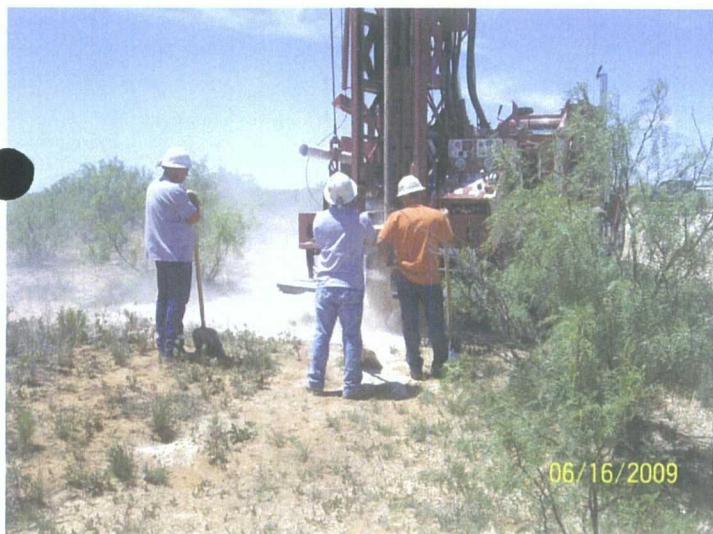
BD Santa Rita - drilling MW-4

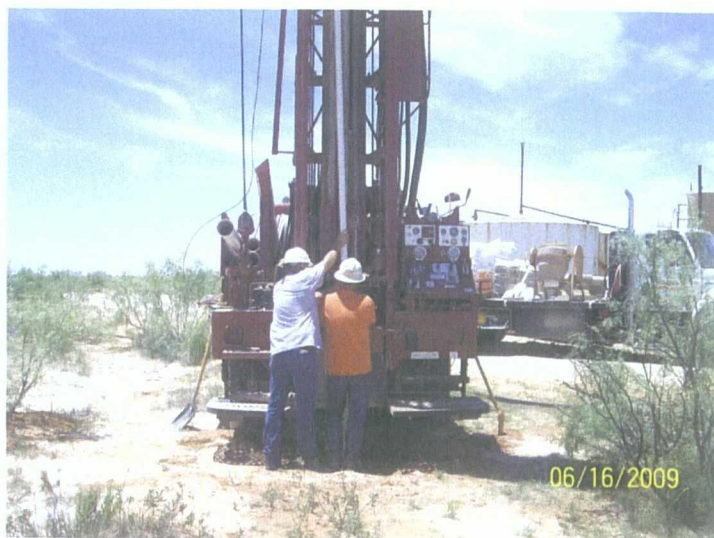
Setting the casing for MW-4

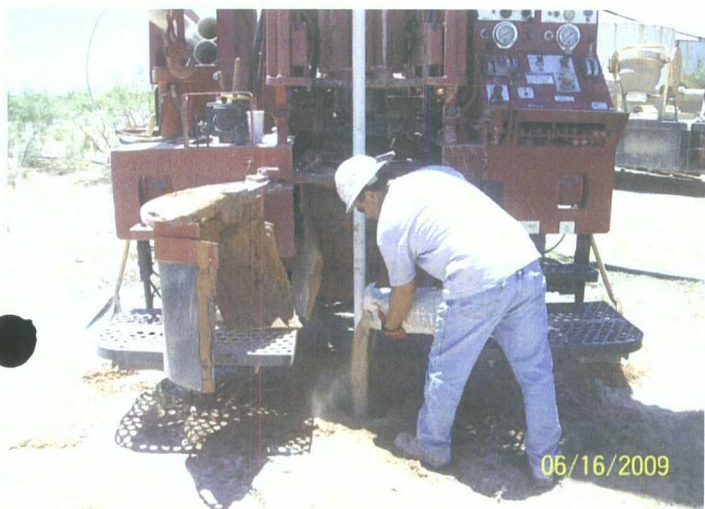
Putting in the sand filter

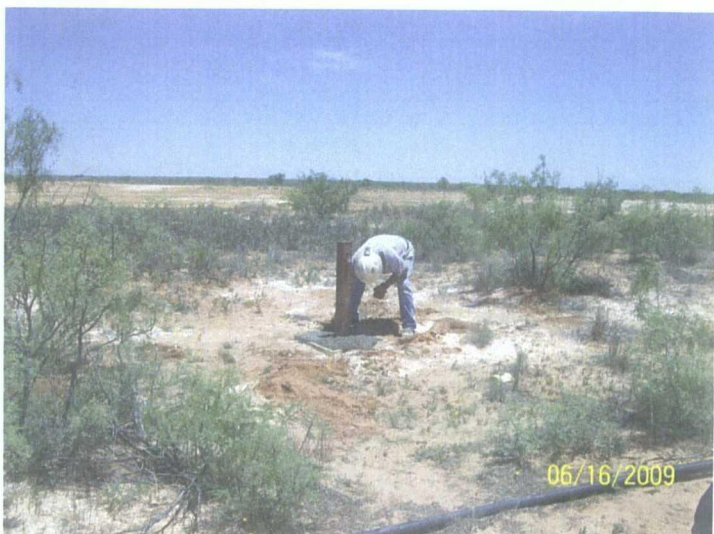
Concreting the well in

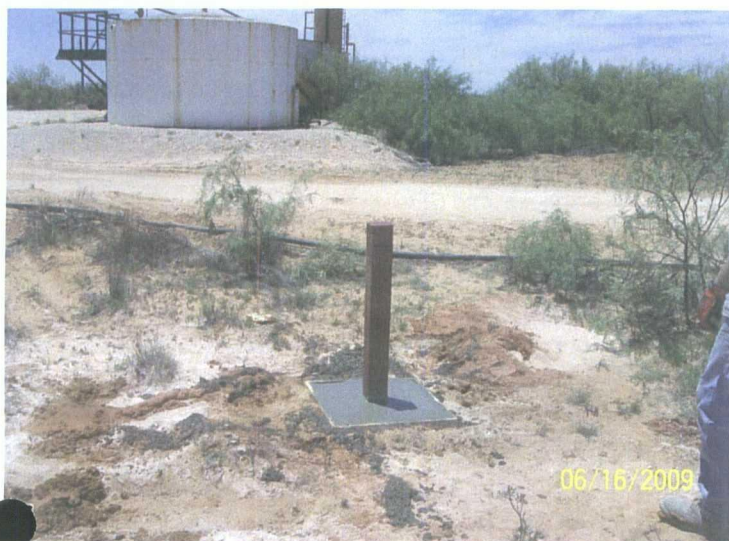
Completed MW-4

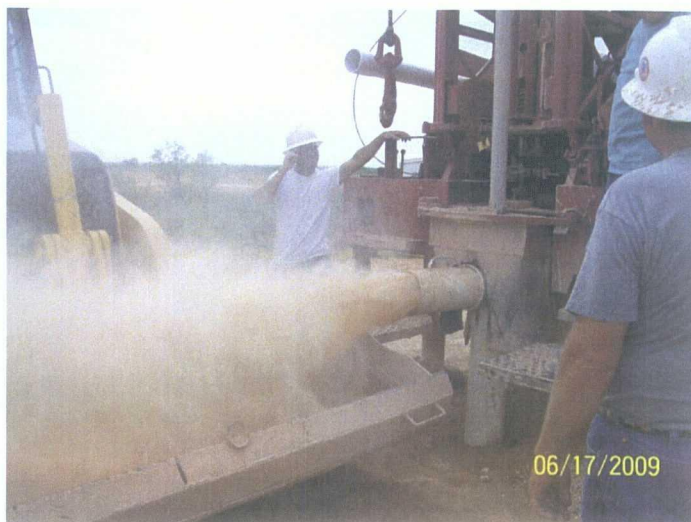
Drilling RW-1

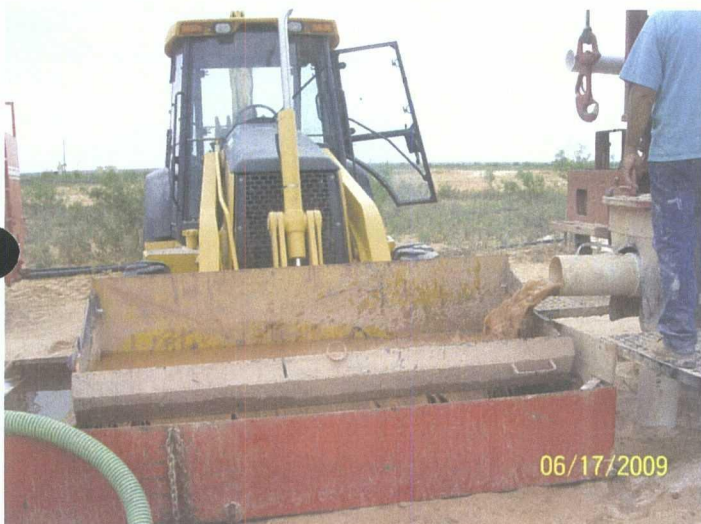
Mudding in the well

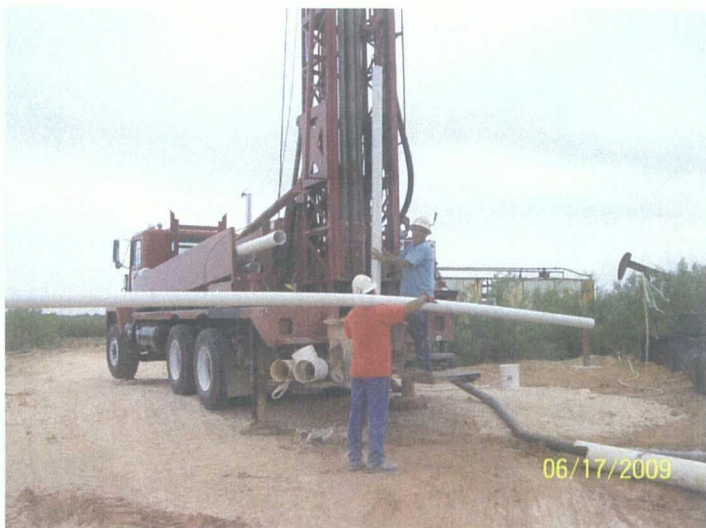
Placing the casing

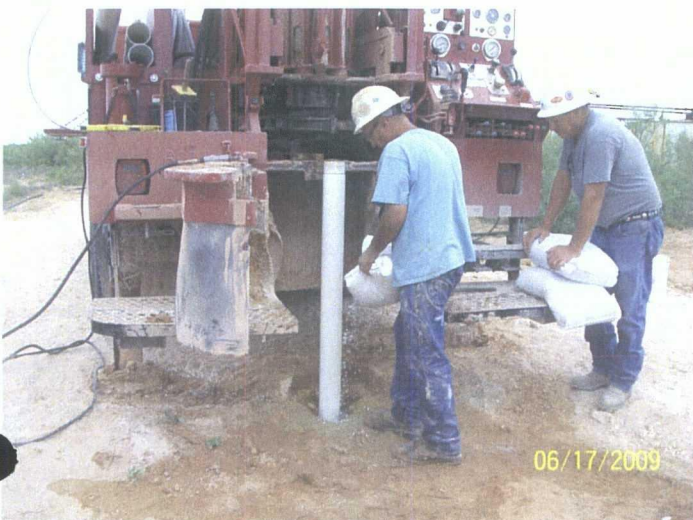
Sealing the well with bentonite

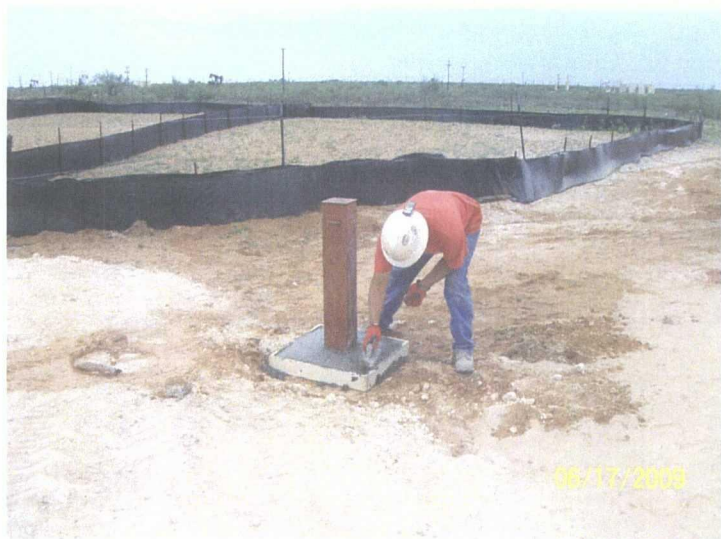
Concreting the well in

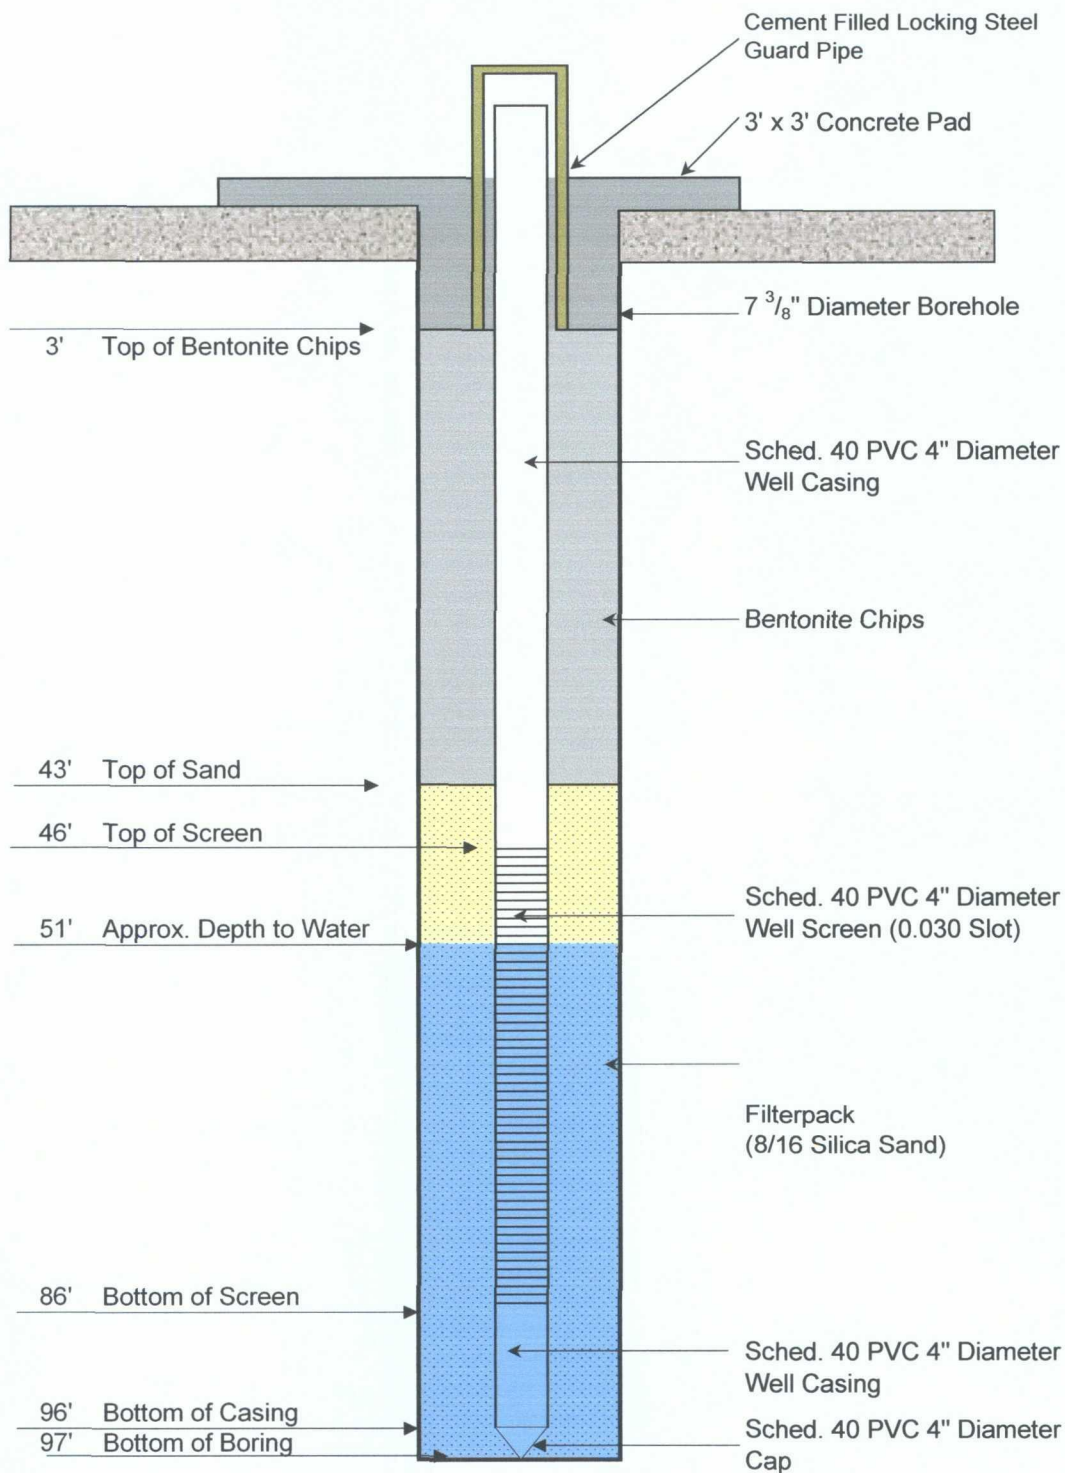
# RECOVERY WELL (RW-1) CONSTRUCTION DIAGRAM

Client:	Rice Operating Company
Site Name:	BD Santa Rita Site (AP-58)
Completion Date:	June 17, 2009
On Site Geologist:	Gil Van Deventer
