**Railroad Lagoon
Fan-Out Area
Excavation (2)**

RE: Response to NMED's Notice of Disapproval, Remedy Completion Report, Railroad Rack Lagoon (SWMU No.8) Revised Report
Western Refining Company Southwest Inc., Gallup Refinery
EPA ID # NMD000333211 HWB-GRCC-06-001"

The purpose of this letter is to respond to the New Mexico Environment Department's (NMED), Notice of Disapproval, Remedy Completion Report, Railroad Rack Lagoon (SWMU No.8) Revised Report, dated October 2006 submitted on behalf of *Western Refining Company Southwest Inc., Gallup Refinery*.

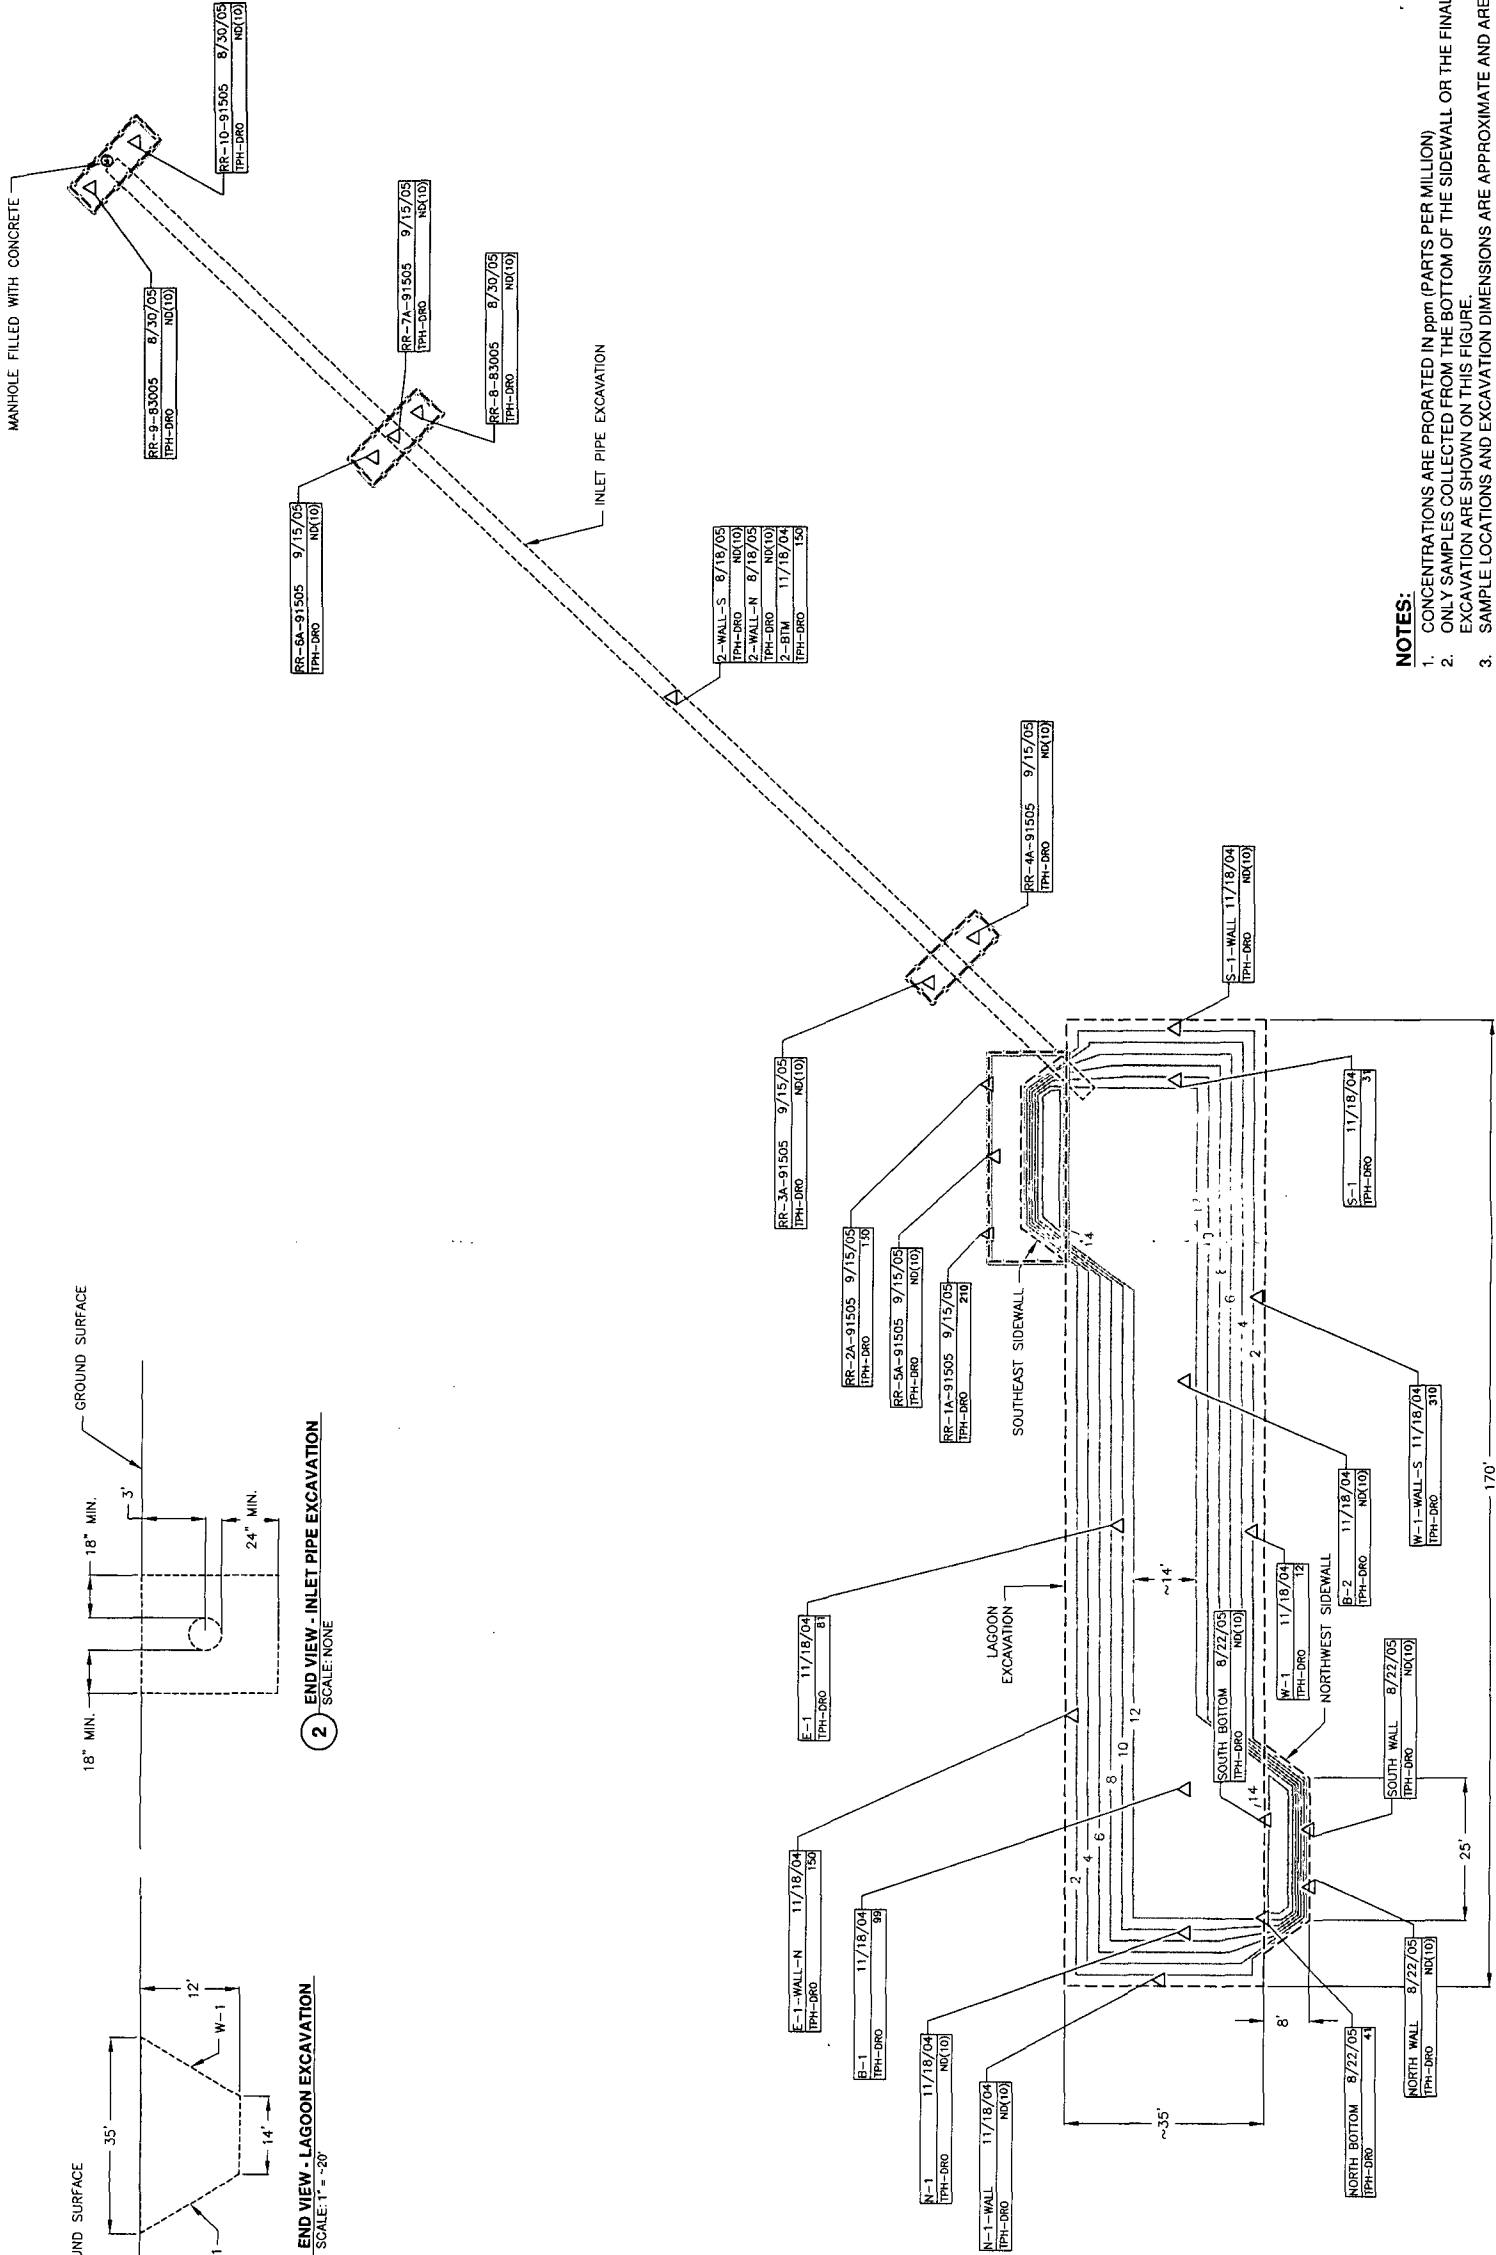
Please see the enclosed Figure 1 (dated 12/28/10) showing the dimensions and locations of the final confirmation samples.

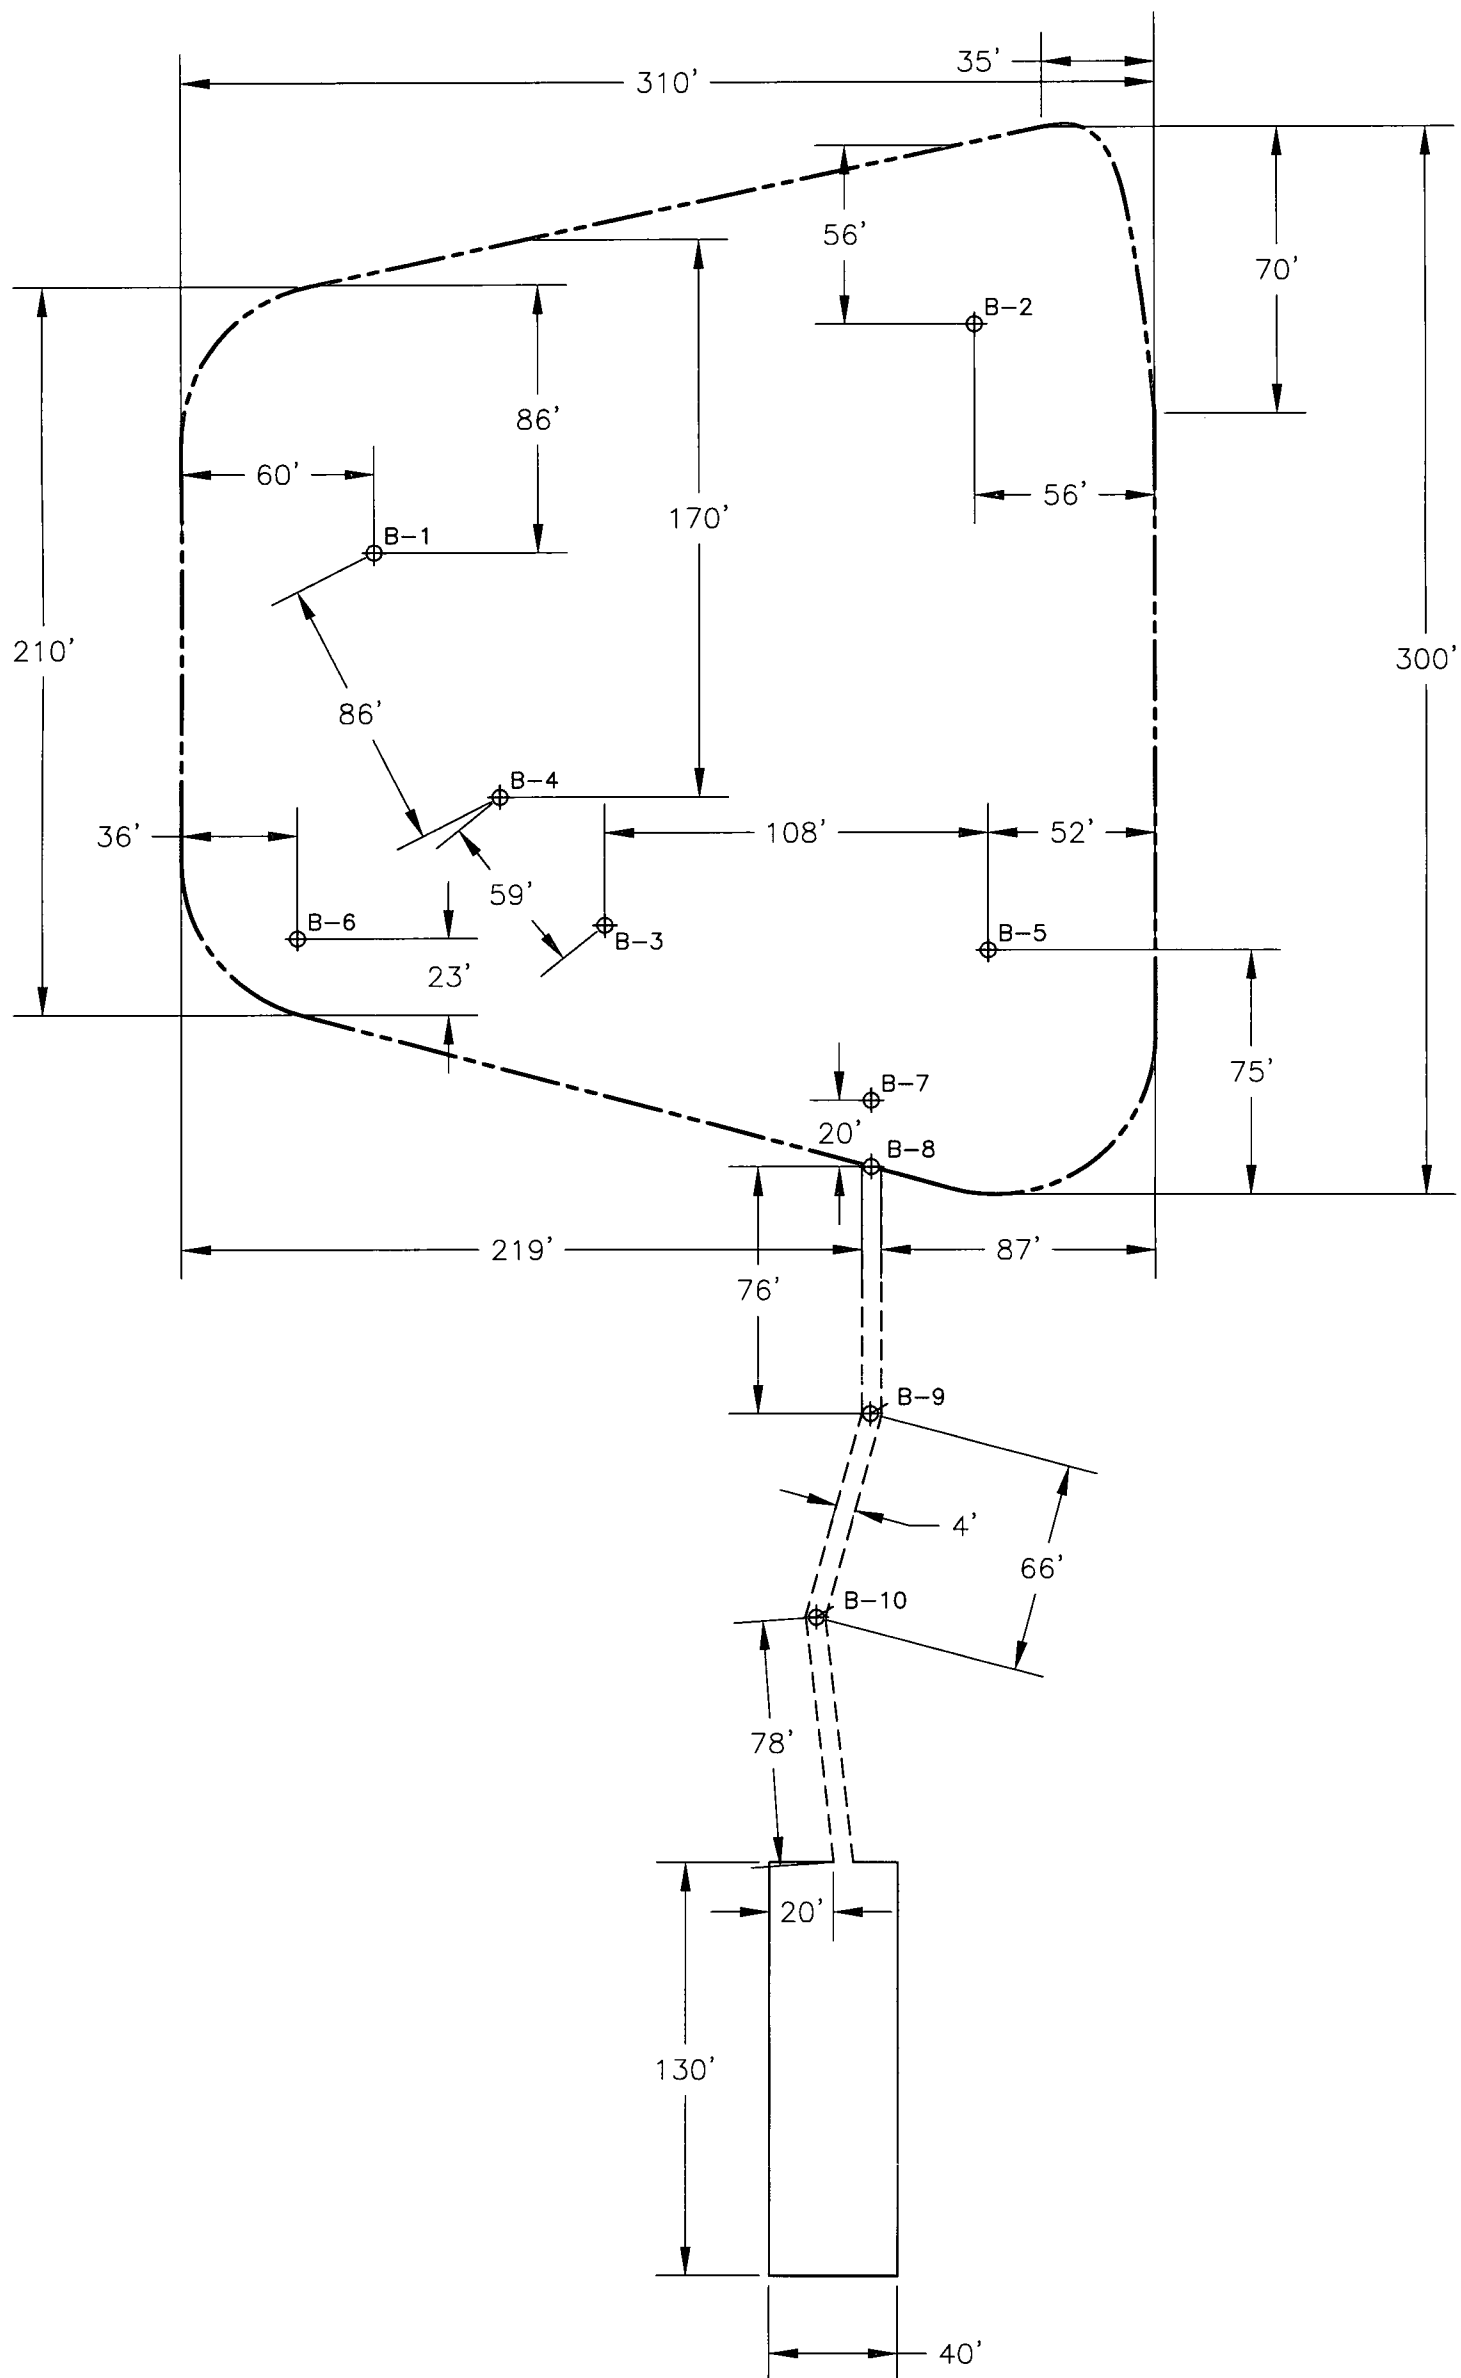
RAILROAD RACK LAGOON
OVERFLOW DITCH AND FAN-OUT AREA
SOIL SAMPLE LOCATIONS
WESTERN REFINING
GALLUP REFINERY
GALLUP, NEW MEXICO

- ⊕ B-10 SOIL BORING LOCATION AND DESIGNATION
- OUTFLOW DITCH
- FAN-OUT AREA
- RAIL ROAD RACK LAGOON

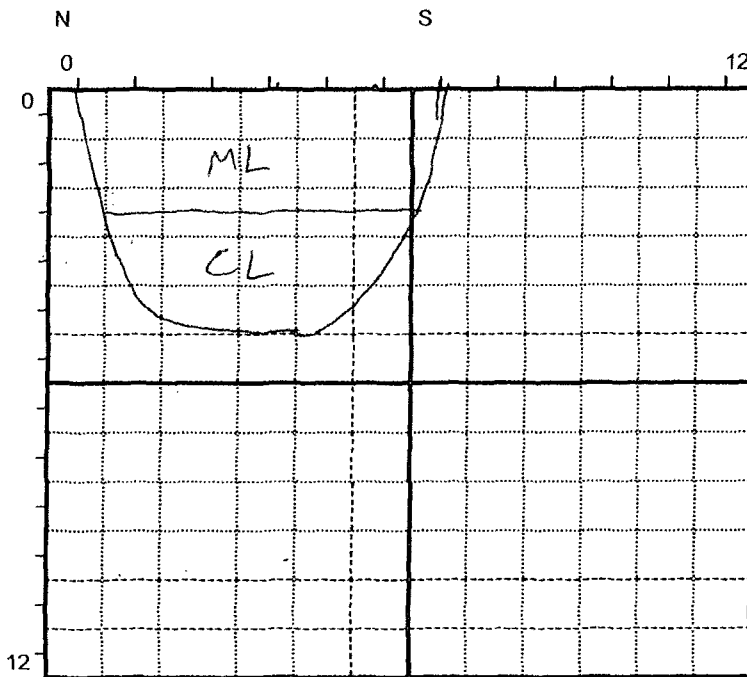
FIGURE 3a. TEST PIT LOG
Ciniza Refinery, Gallup, New Mexico

Depth (ft-bgs)	Description
0 - 2.5	Brown clayey silt, damp, mostly loose, low plasticity, no staining, no odor.
2.5 - 5	Brown silty clay, damp/moist, low plasticity, stiff, slightly siltier in center of excavation. Some black staining noted, very faint odor. Odor does not seem to be associated with staining.

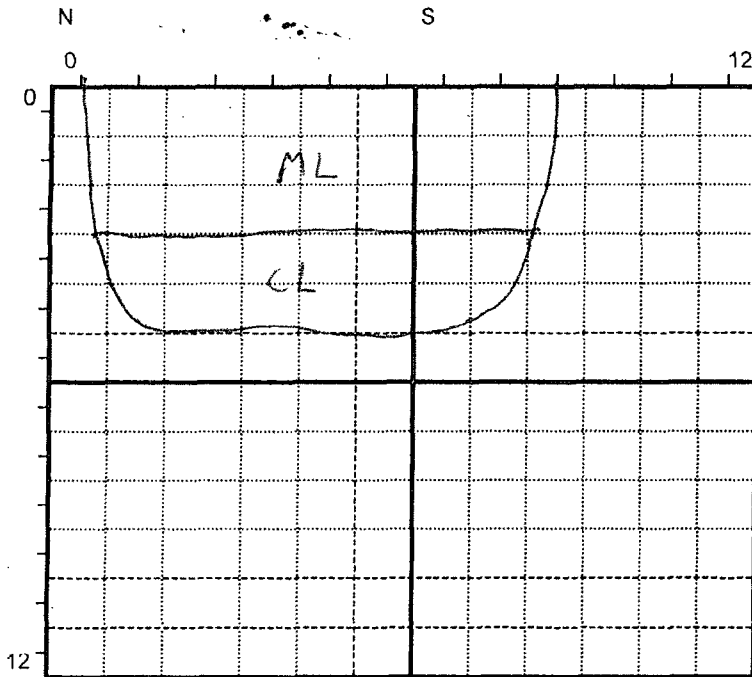
FIGURE 3a. TEST PIT LOG
Ciniza Refinery, Gallup, New Mexico

Depth (ft-bgs)	Description
0 - 3	Brown silt, some clay, dry/damp, mostly loose, low plasticity, no odor. Trace of black staining, follows fractures, soil is not saturated, see photos 690 and 691, no odor.
3 - 5	Brown silty clay, damp to moist, low plasticity, stiff to very stiff, same staining as above, no odor.

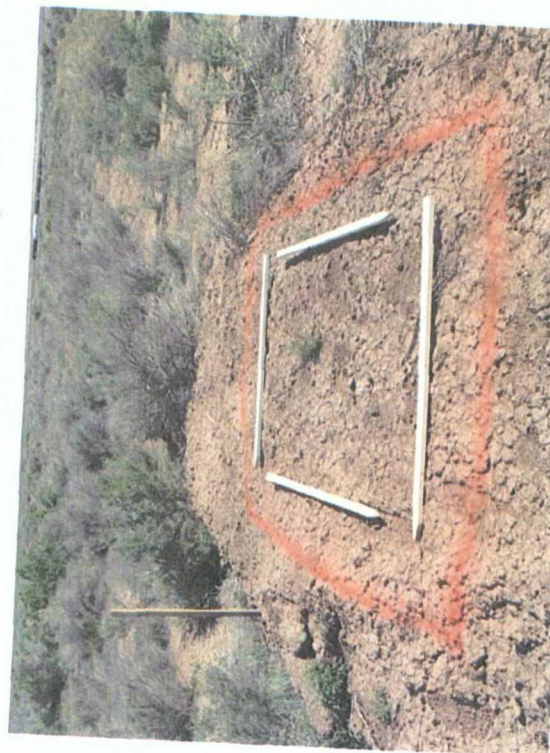
Photo 15. Excavation boundary at B9 (9' x 7') with stakes (4' x 6')

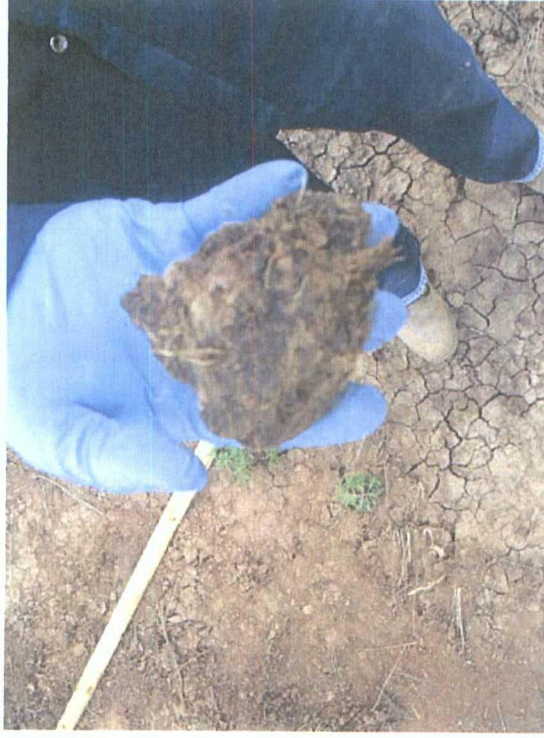
Photo 18. B8 - Black staining (intact)

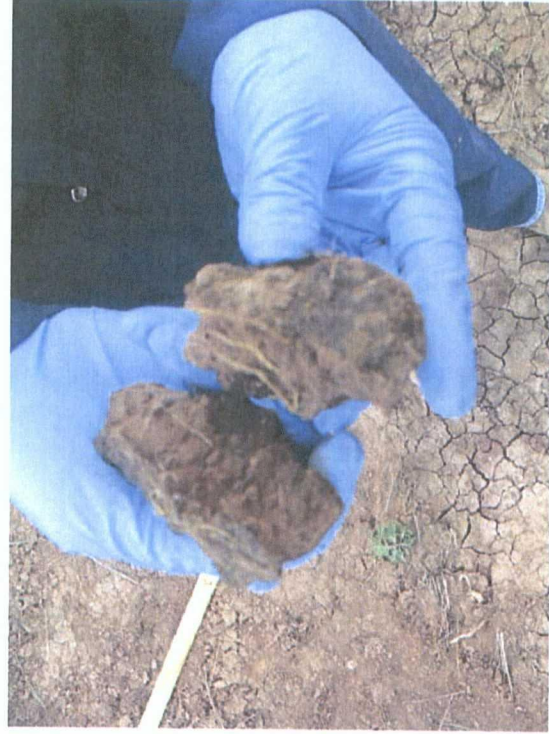
Photo 19. B8 - Black staining broken (not evident on fresh surface)

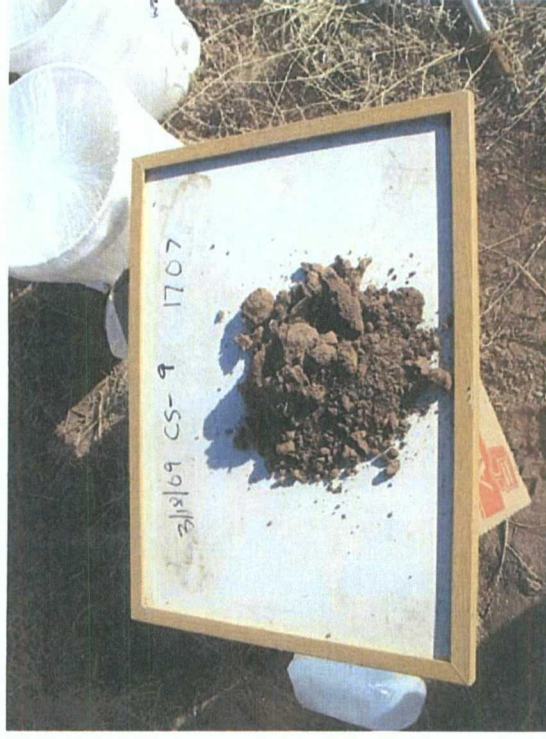
Photo 106. Sample CS-9

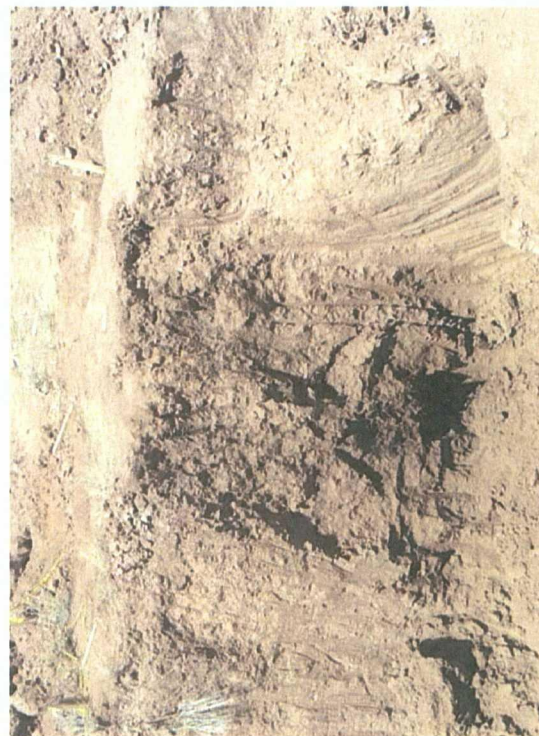
Photo 112. North wall of 13' excavation - potential staining

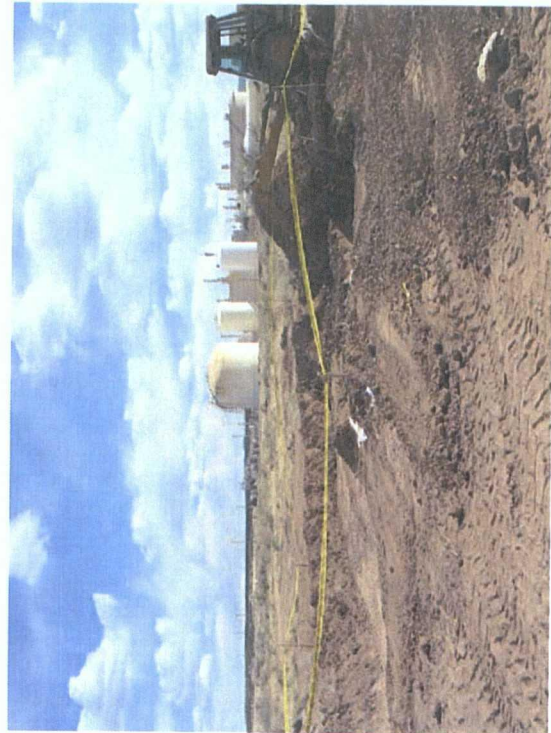
Photo 123. Looking South; excavation as of 1630 4/23/09; excavating extra 7' area

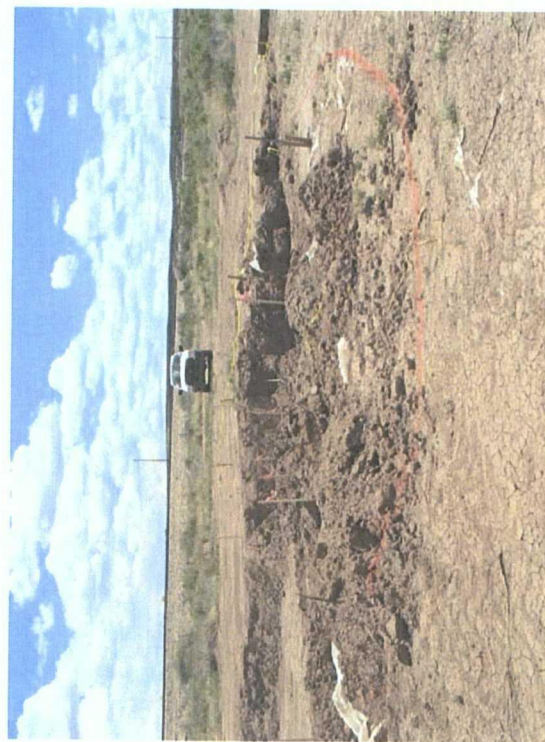
Photo 132. Excavation pit looking East showing excavation area for CS-22 through CS-24

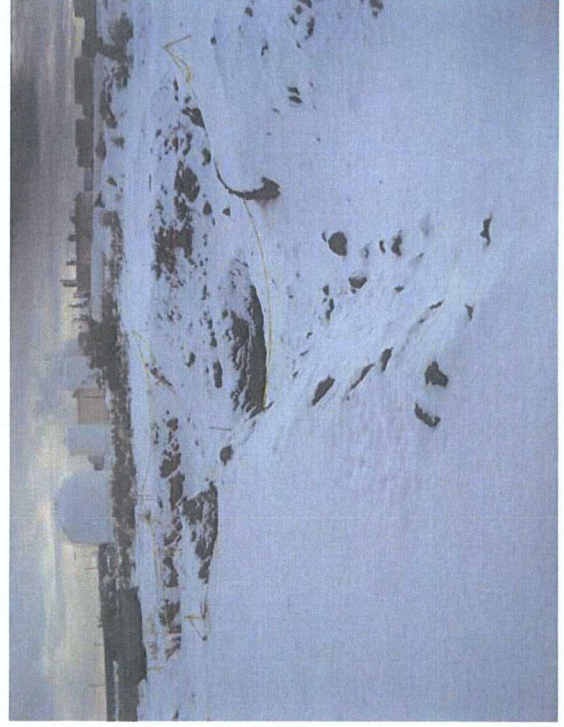
Photo 148. Final excavation looking south

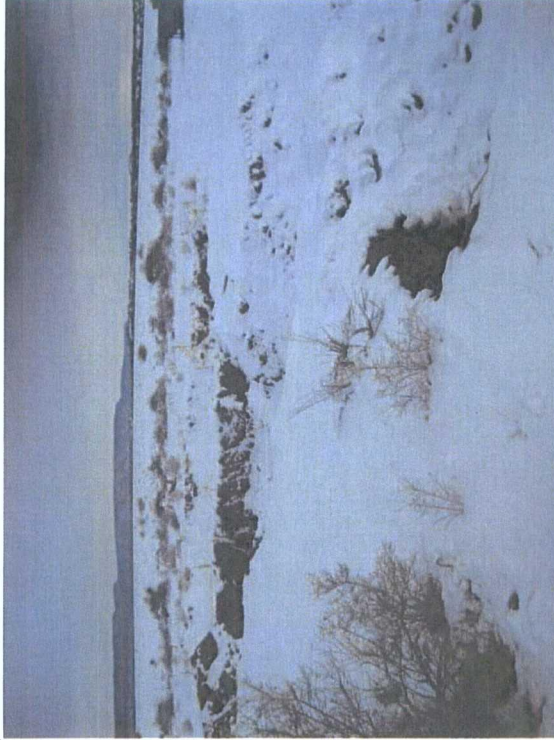
Photo 150. Final excavation looking east

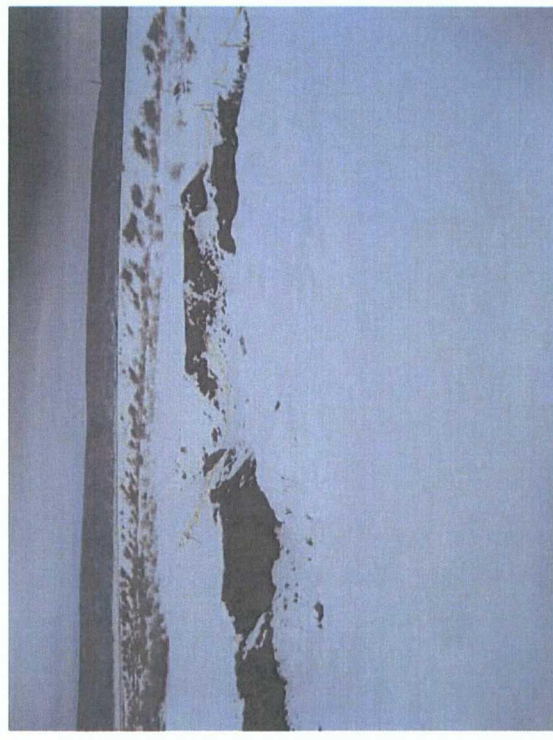
Photo 152. Final excavation looking north

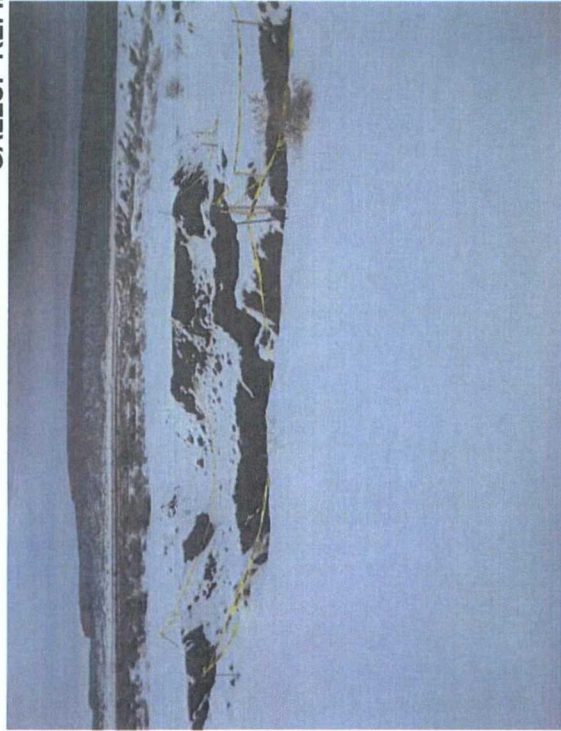
Photo 153. Final excavation looking northwest

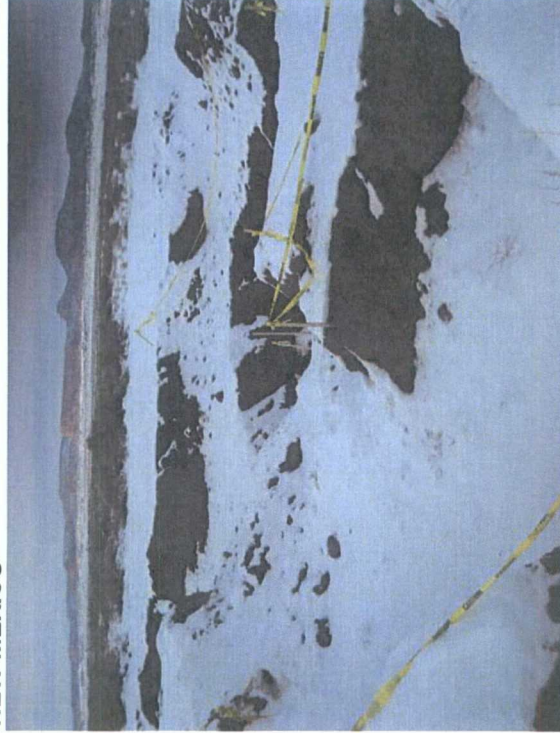
Photo 154. Final excavation looking west

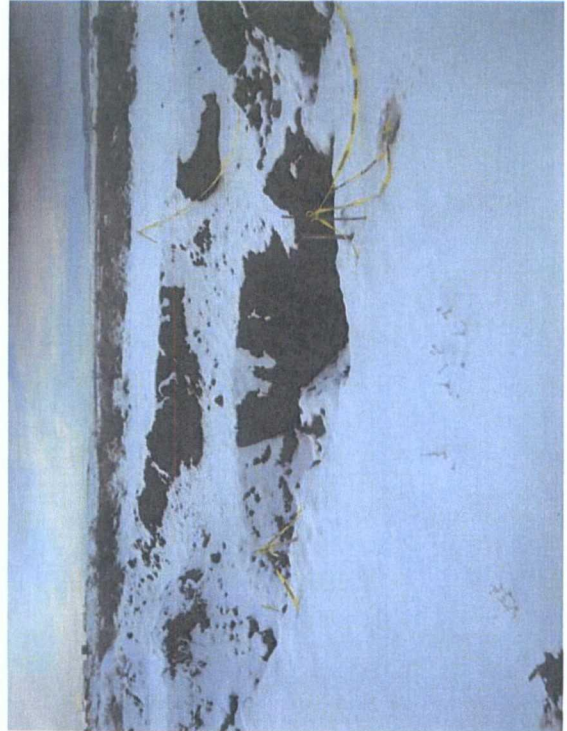
Photo 155. Final excavation looking southwest
