Release Notification and Corrective Action

**XTO Energy, Inc.
EMSU-B #856
Unit K, Section 11, T20S R36E
Lea County, New Mexico**

Closure Report

July 29, 2009

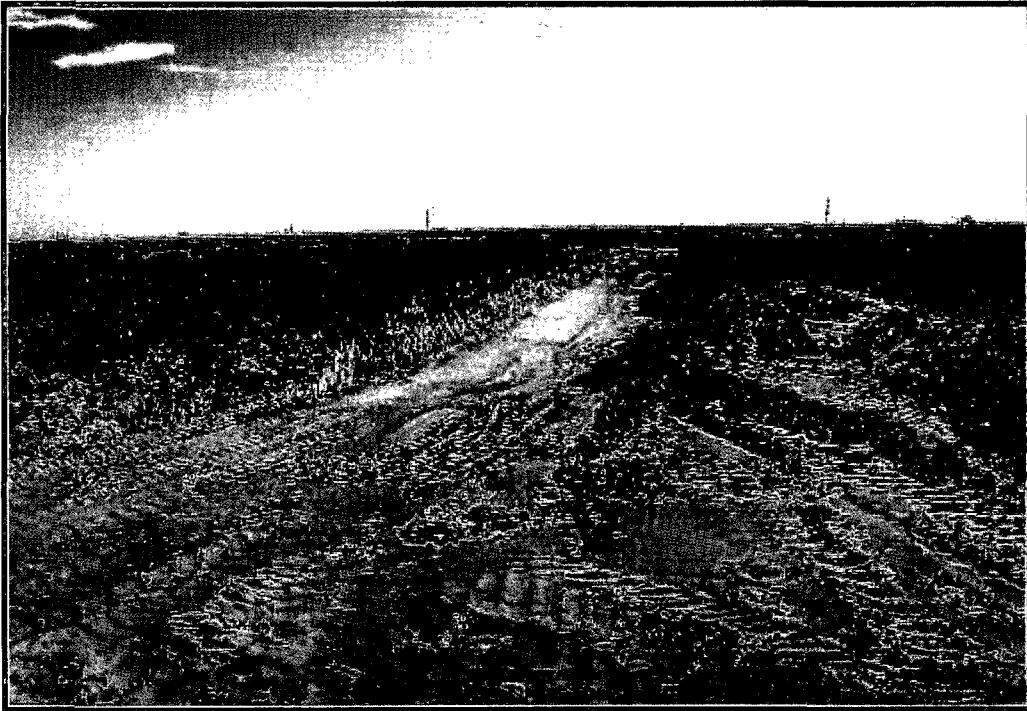
Excavated area facing east

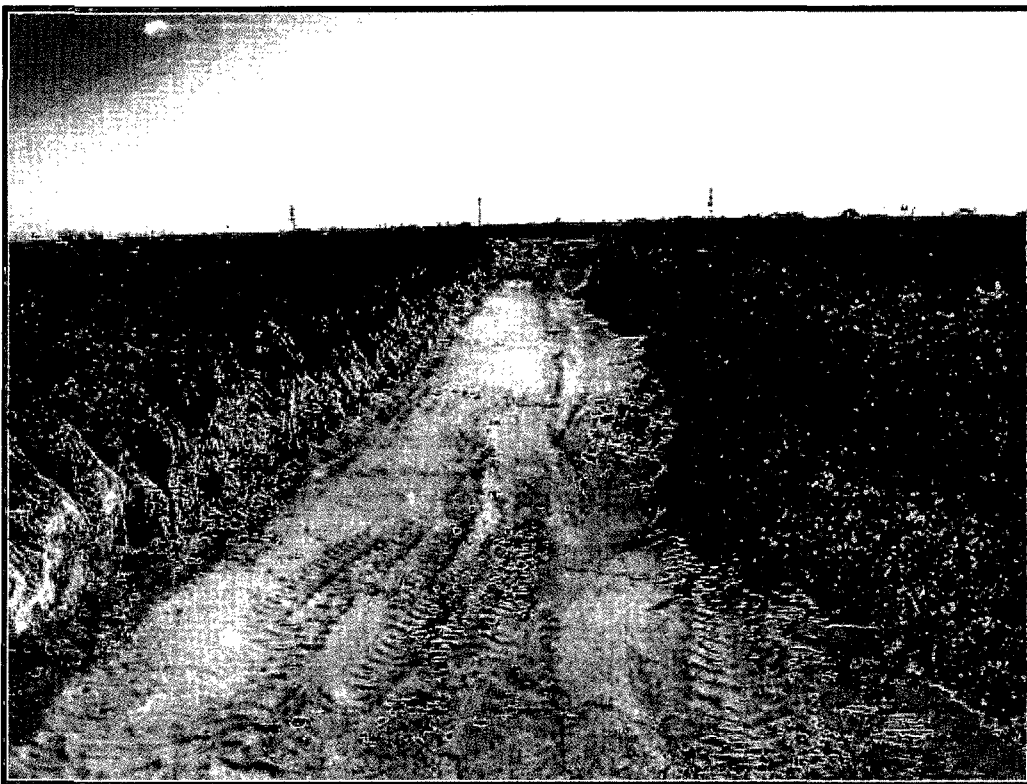
Excavated area facing east

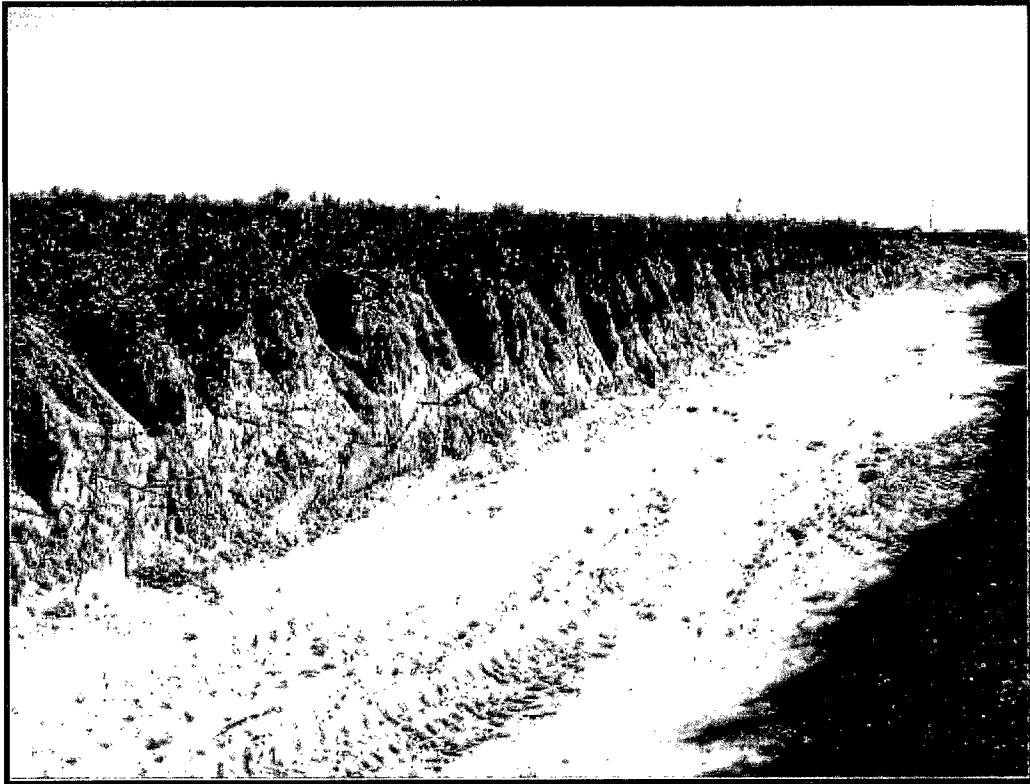
Excavated area facing northeast

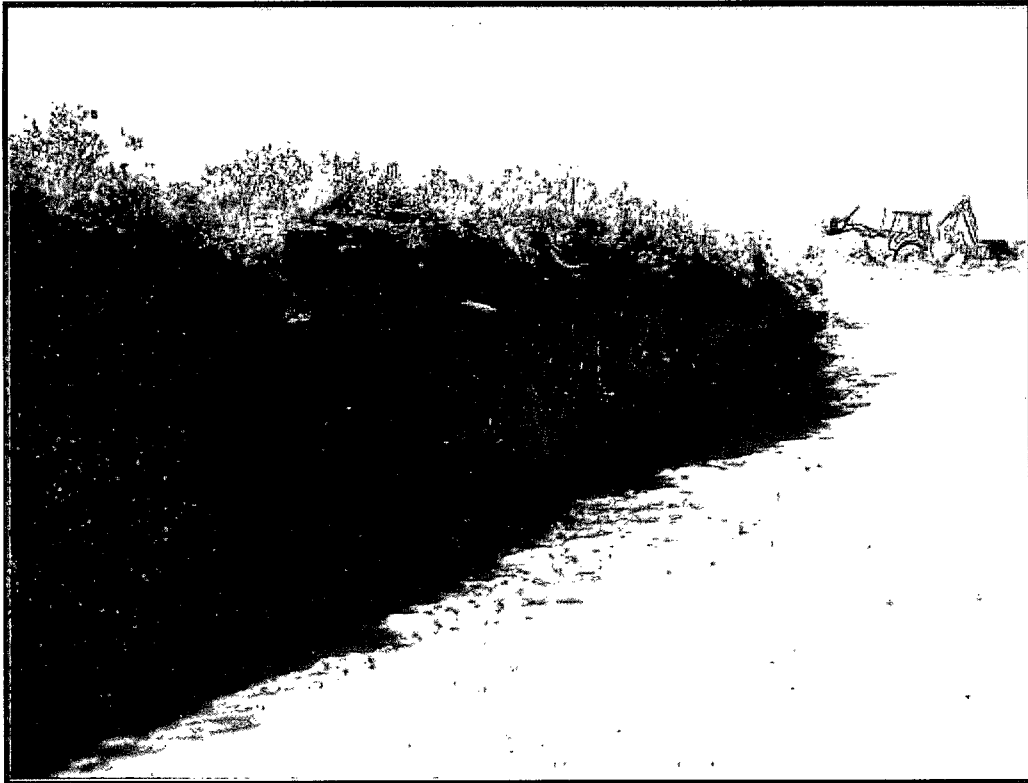
Excavated area facing southwest

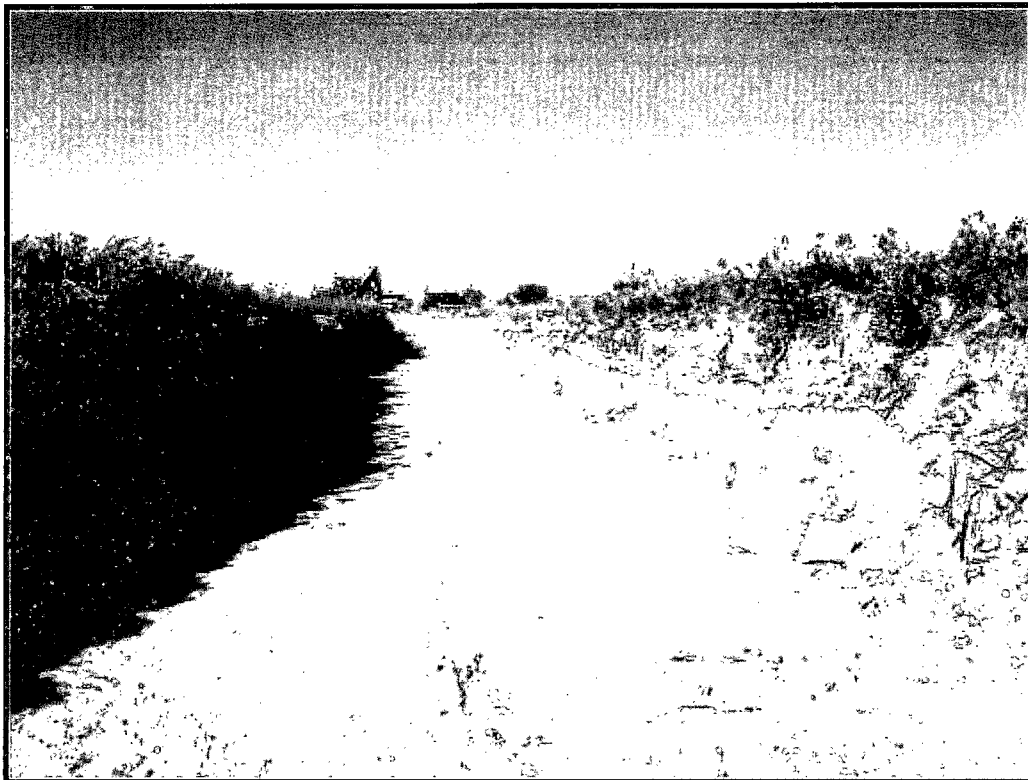
Excavated area facing west

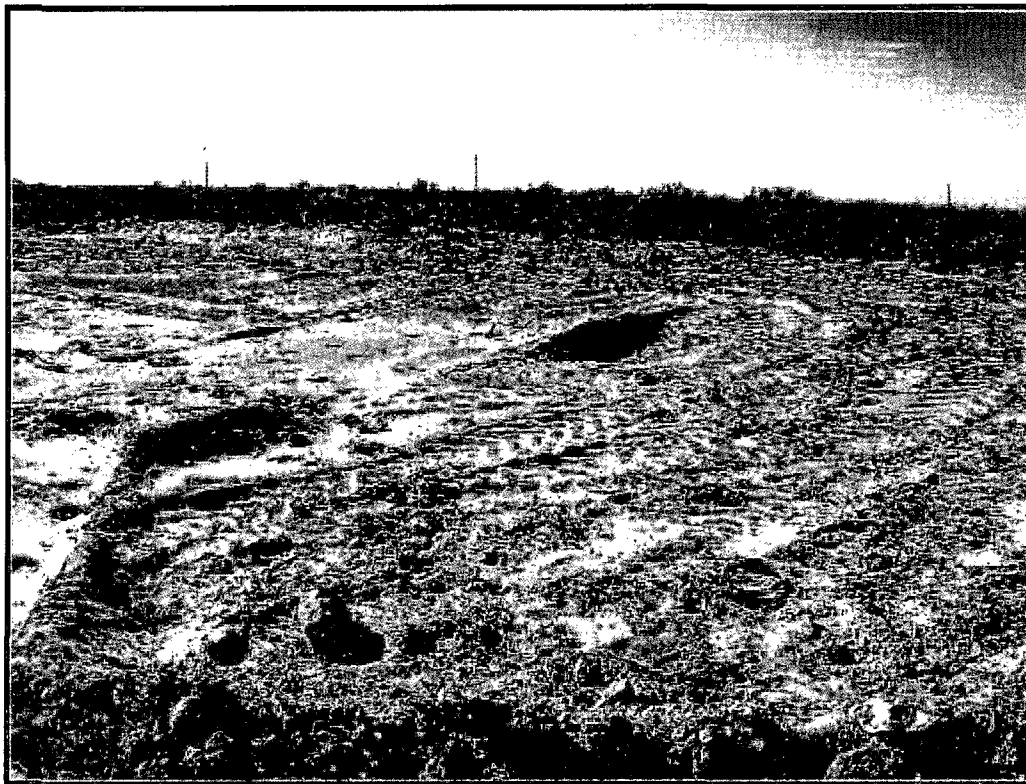
East side of lines backfilled facing south

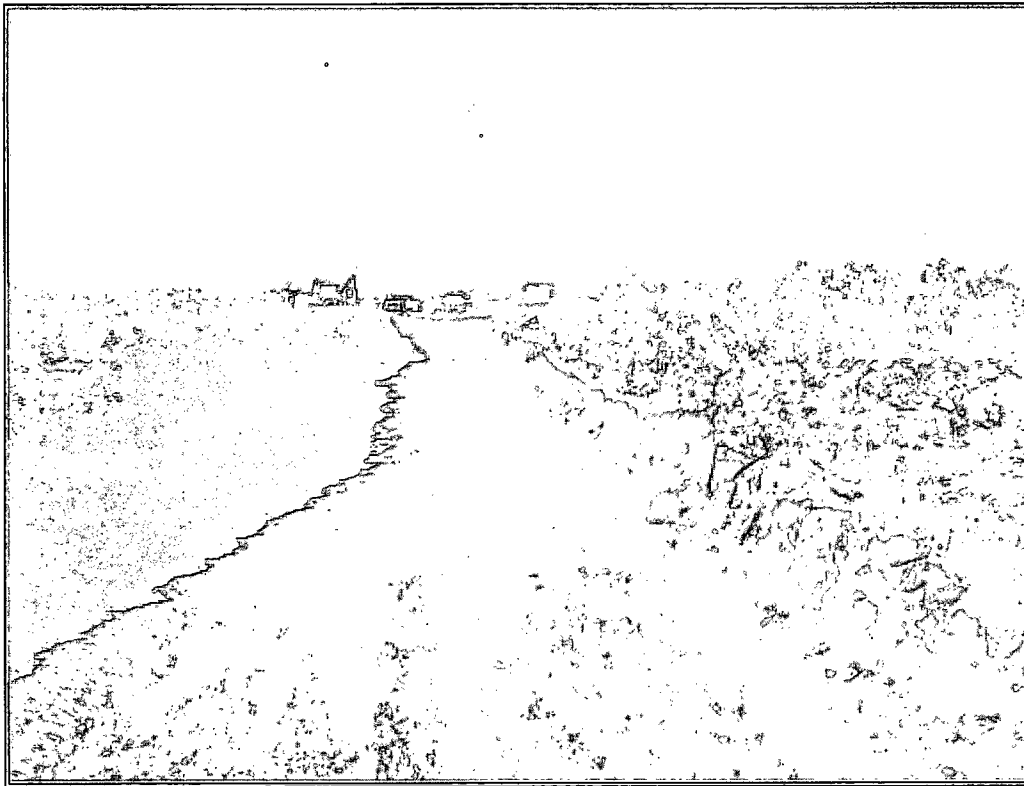
Excavated area facing west

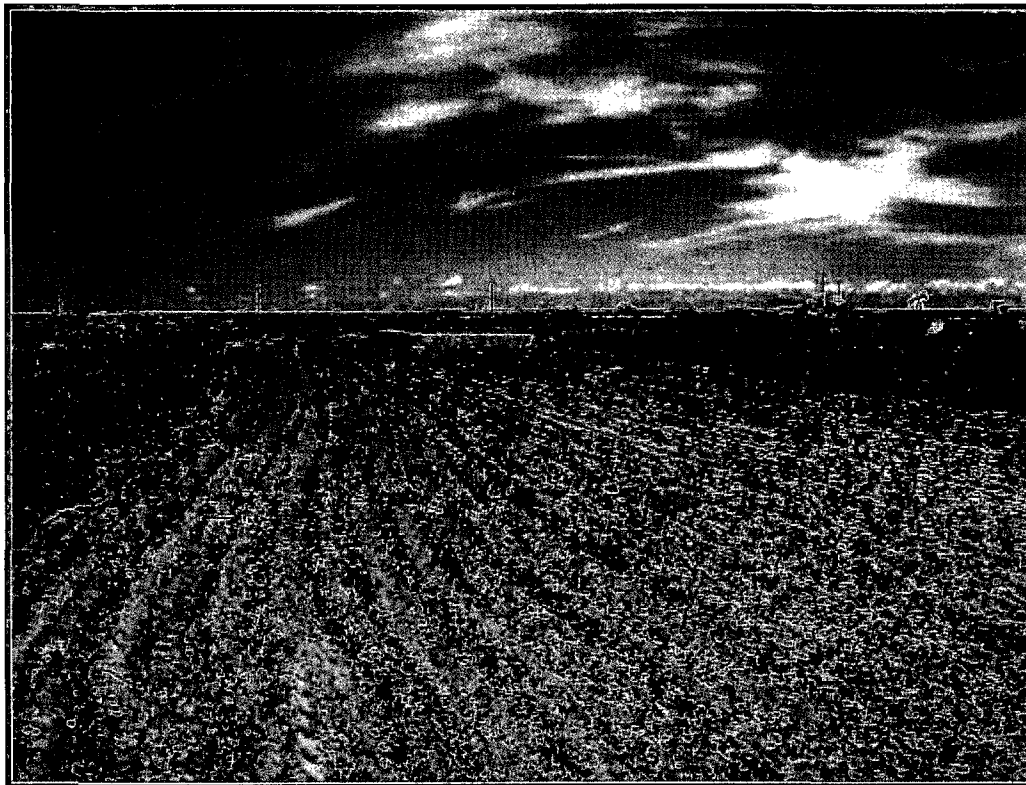
Backfilled area facing east
