GW - 125

Soil Remediation

RE: Yates Penasco Compressor station, Passive Vent Well Installation

PENASCO YARD

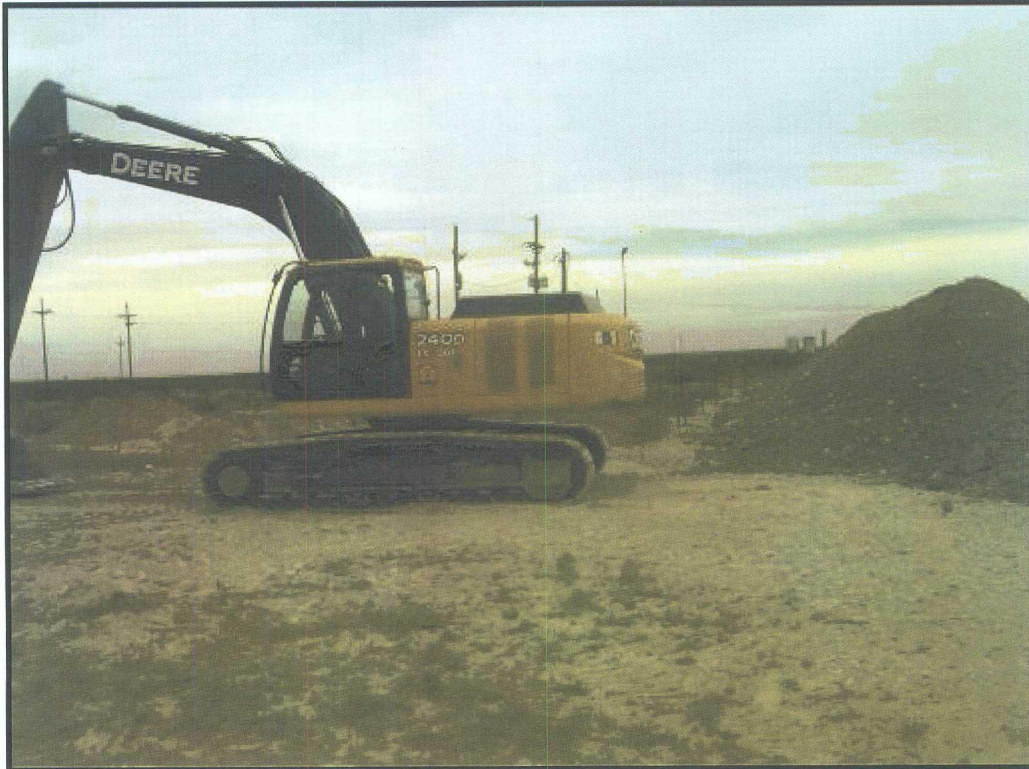
Excavated soils facing west

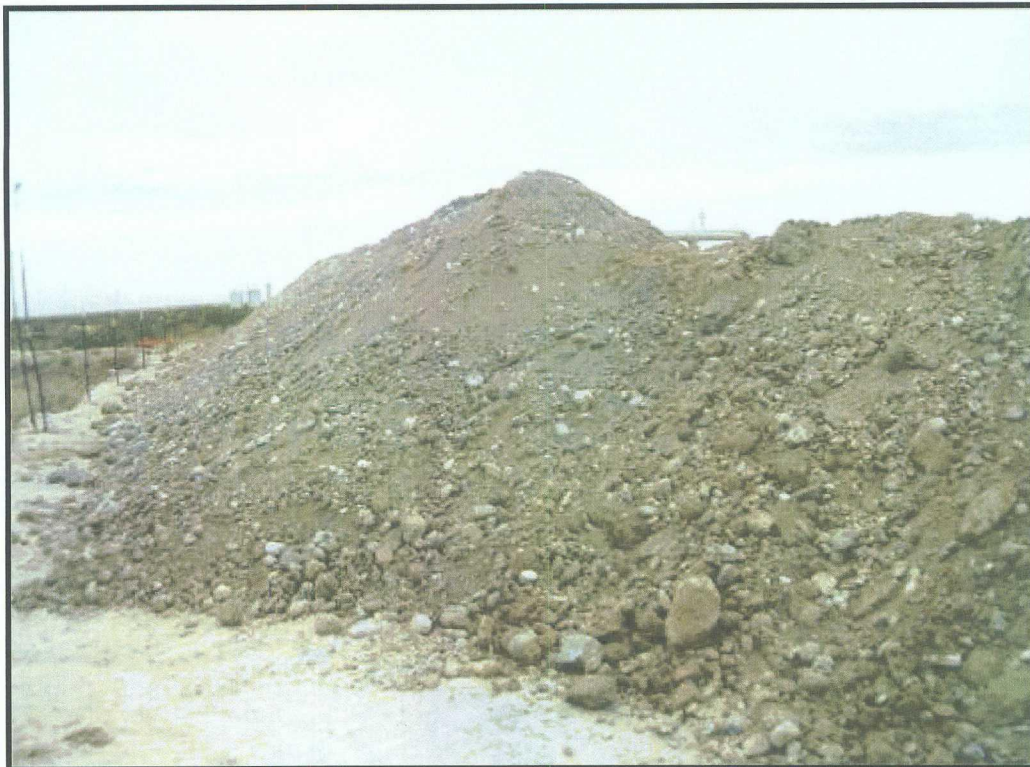
Highly stained soils stockpiled facing west

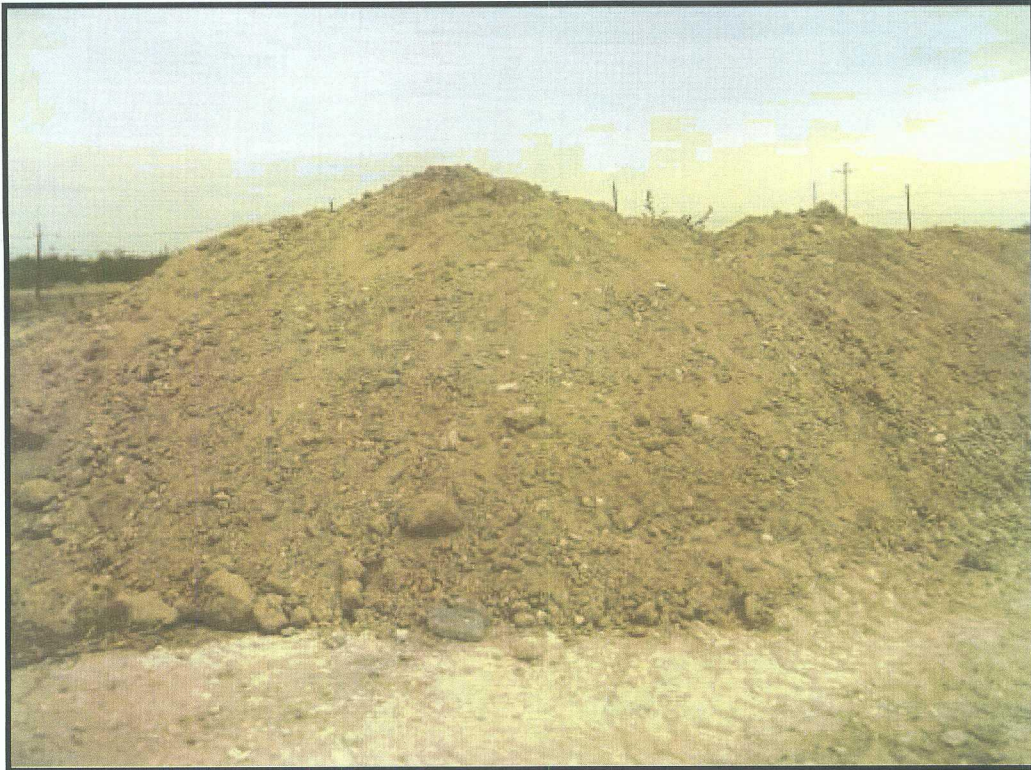
In addition several hundred yards of unsaturated, non-stained material were removed from the excavation and stockpiled on site for later return to the excavation. This material was tested on October 26 with results of the analysis shown below. This material was directed to be blended with the caliche before placement in the excavation.

Non stained soils stockpiled southeast corner of excavation

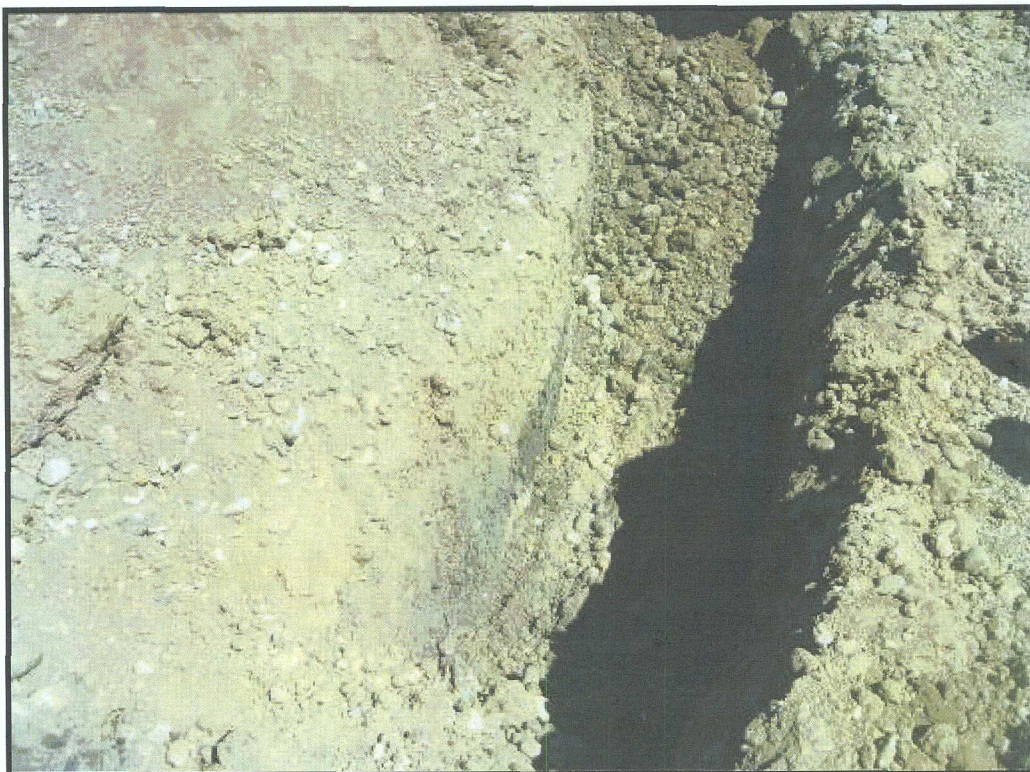
Trench with staining 30' from desire stop point facing east

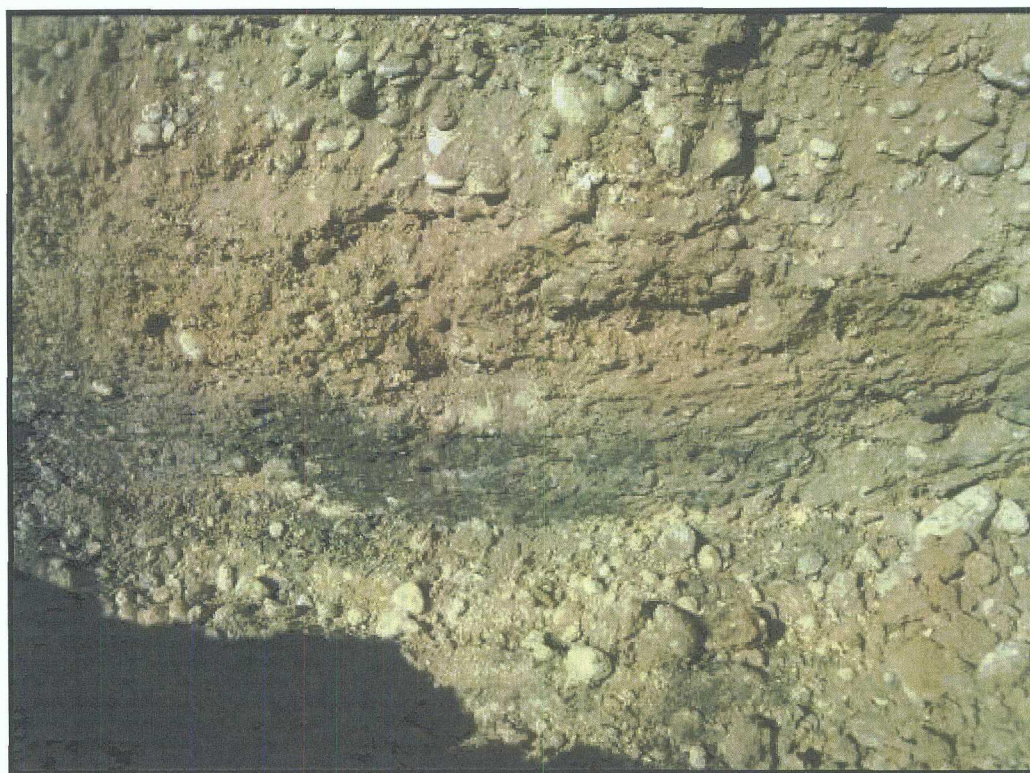
Test trench north wall

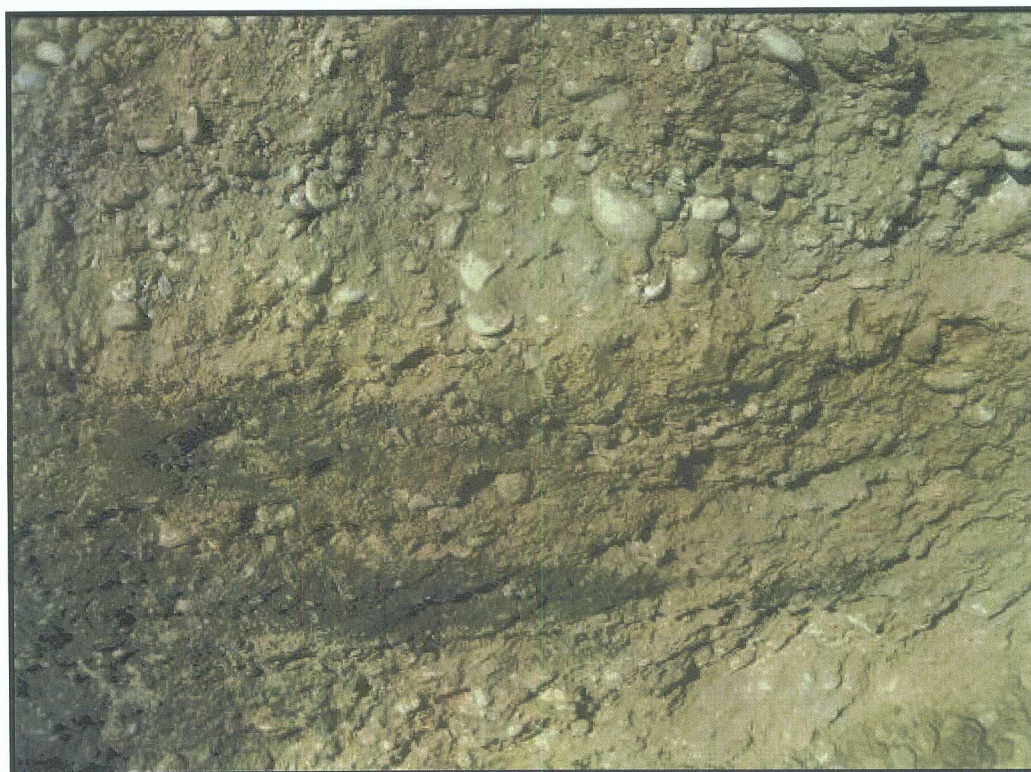
Test trench with staining on north wall

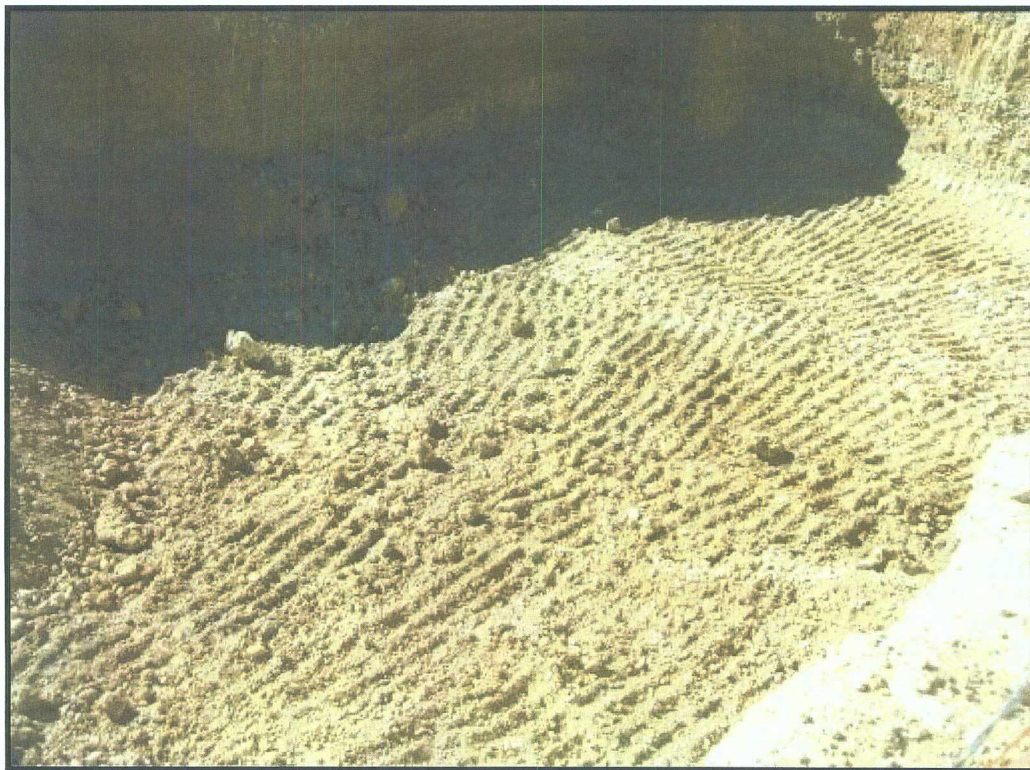
Excavation bottom floor at 24'bgs

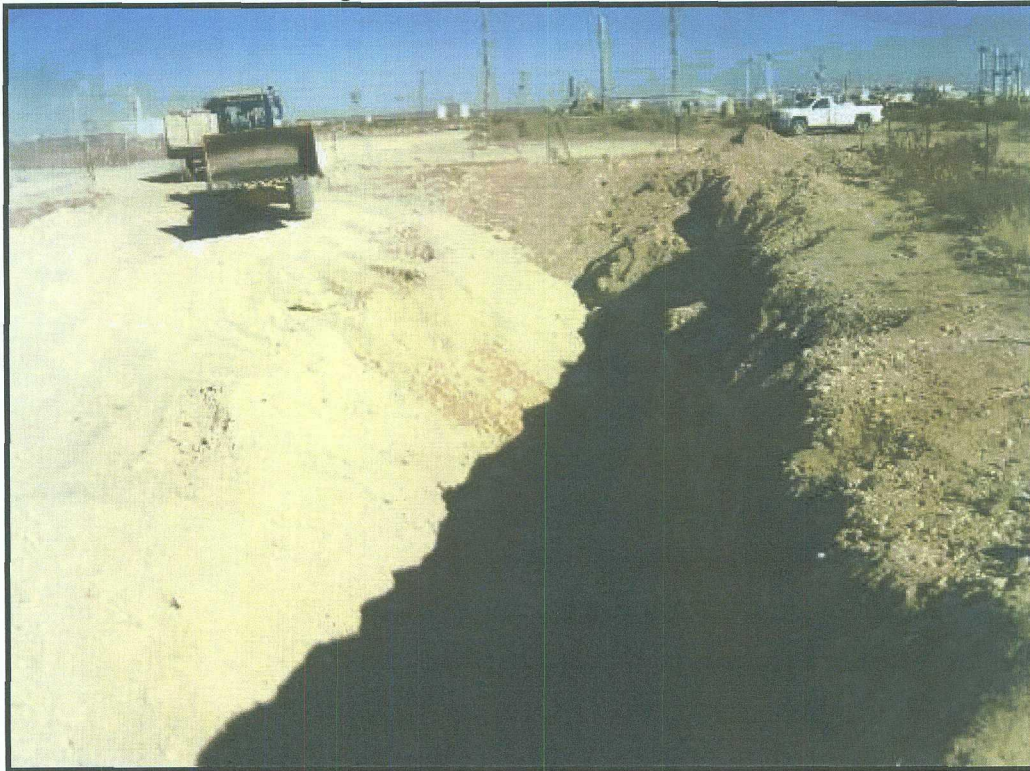
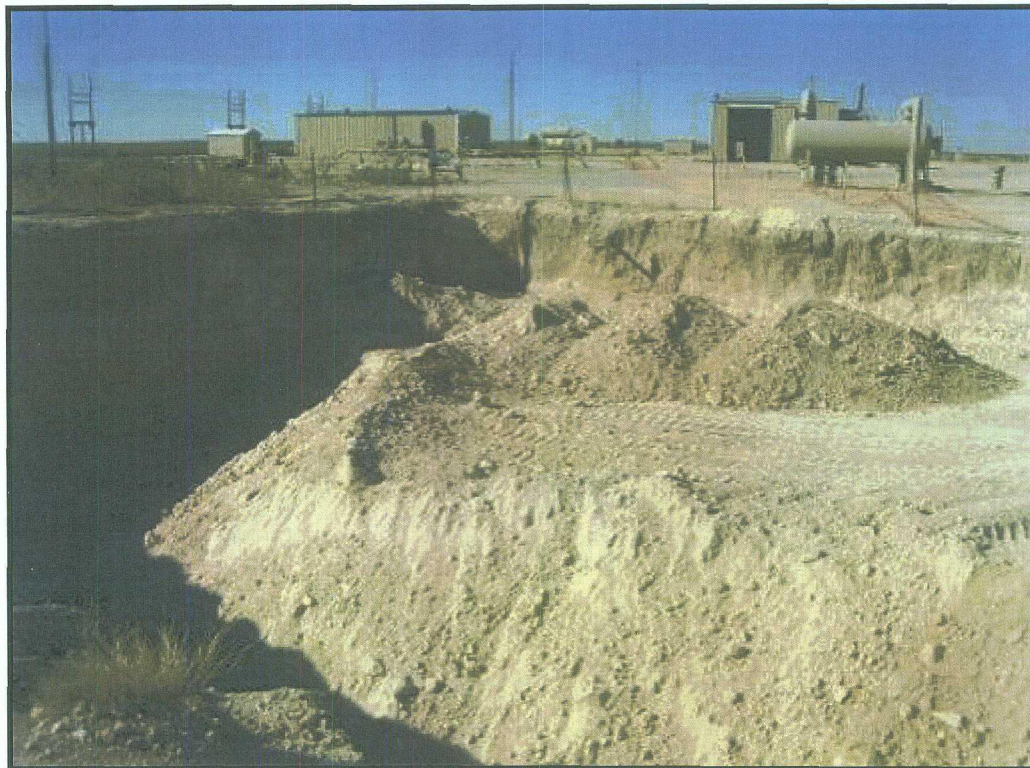
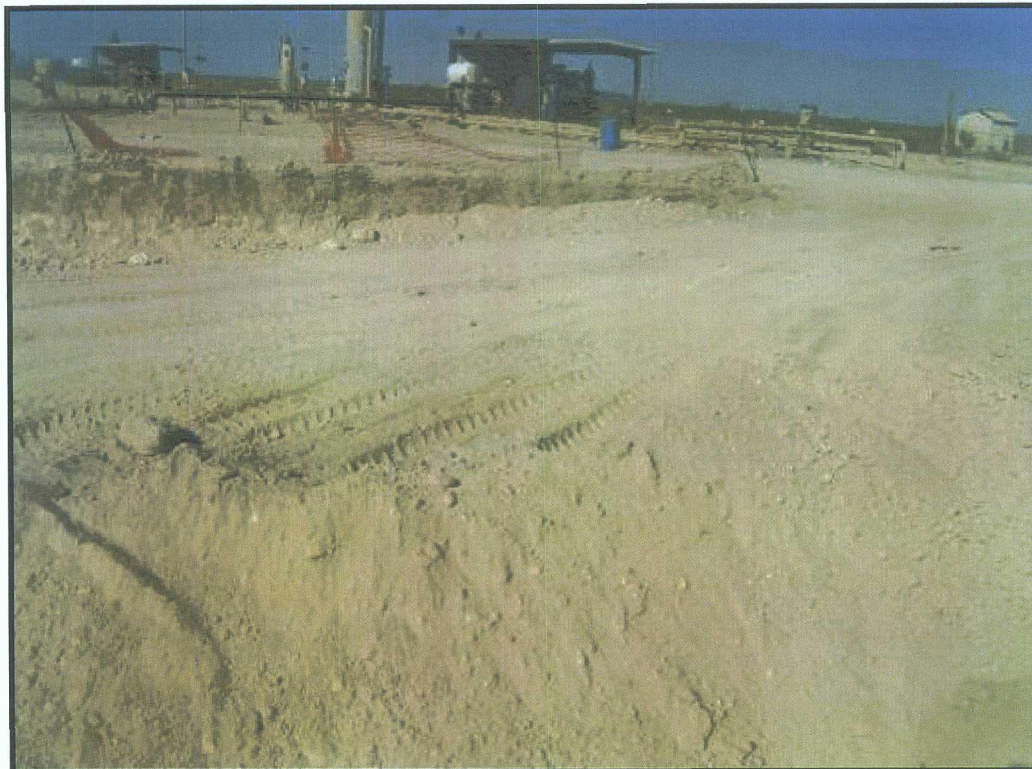
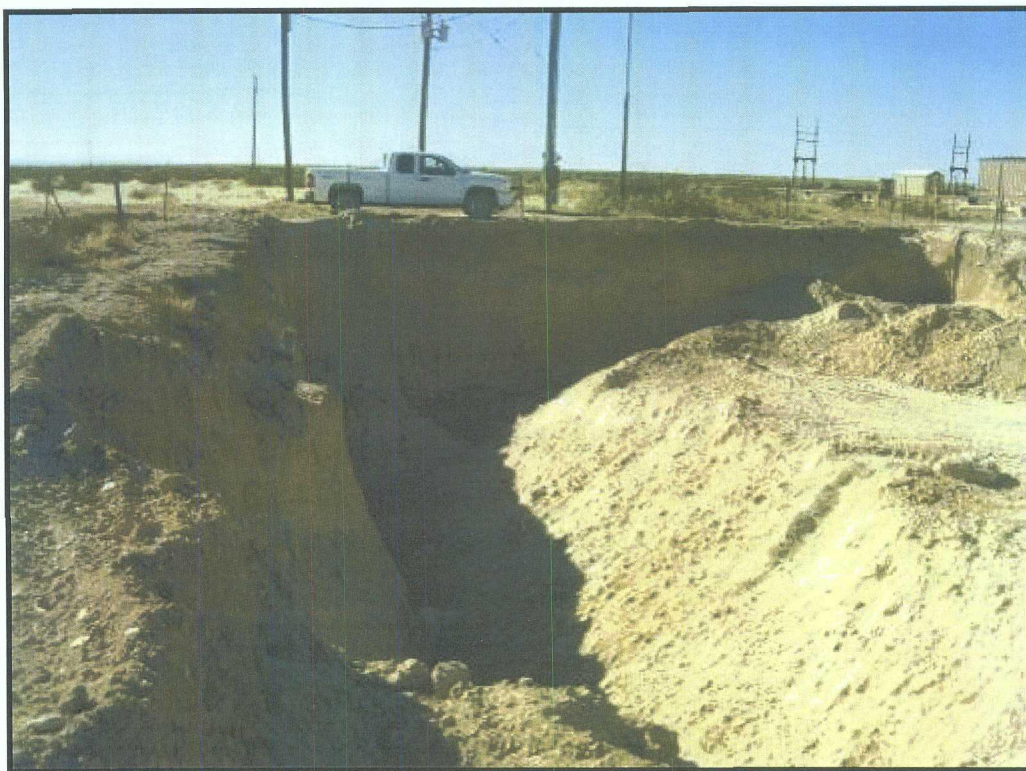
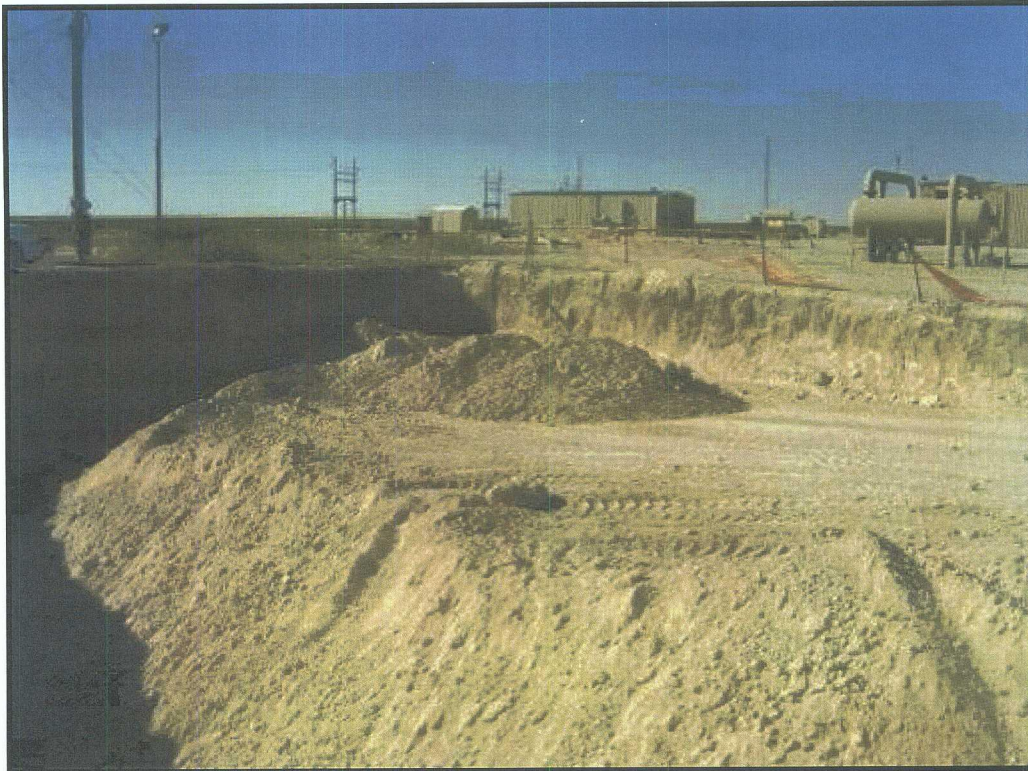
NMOCD approved backfill of the excavation on November 4, 2010. SESI and Watson Construction began backfilling with clean caliche from an offsite location on November 10, 2010. Backfill continued on November 11-12. Approximately 3,536 cubic yards of caliche plus the non-stained stockpiled material were used as backfill. The location area was then contoured to its natural earth form.

Excavated area backfilled facing east

Excavated area backfilled facing north

Excavated area backfilled facing west

Excavated area backfilled facing northwest

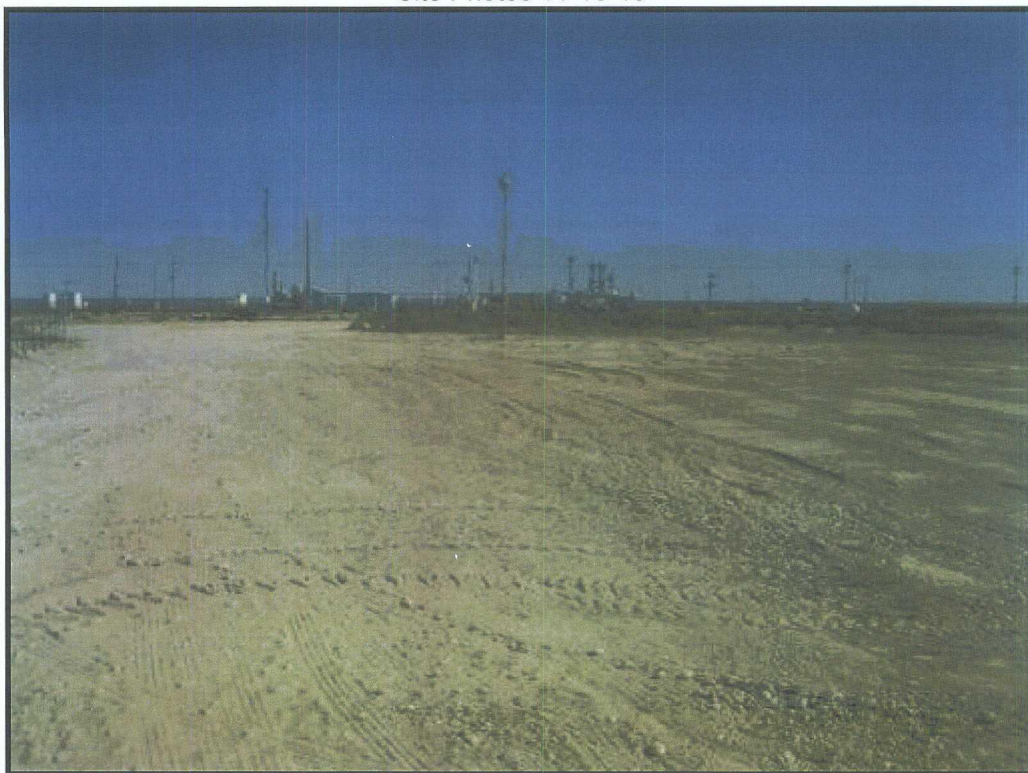
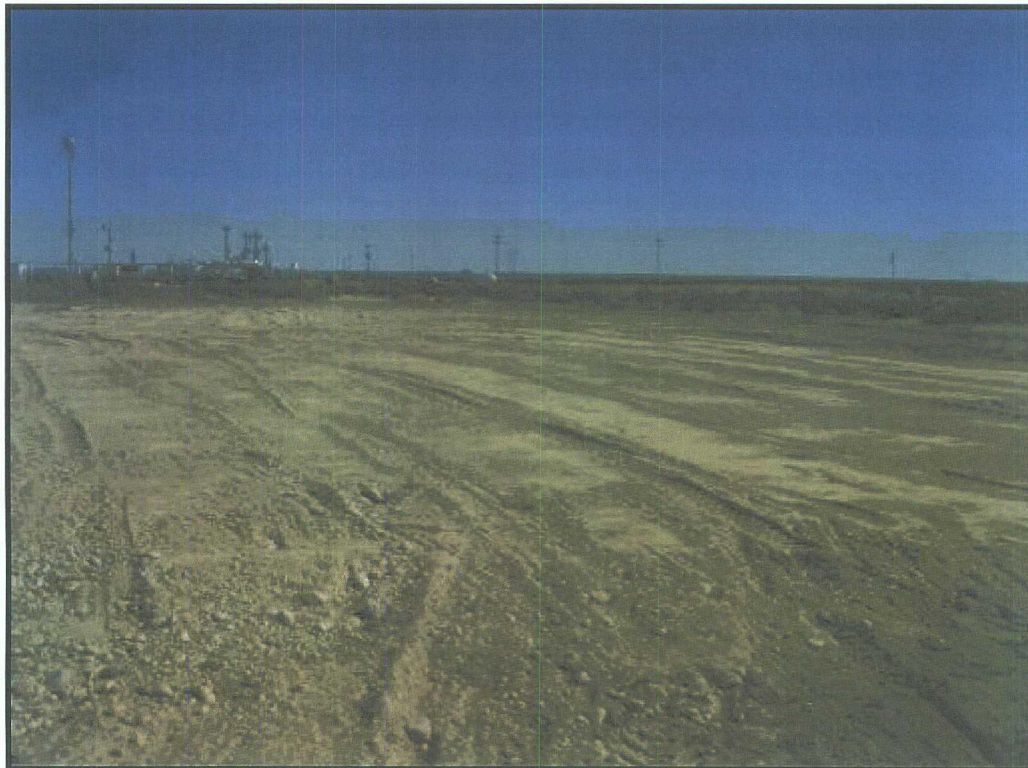
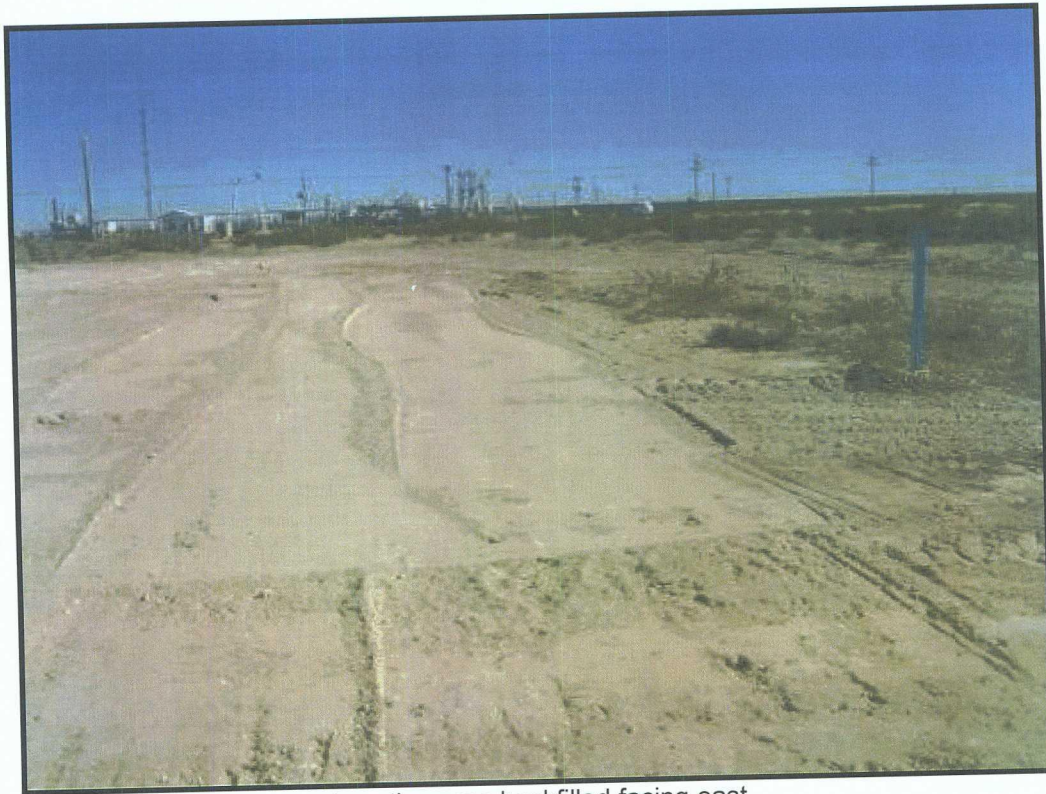
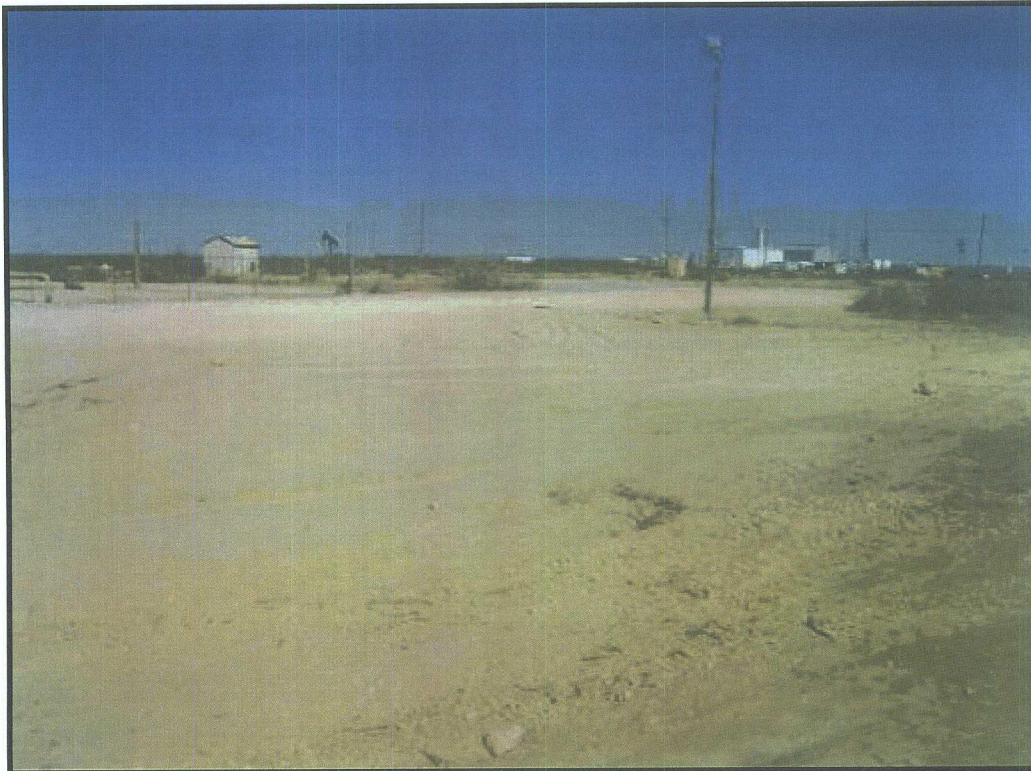
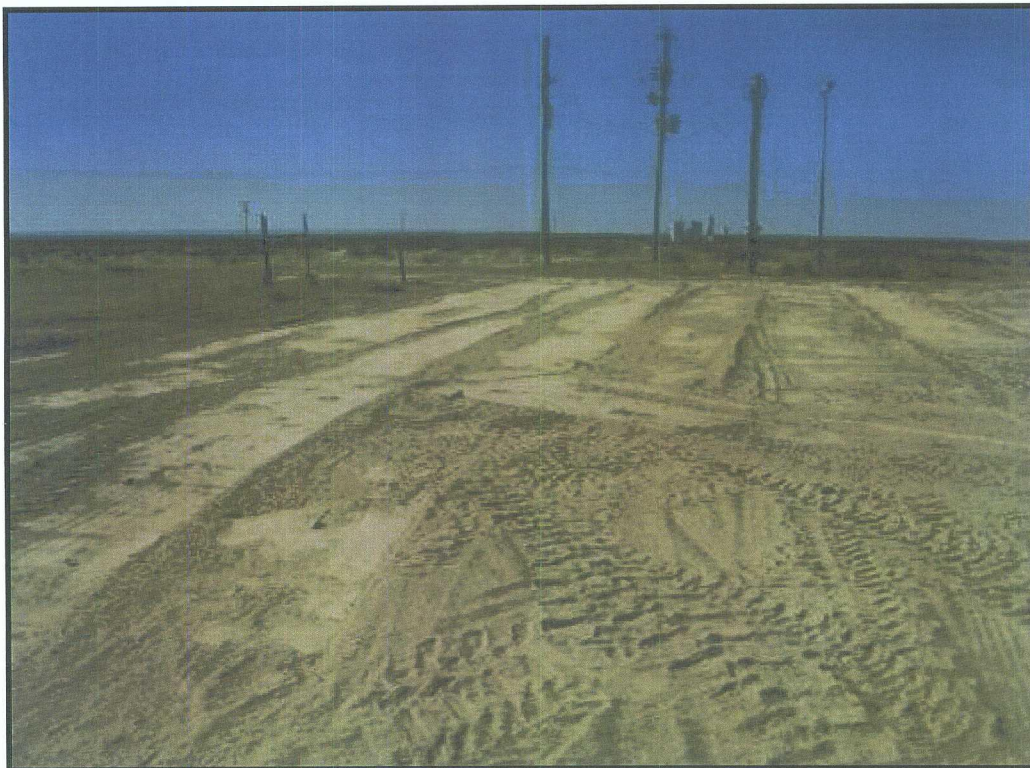
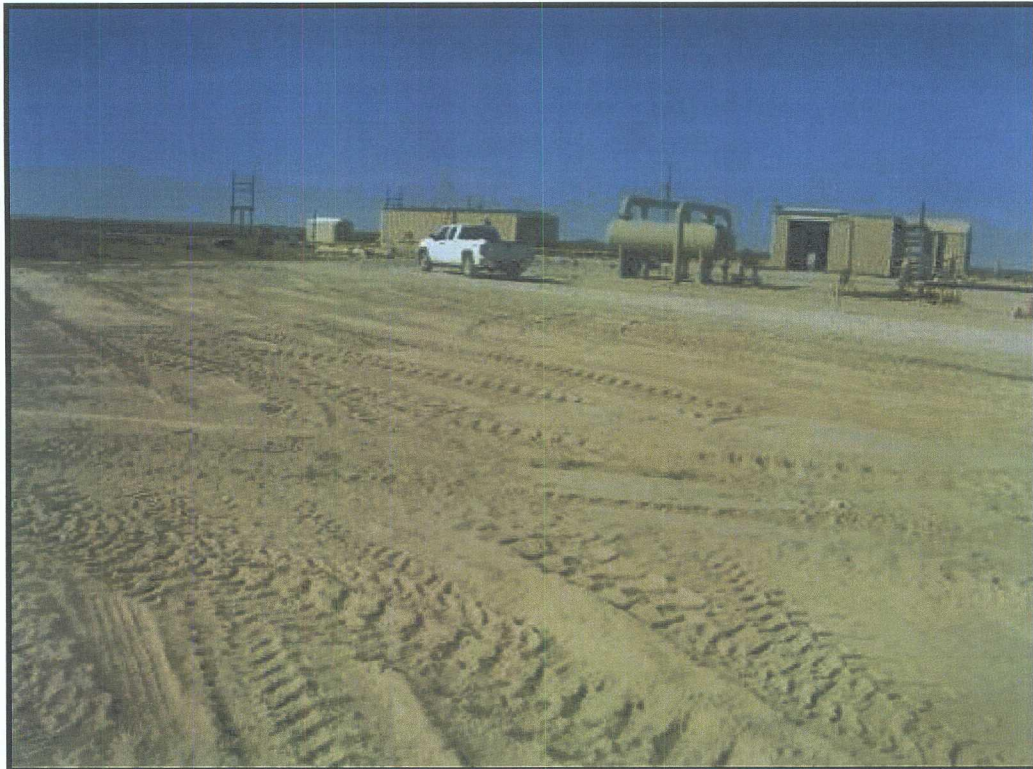
Location area backfilled facing east

Location area backfilled facing north

Location area backfilled facing northeast

Location area backfilled facing west

Location area backfilled facing northwest
