Release Notification and Corrective Action

RE: **Range Operating New Mexico
H.S. Turner Battery accidental discharge (IRP- 2686)
TERMINATION REQUEST
Unit Letter M, Sec. 29, T21S, R37E
Lea County, New Mexico**

H.S. Turner Battery Accidental Discharge UL M Sec. 29 T21S R37E

Range H.S. Turner Battery
Unit letter M, Section 29, Township 21S, Range 37E
GPS: N32*26.674, W103*11.403'

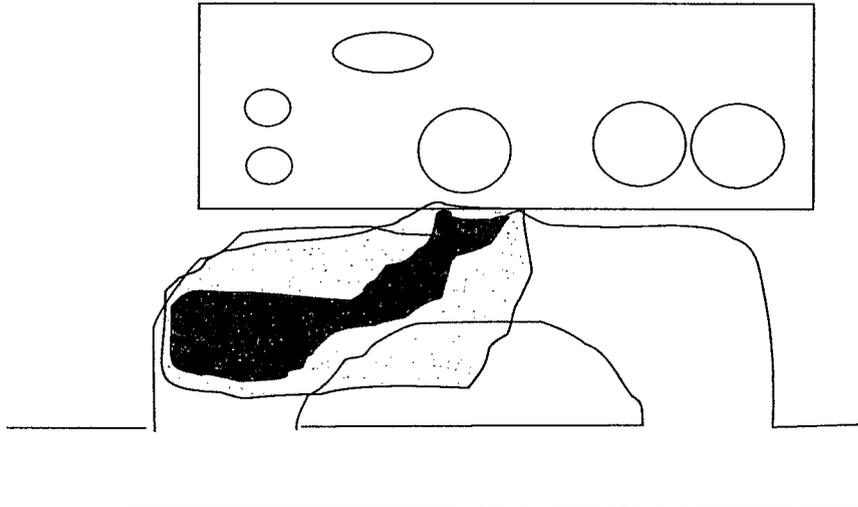
Affected Area all on Lease Road 839 ft.²
Scraped Area 2,312 ft.²

PID		Lab Results
15' West	1104	TPH 31,800
37' West	691.1	
50' West	636.5	
64' West	562.8	TPH 13,050
Btm Comp.	9.3	TPH 22.9

On February 10, 2011, four surface samples were collected from the leak area and field screened for volatile organic compounds (VOCs) using a PID. PID (field) readings were elevated (see attached site map and PID sheet) and two samples were sent to a commercial laboratory for verification of TPH concentrations. Lab results confirmed elevated concentration of DRO and GRO in both samples. The 15 foot West sample yielded a GRO concentration of 9,000 mg/kg and a DRO concentration of 22,800 mg/kg. The 64 foot West sample yielded a GRO concentration of 2,350 mg/kg and a DRO concentration of 10,700 mg/kg (see attached laboratory report). The wet soil was scraped and approximately 800 ft² of soil was disposed of at an NMOCD approved facility. On February 11, 2011, a 68x34-ft area was scraped to a depth of one (1) foot below ground surface (bgs) and the soil was disposed of at an NMOCD facility. Once scraping was complete, a 5 foot bottom composite sample was collected and field screened for VOCs using PID. The PID (field) reading resulted in 9.3 ppm. The sample was sent to a commercial laboratory for verification. Lab results confirmed a GRO concentration of <10.0 mg/kg and a DRO concentration of 22.9 mg/kg (see attached laboratory report). Gravel located within the diked area was removed and properly disposed of at an OCD approved facility on February 17, 2011. Upon NMOCD approval, the site will be backfilled with soil containing a PID reading of <100 ppm.

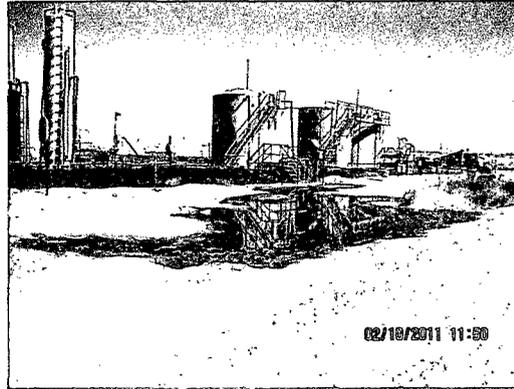
Affected Area

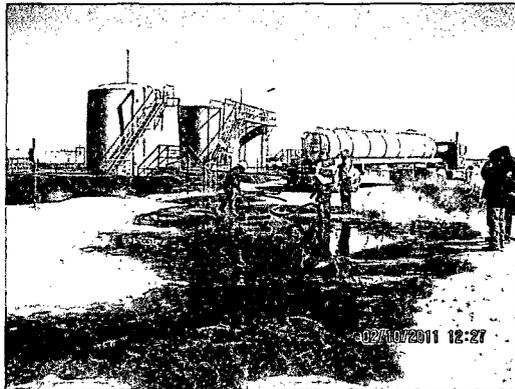
Picking up fluid

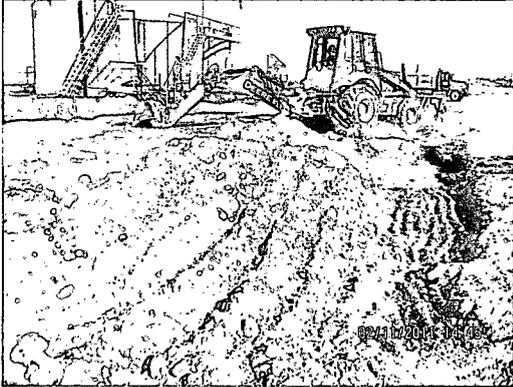
Scraping to 1 ft. BGS 2/11/2011

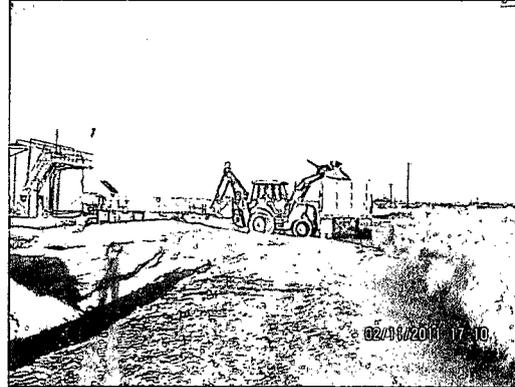
Hauling off soil 2/11/2011

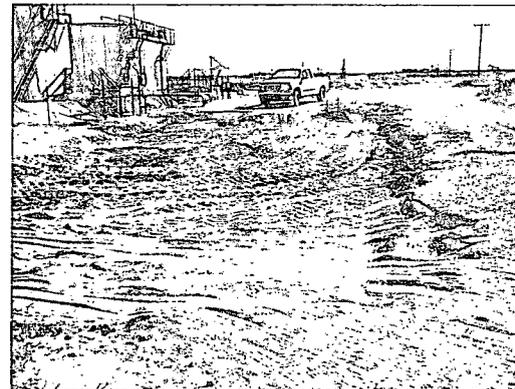
Scrape complete 2/24/2011
