CLOSURE

**RICE OPERATING COMPANY
JUNCTION BOX FINAL REPORT**

EME C-10-1 EOL

Unit C, Section 10, T21S, R36E

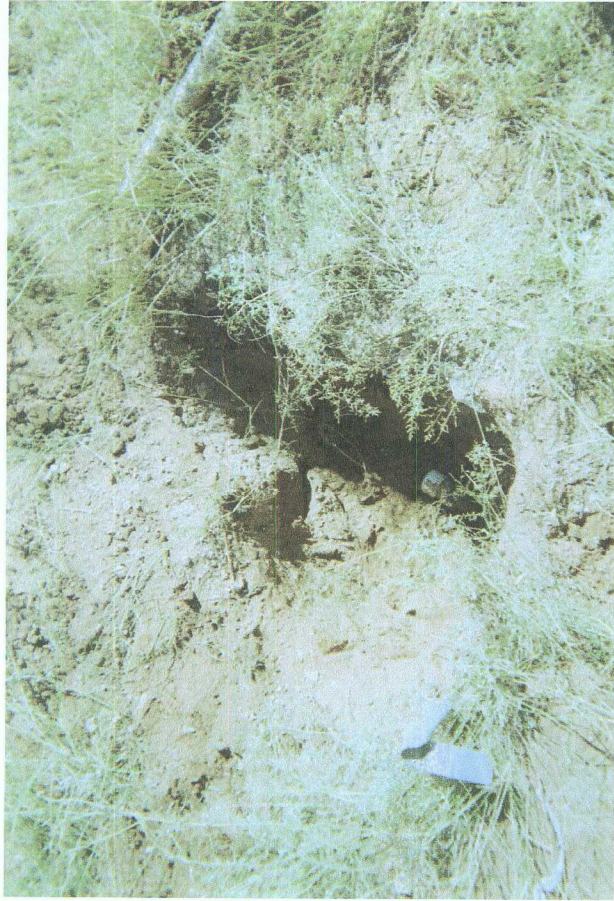
9/14/2010

Site prior to excavation

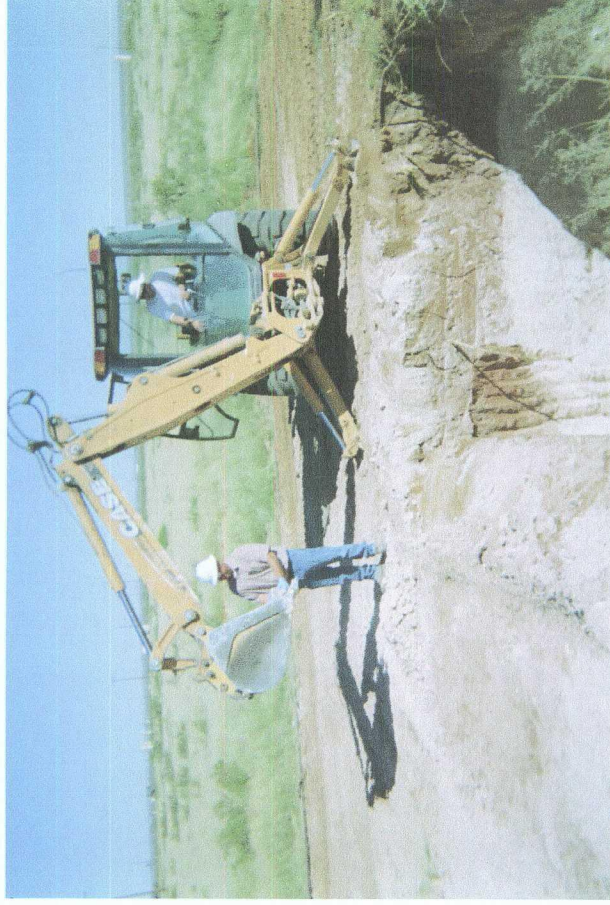
9/29/2010

Collecting Sample

Organic vapors were measured using a PID. The excavated soil was blended on site and representative composite samples were collected from the blended backfill, the bottom of the excavation, and the excavation walls. The representative samples were sent to a commercial laboratory for analysis of chloride and TPH. The blended backfill was returned to the excavation to 2 ft. below ground surface. The remaining excavation was backfilled with clean imported soil to ground surface and contoured to the surrounding area. On 10/15/2010, the site was seeded with a blend of native vegetation and is expected to return to a productive capacity at a normal rate.

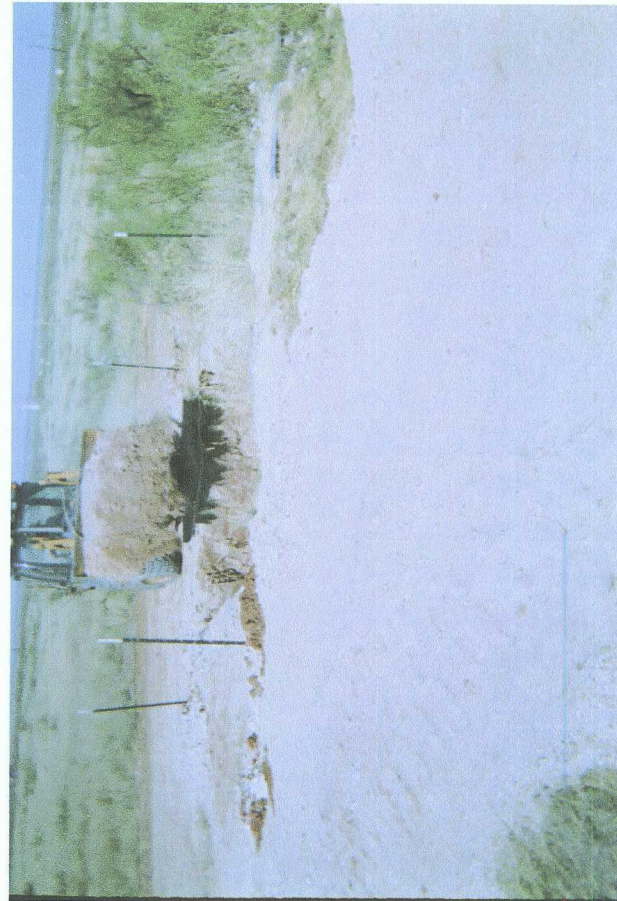
10/27/2010

Backfilling site

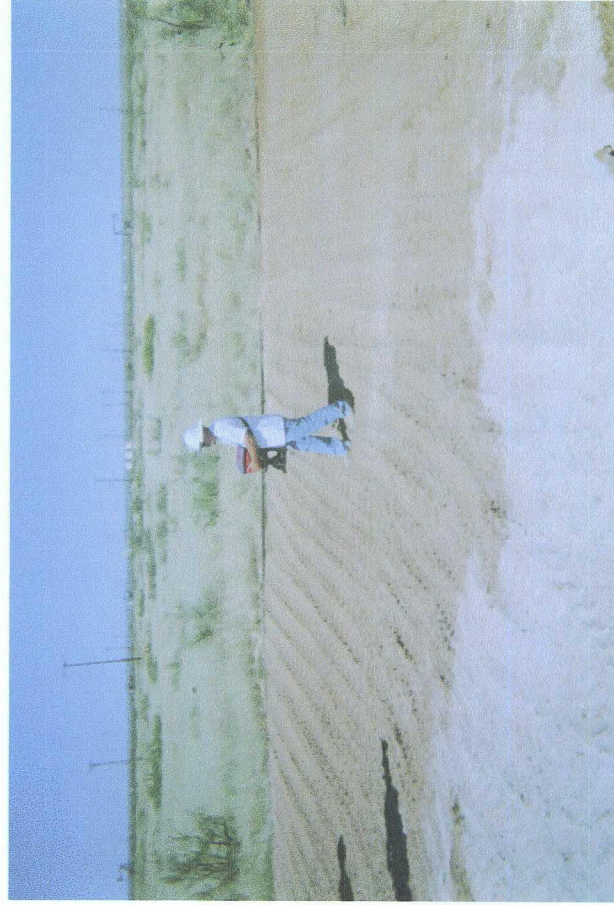
10/27/2010

Seeding site
