EME Jct. C-17

**RICE OPERATING COMPANY
JUNCTION BOX FINAL REPORT**

Unit C, Section 17, T21S, R36E

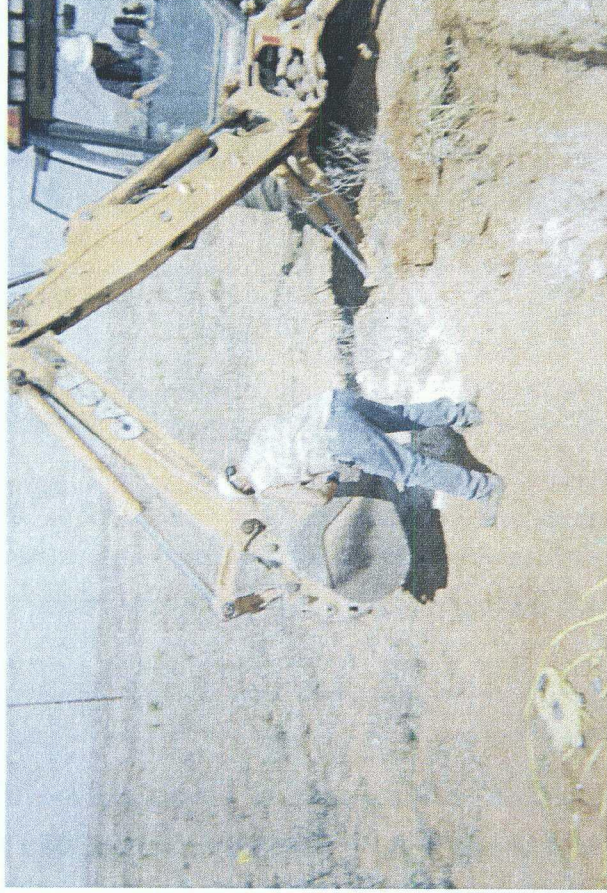
Sampling the source facing east 3/30/10

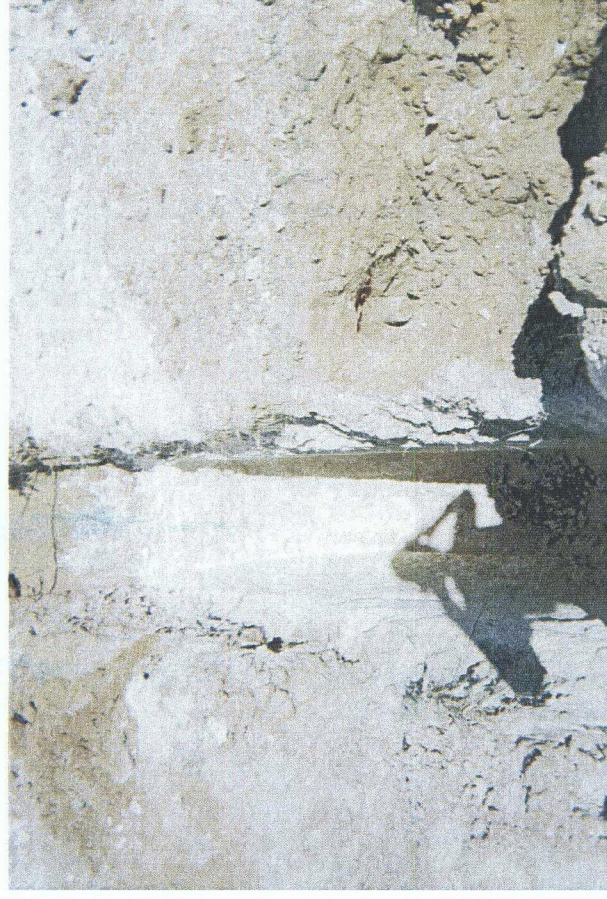
Digging the source facing east 3/30/2010

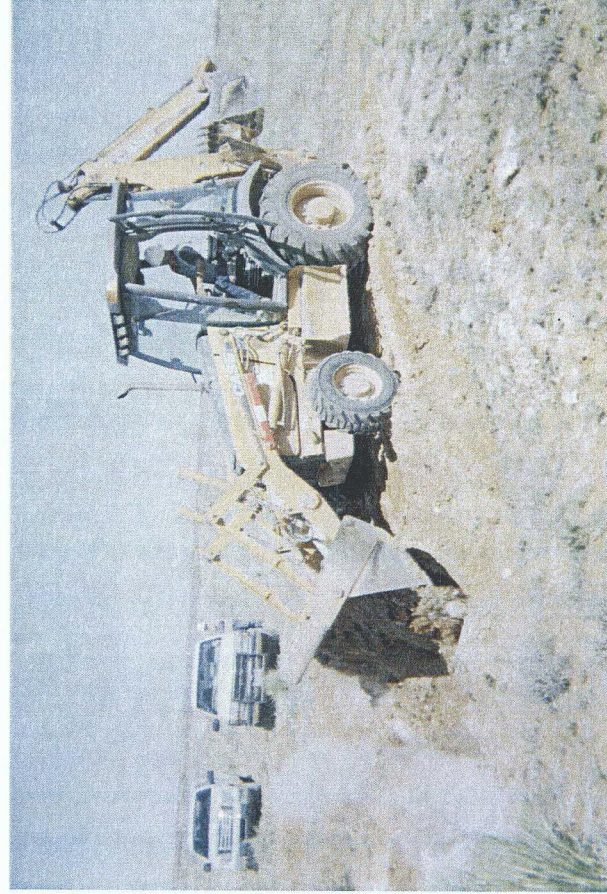
Final excavation facing east 3/30/10

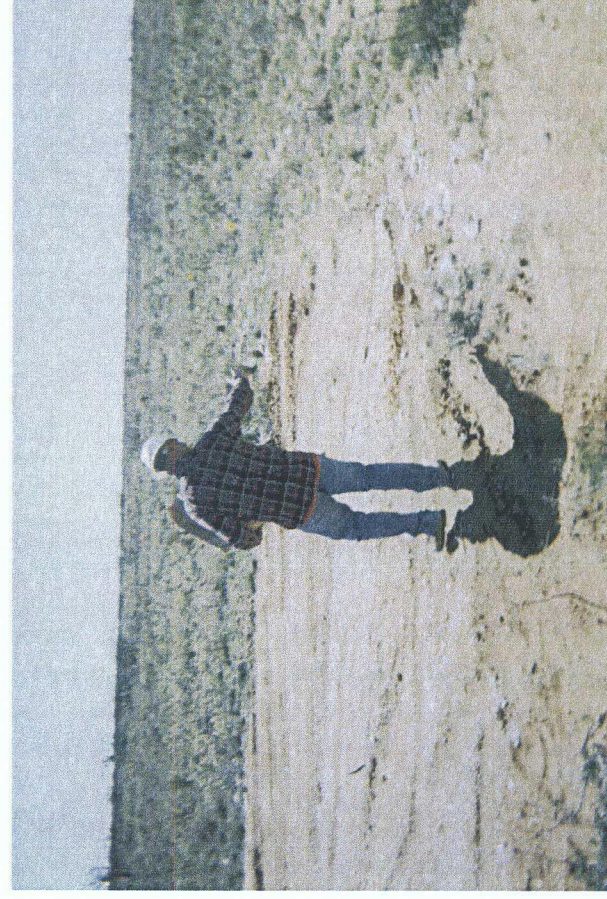
Seeding site facing west 4/7/2010

surrounding area. On 4/07/2010, the site was seeded with a blend of native vegetation and is expected to return to a productive capacity

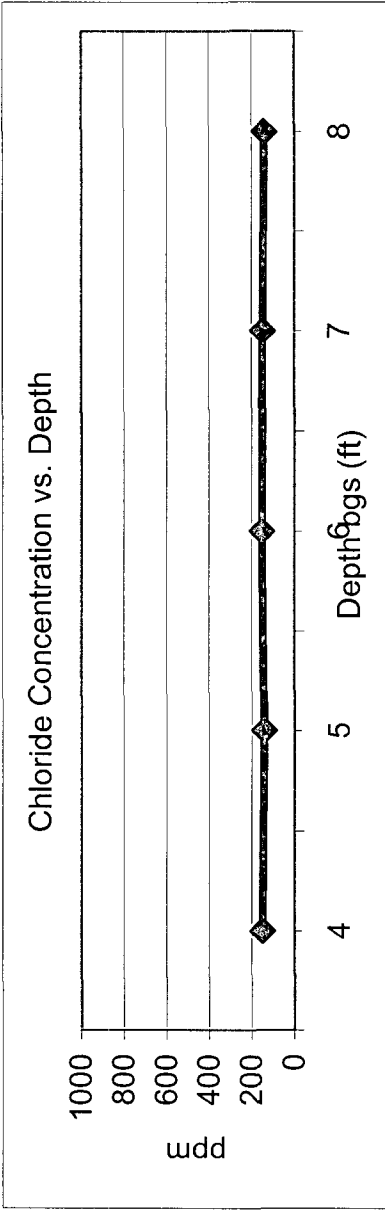
CHLORIDE CONCENTRATION CURVE

Backhoe samples at the junction (source)

Depth bgs (ft)	Cl ⁻ ppm
4	149
5	142
6	152
7	148
8	141

Groundwater = 178 ft
