**Vacuum Jct. C-27**

**CLOSURE**

RICE OPERATING COMPANY  
JUNCTION BOX FINAL REPORT

SWD SYSTEM	JUNCTION	UNIT	SECTION	TOWNSHIP	RANGE	COUNTY	BOX DIMENSIONS - FEET		
Vacuum	Jct. C-27	C	27	17S	35E	Lea	Length	Width	Depth
							Eliminated

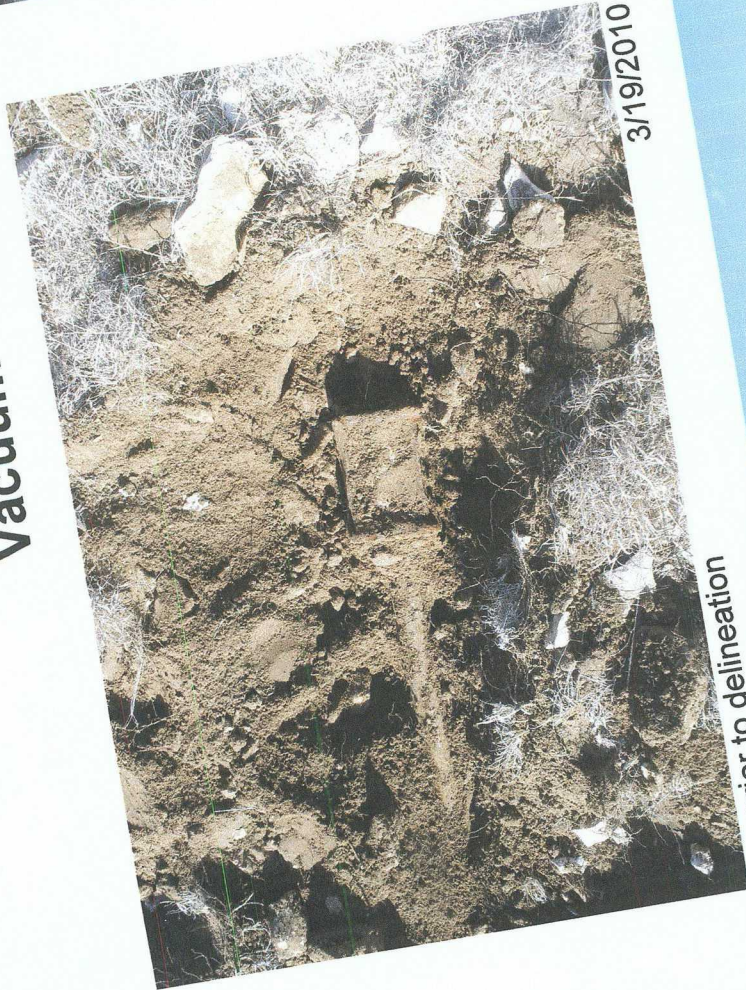
3/19/2010

Site prior to delineation

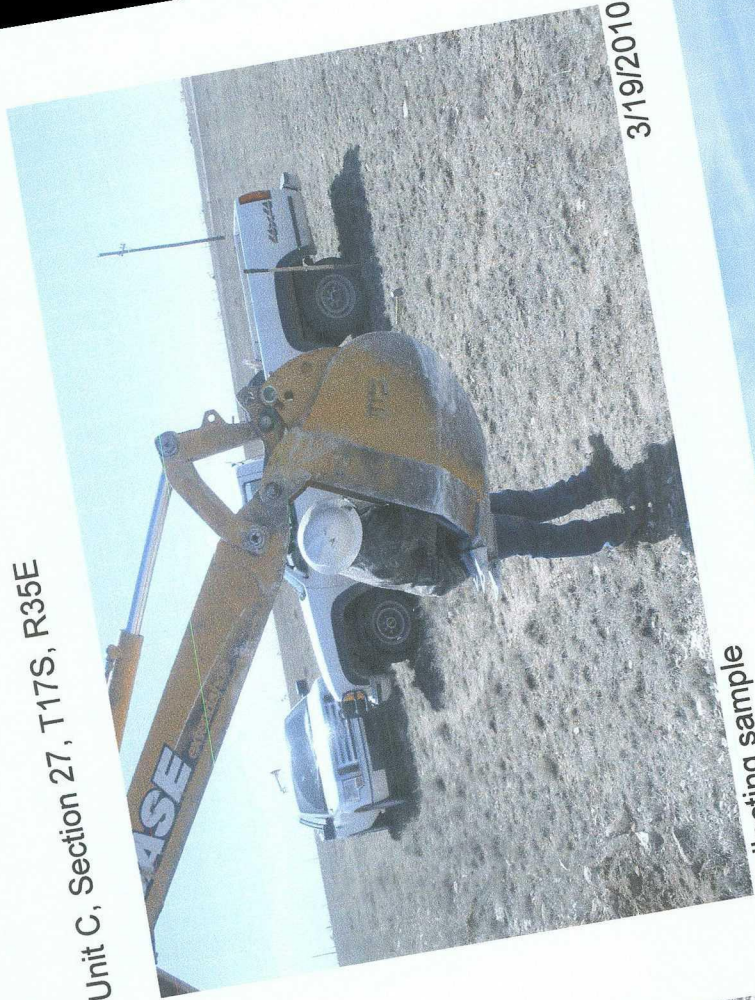
3/19/2010

Collecting sample

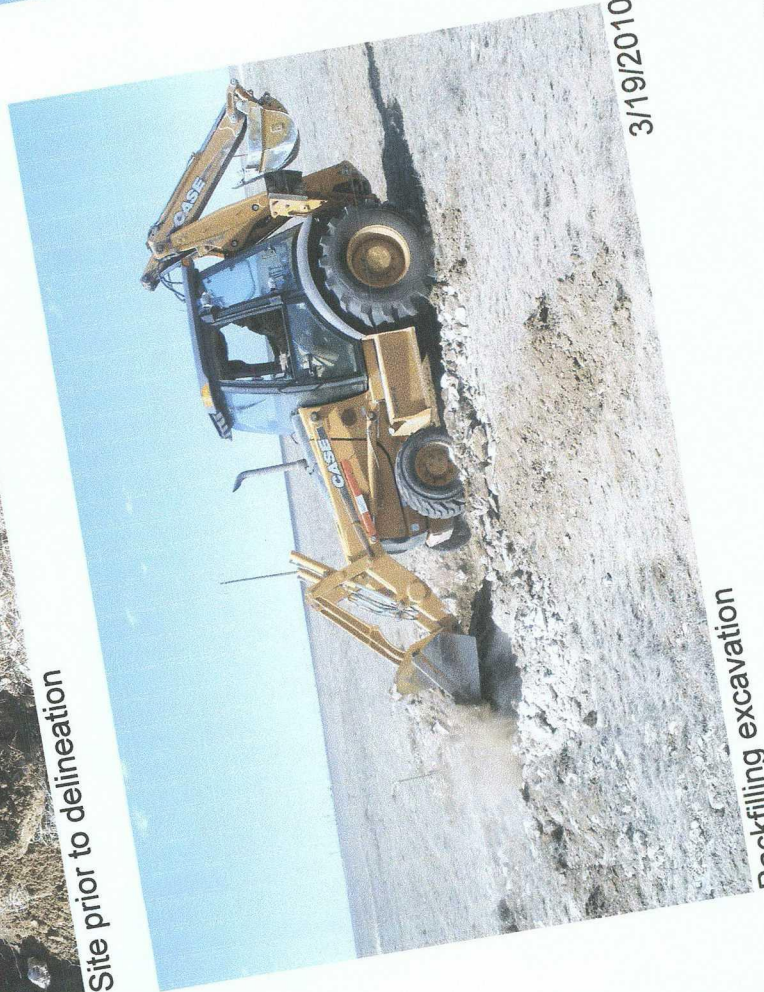
3/19/2010

Backfilling excavation

The excavated soil was returned to the excavation to ground surface and contoured to the surrounding area. On 3/03/2011, the site was seeded with a blend of native vegetation and is expected to return to a productive capacity at a normal rate.

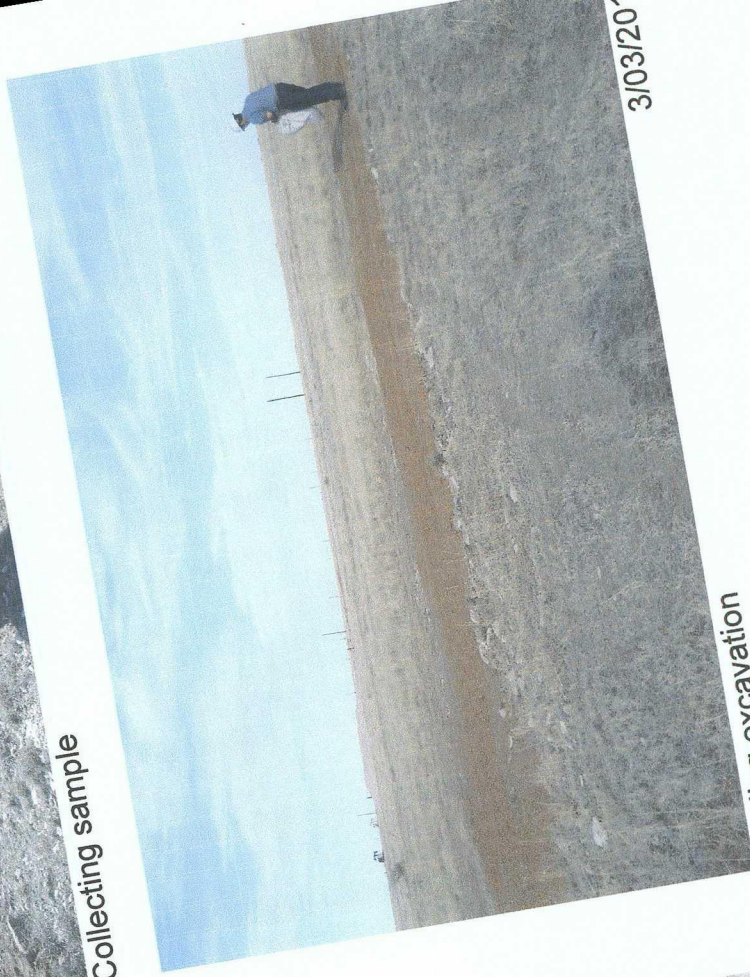
3/03/2010

Seeding excavation

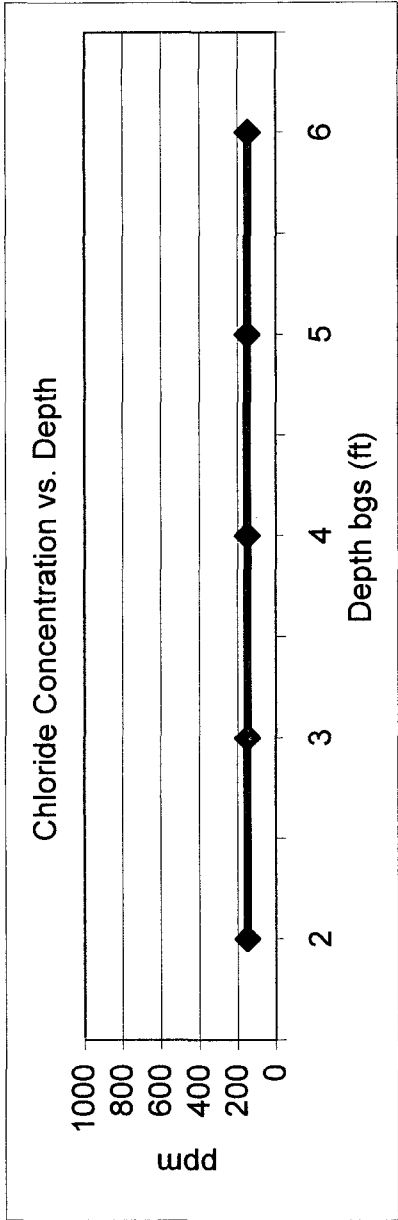
# Vacuum Jct. C-27

Backhoe samples at the junction (source)

Depth bgs (ft)	[Cl <sup>-</sup> ] ppm
2	149
3	148
4	150
5	150
6	146

Groundwater = 54 ft
