Vacuum E-31 EOL

CLOSURE

RICE OPERATING COMPANY
JUNCTION BOX FINAL REPORT

Unit E, Section 31, T17S, R35E

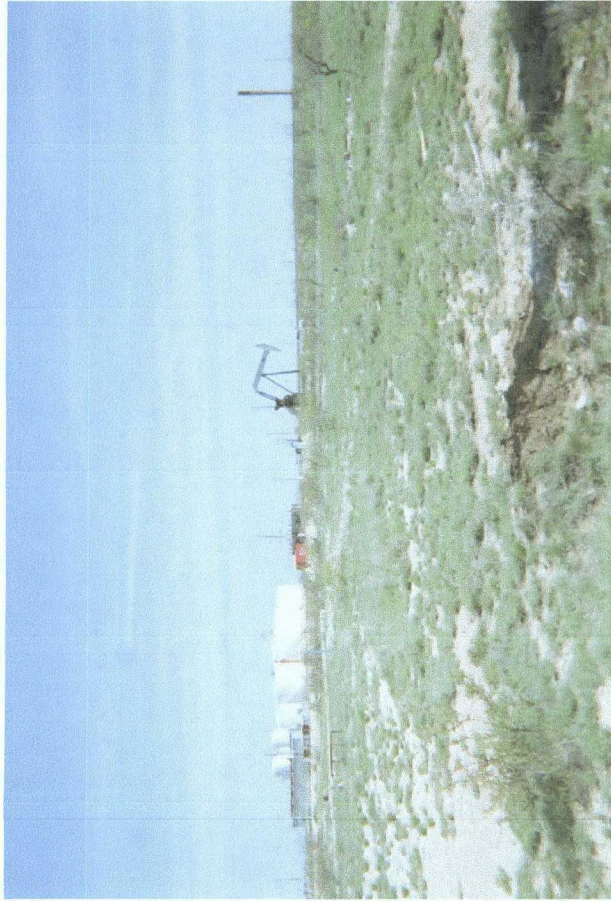
Site prior to delineation

4/27/2010

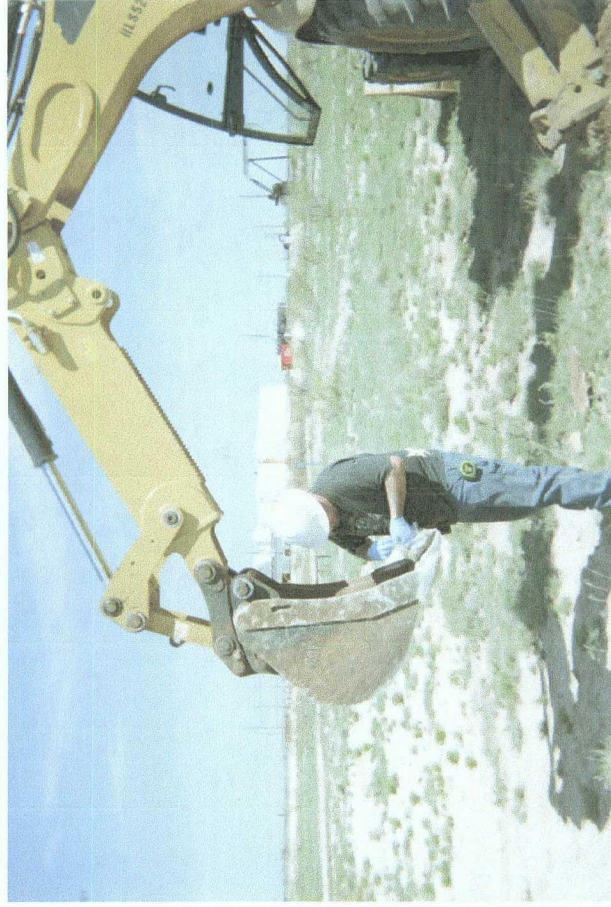
Collecting Sample

4/27/2010

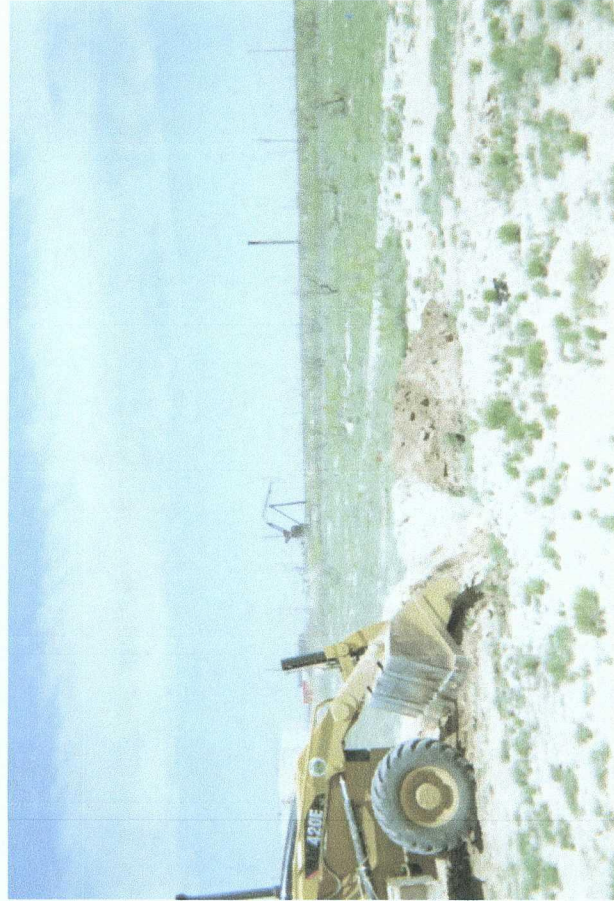
Backfilling excavation

4/27/2010

The excavated soil was return to the excavation to ground surface and contoured to the surrounding area. On 5/21/2010, the site was seeded with a blend of native vegetation and is expected to return to a productive capacity at a normal rate.

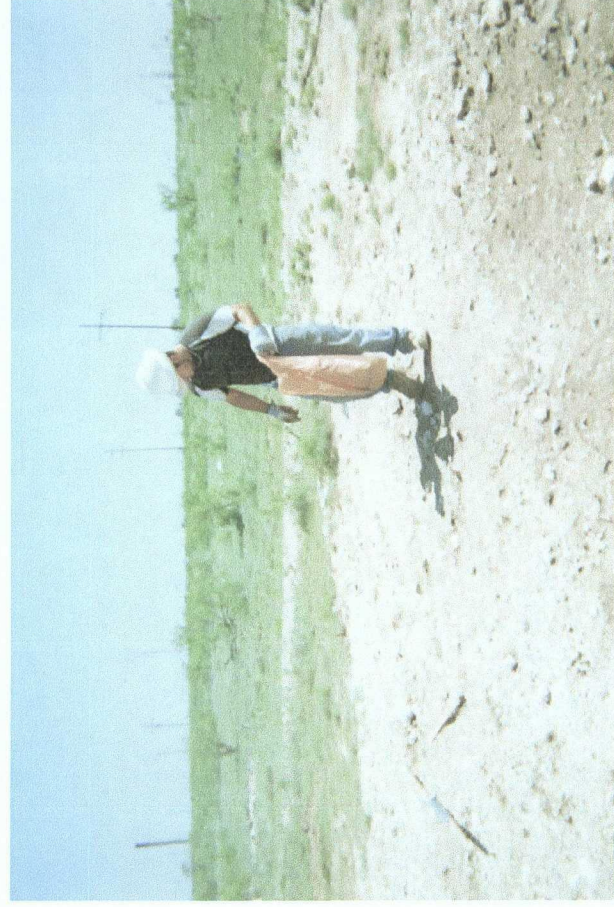
Seeding excavation

5/21/2010

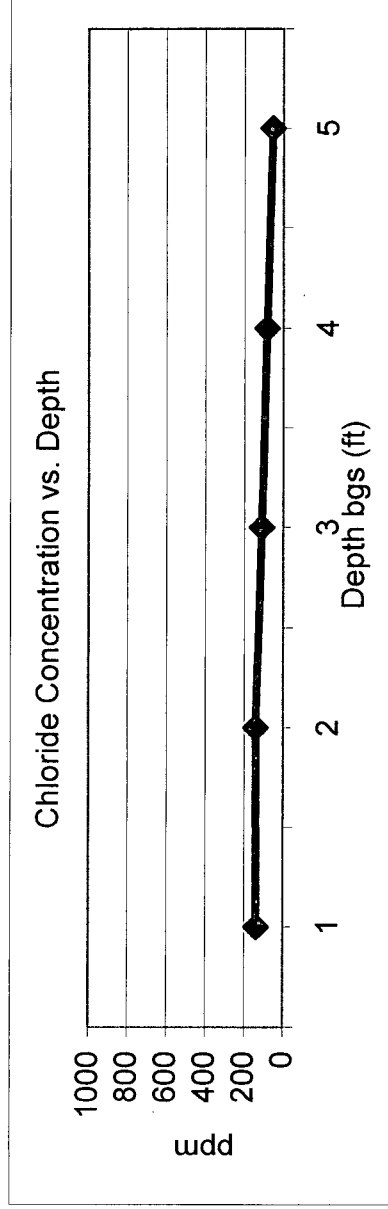
Backhoe samples at the junction (source)

Depth bgs (ft)	[Cl ⁻] ppm
1	139
2	142
3	110
4	84
5	55

Groundwater = 112 ft.
