## **OCD Exhibit 9: Preliminary Environmental Assessment of Cano Petro Operations in Cato Field, Chavez County**

prepared by Jim Griswold

OCD Environmental Bureau Chief

August 14, 2018

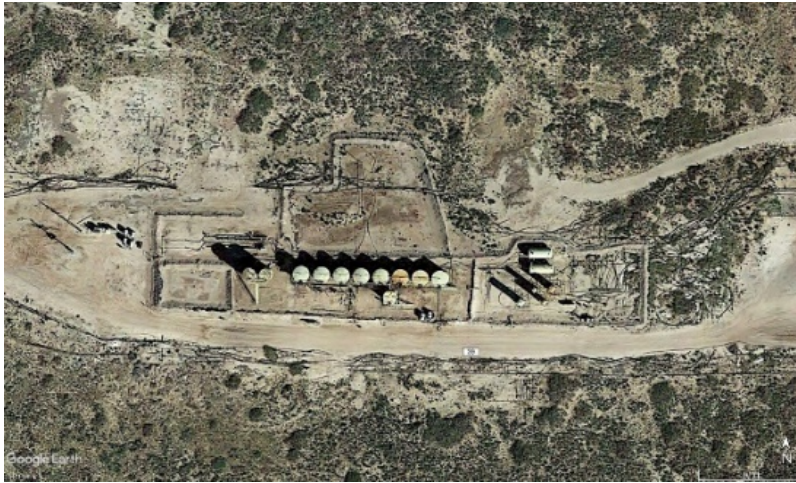
**Cato San Andres Unit Battery #6.** This is a group of 13 tanks and 4 heater treaters located in Unit Letter L of Section 11 in Township 8 South, Range 30 East. Based on available images from Google Earth, the battery was constructed sometime after August of 2005 and before August of 2009 with numerous surface flowlines in the immediate area. An aerial image of the battery from Google Earth with a date of 10/4/14 is provided at the top of the following page.

The approximate dimensions of the battery are 500 feet East/West and 200 feet North/South. Each of the tanks has an approximate capacity of 500 barrels (21,000 gallons) and each appears to have been historically overfilled as indicated by sidewall staining emanating from the widow's hatch at the top of each tank and down each tank's side. See photographs below:

Despite the presence of a synthetic liner beneath portions of the tank battery, the apparent history and inattention to best management practices leads the Environmental Bureau to the following recommendations:

1. All liquids from the tanks should be drained and disposed.
2. The tanks, piping, and other infrastructure should be removed or relocated.
3. The liner(s) should be removed and properly disposed.
4. The vadose zone beneath the battery should be investigated for adsorbed contamination by crude oil and produced water.
5. If the soils beneath the battery are contaminated, they should be excavated and backfilled with clean soils.
6. If soil contamination has impacted groundwater, a hydrogeologic investigation of the extents of that contamination must be undertaken such that an appropriate abatement program can be developed.
7. Implementation of groundwater abatement, if necessary.

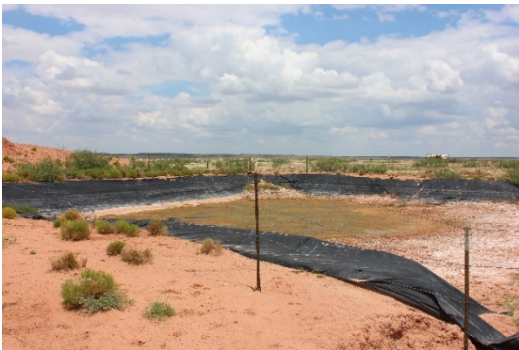
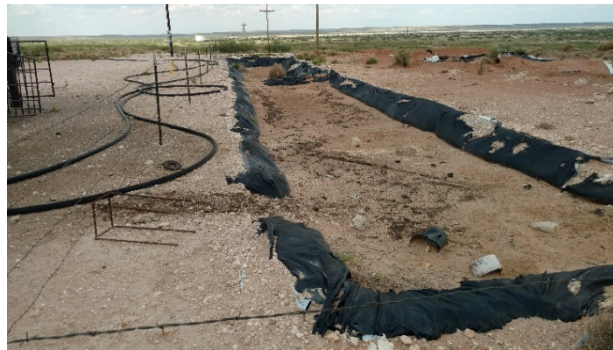
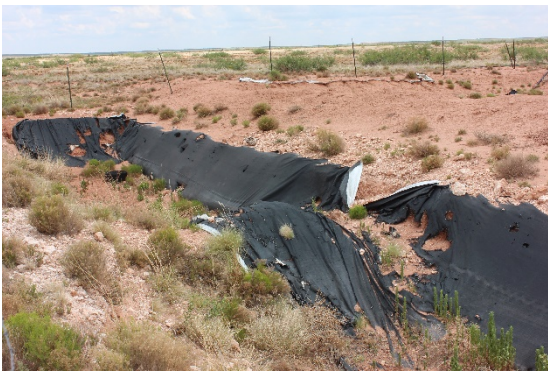
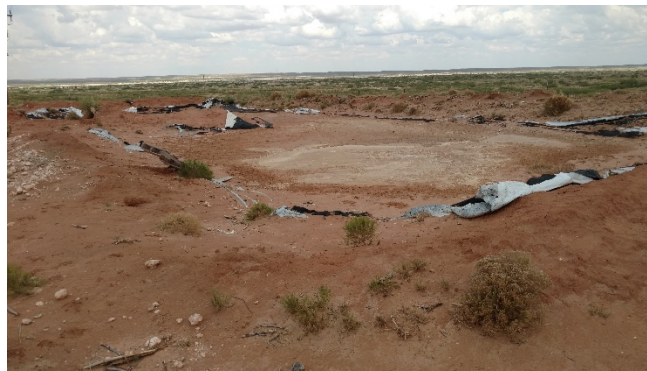
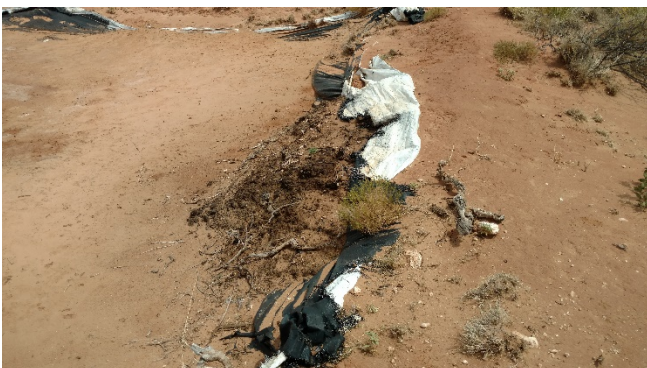
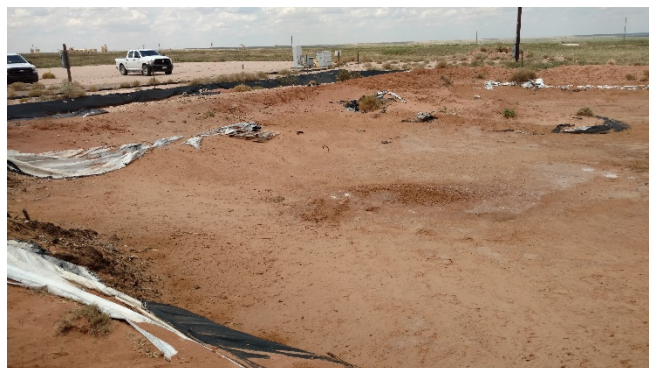
**Unclosed Pits.** As mentioned previously, a group of 8 open pits were identified using Google Earth. Four of those pits were inspected. Photographs are provided below:

To be compliant with OCD's "pit rule" (19.15.17 NMAC), these pits must be closed using the following procedure:

1. Contents of the pit must be removed and properly disposed.
2. The pit liner must be removed and properly disposed.
3. The soils beneath the pit must be sampled and analyzed for concentrations of adsorbed chloride, total petroleum hydrocarbons, benzene, toluene, ethylbenzene, and total xylenes.
4. If the soils are found to be contaminated in excess of the pertinent standards, the extents of the soil contamination must be determined and those soils found to be environmentally problematic should be excavated. Even if the soils are not adversely impacted, the pit area must be properly backfilled and the surface restored and revegetated.
5. If soil contamination has impacted groundwater, a hydrogeologic investigation of the extents of that contamination must be undertaken such that an appropriate abatement program can be developed.

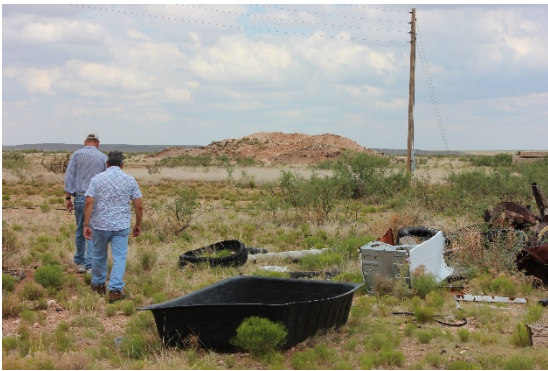
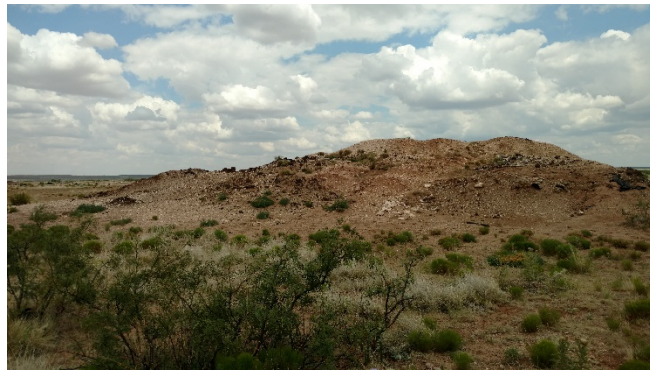
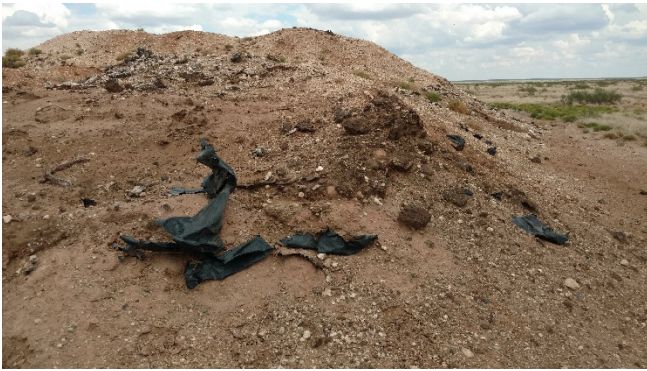
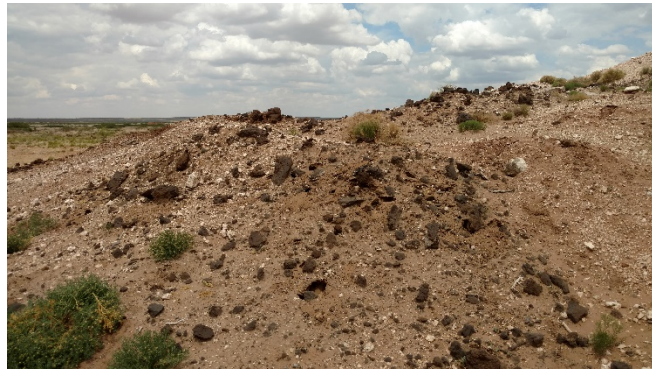
**Contaminated Soil Piles.** Both soil piles were inspected. They are within close proximity to each other and appear to contain hydrocarbon-impacted materials atop synthetic liners. Photographs are provided below:

These are not properly permitted or constructed surface waste management facilities and should be dealt with as follows:

1. The contaminated soils must be removed for proper disposal.
2. The liners must be removed and properly disposed.
3. The vadose zone beneath the liners should be investigated for adsorbed contamination by crude oil and produced water.
4. If the soils are contaminated, they should be excavated and backfilled with clean soils.
5. If soil contamination has impacted groundwater, a hydrogeologic investigation of the extents of that contamination must be undertaken such that an appropriate abatement program can be developed.
