AP - 27

STAGE 2 WORKPLANS

From: Katie Jones <kjones@riceswd.com>
Sent: Wednesday, June 19, 2013 12:09 PM
To: Hansen, Edward J., EMNRD
Cc: Hack Conder; 'Tim Reed'; Laura Pena
Subject: ROC - BD E-15 (AP-27) Groundwater Recovery *UPDATED*

BD E-15 Leak in Relation to BD O-23 and O-23 vent

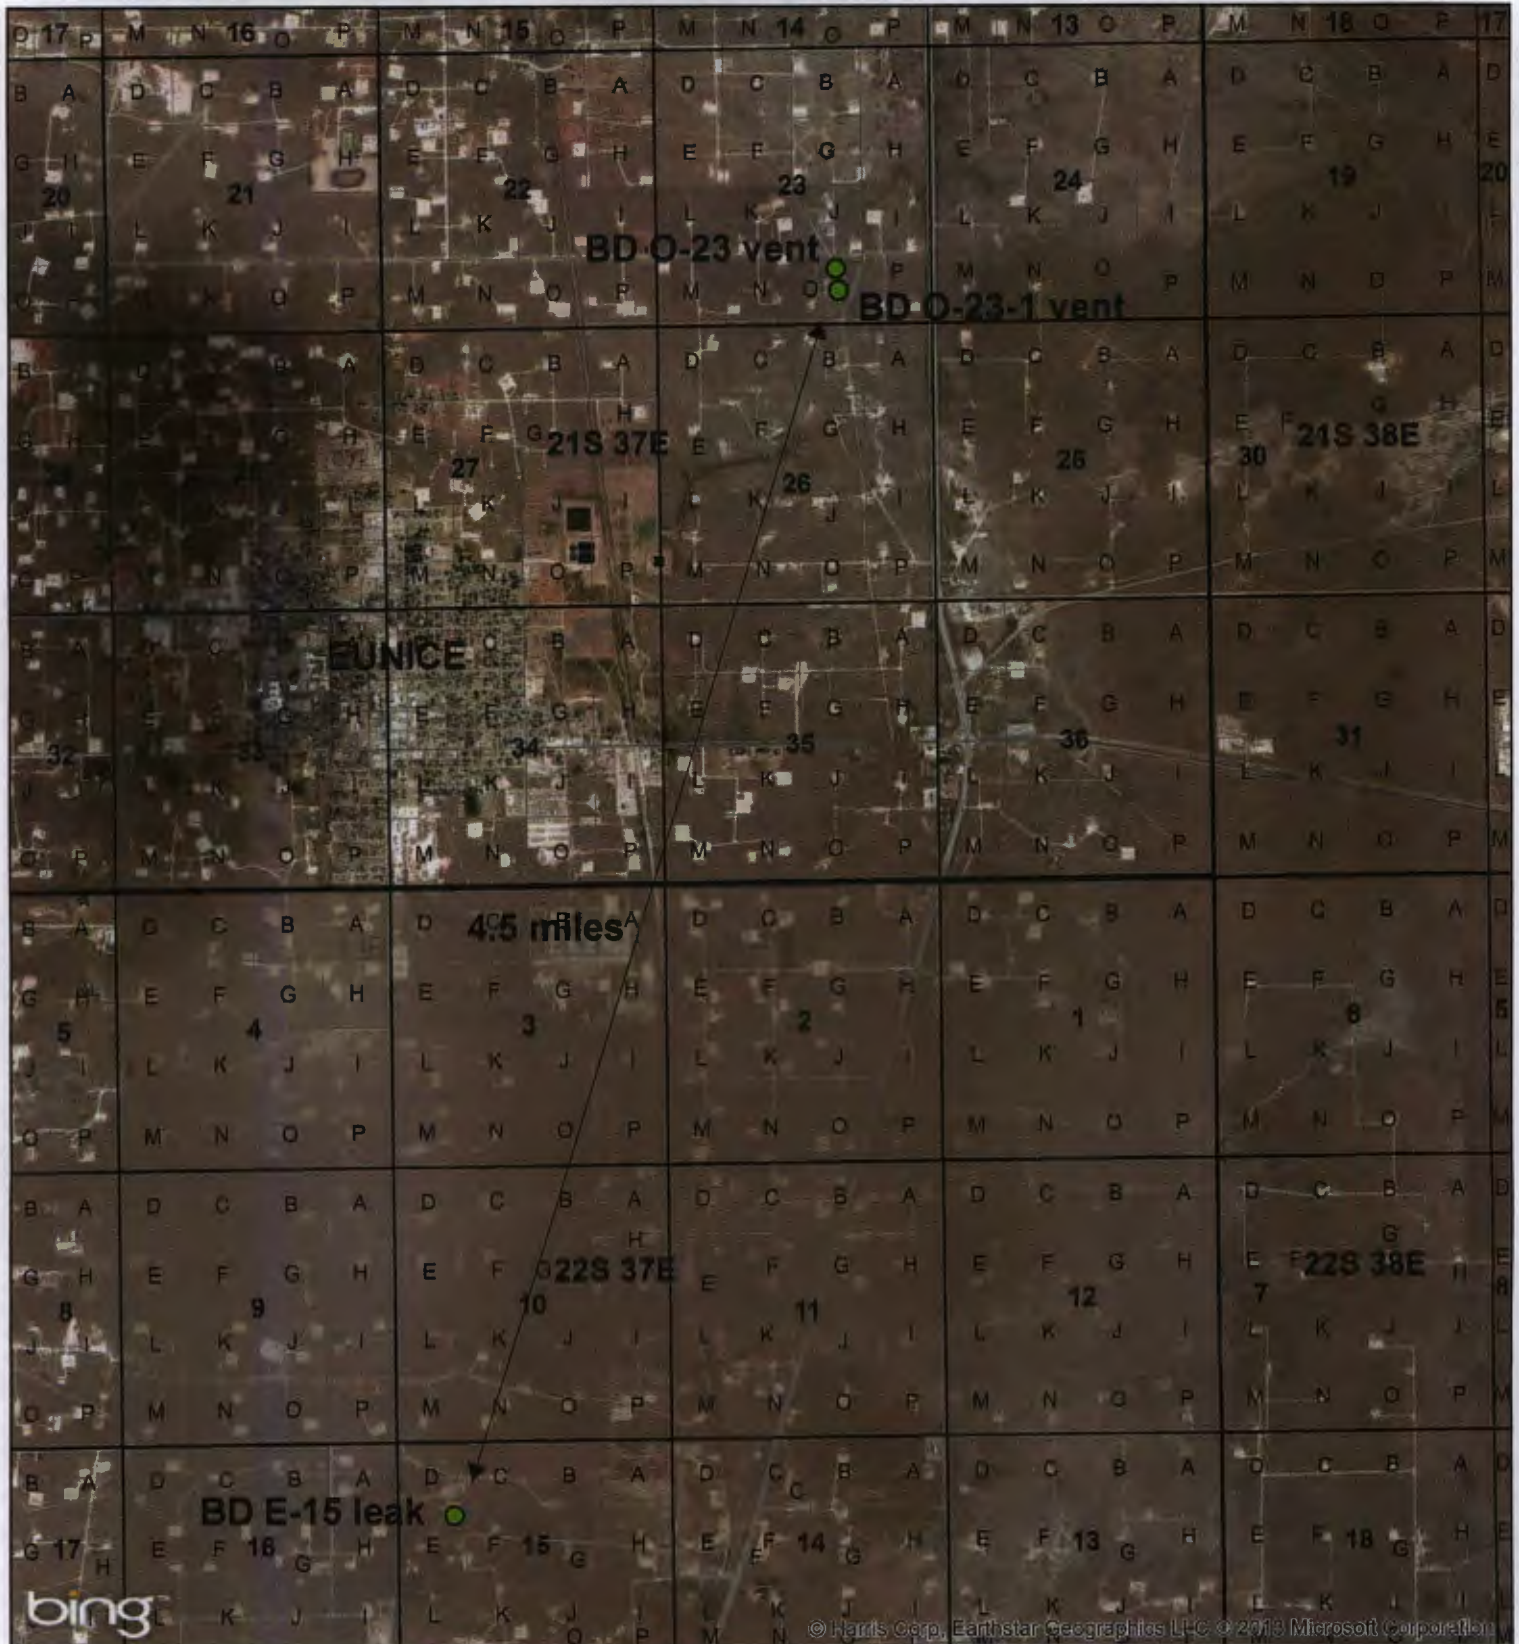
BD E-15 LEAK

LEGALS: UL/E sec. 15
T-22-S R-37-E
LEA COUNTY, NM

Case #: AP-027
