**North Lea Joint
Venture**

**Preliminary Site Visit
10/25/11**

**Subject: Site Visit and Initial Assessment
 North Lea Joint Venture Site
 Crossroads, New Mexico**

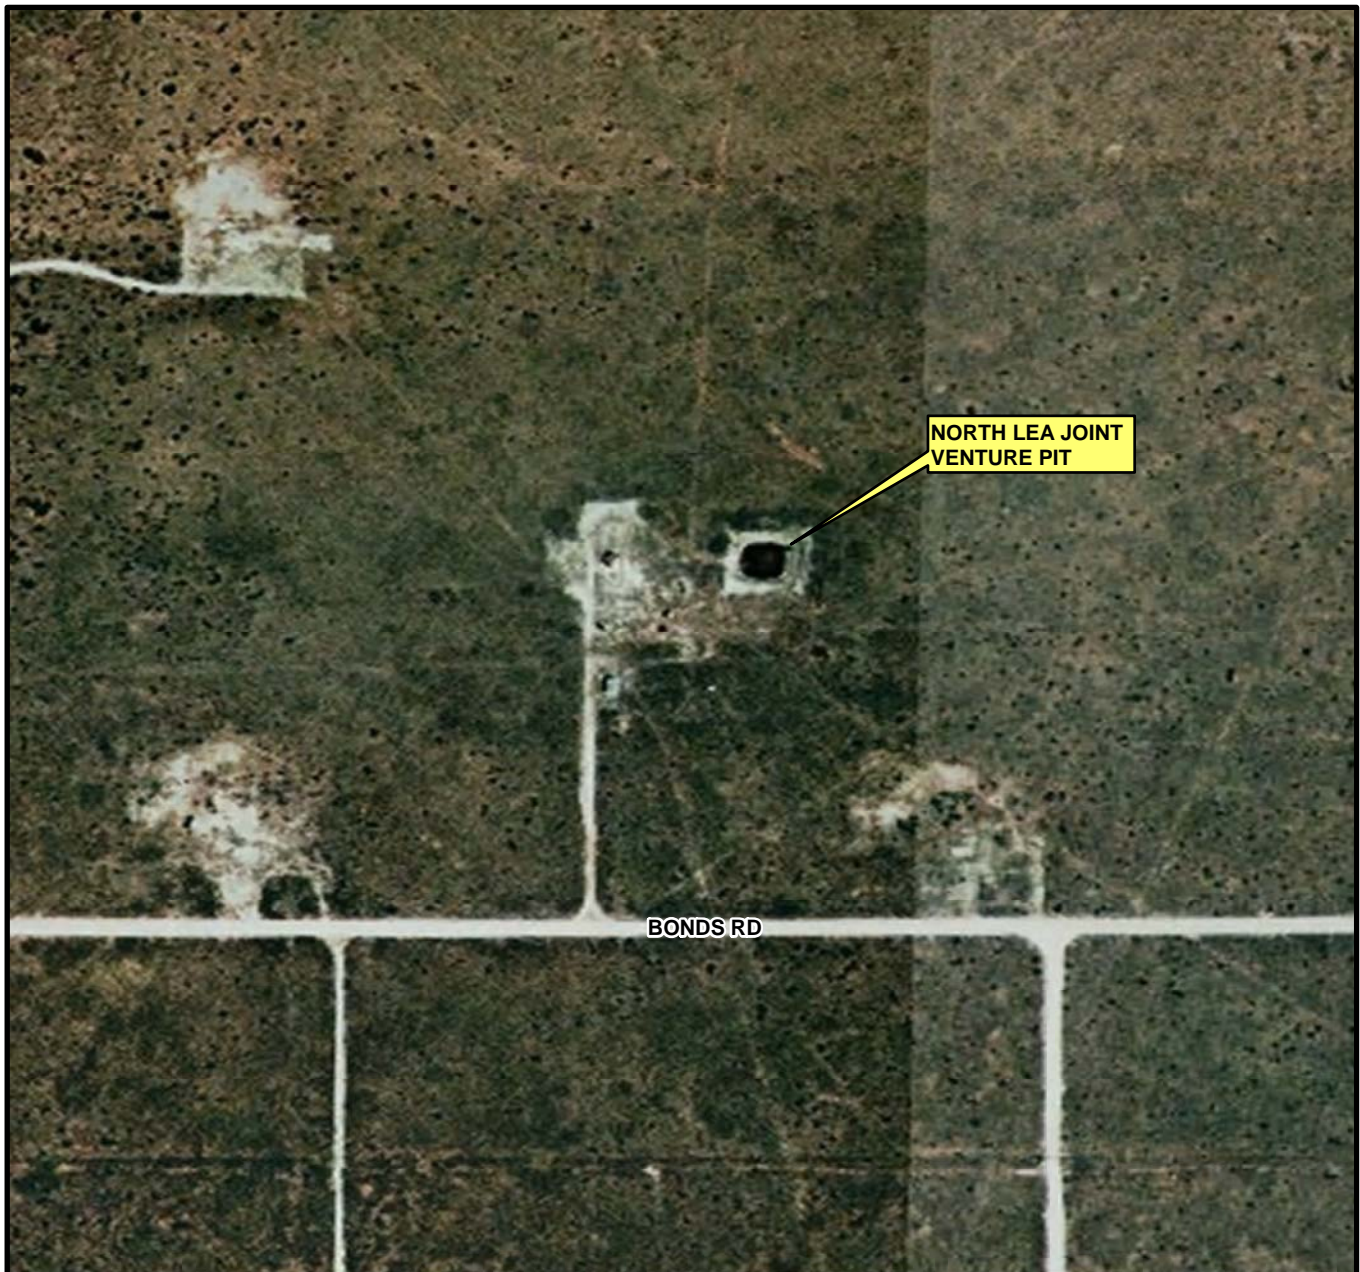
<p>KLEINFELDER <i>Bright People. Right Solutions.</i> www.kleinfelder.com</p>	PROJECT NO. 122078	SITE MAP	FIGURE 1
	DRAWN: 10/20/2011		
	DRAWN BY: PD		
	CHECKED BY: BB	NORTH LEA JOINT VENTURE PIT 2.6 MILES NW OF CROSSROADS, NM LEA COUNTY, NEW MEXICO	
	FILE NAME: 122078_SiteMap.MXD

The Subject Site consists of an abandoned crude oil pit that is surrounded by an earthen berm (See Figure 1, Site Plan). The pit is approximately 80 feet long by 80 feet wide. The earthen berm varies in height from approximately 3 to 6 feet high. It is approximately 20 feet wide at the base and 8 to 10 feet wide at the top. The pit is currently surrounded by a 4-wire barbed-wire fence. A gate is located along the western side of the pit. It appears that a portion of the western berm was pushed into the pit and may have been performed to provide access for a piece of equipment, possibly a drill rig.

4-STRAND
BARBED-WIRE
FENCE

APPROXIMATE 5' HIGH SOIL
BERM, 20' WIDE AT BASE
AND 8' TO 12' WIDE AT TOP

SURFACE
STAINED
AREA

Prior to performing pit closure, Kleinfelder recommends advancing three borings at the Subject Site to assess the potential horizontal and vertical extent of COCs. The first boring would be advanced as close to the pit as possible within the portion of the berm that was pushed into the pit (see Figure 1). This boring would help assess the vertical extent of COCs as well as provide an estimate of the depth of material in the pit. The remaining two borings would be placed to the northeast and southeast corners of the pit. These borings would assist with assessing the horizontal extent of impacts from the pit. Each boring would be advanced to a depth of approximately 75 ft (bgs) and sampled for TPH and chlorides. Kleinfelder would also collect a sample of the pit material for possible landfill disposal characterization.
