**Termination  
Request**

**RE: Termination Request  
Apache Corporation  
Lou Wortham Central Battery AD (1R0811-2733)  
UL/C, D, E & F sec. 11 T22S R37E**

**Apache  
Lou Wortham  
Central Battery AD**  
NMOCD Case #: 1R0811-2733  
**LEGALS: UL/C, D, E & F  
sec. 11 T2S R37E**

## Apache Lou Wortham Central Battery AD

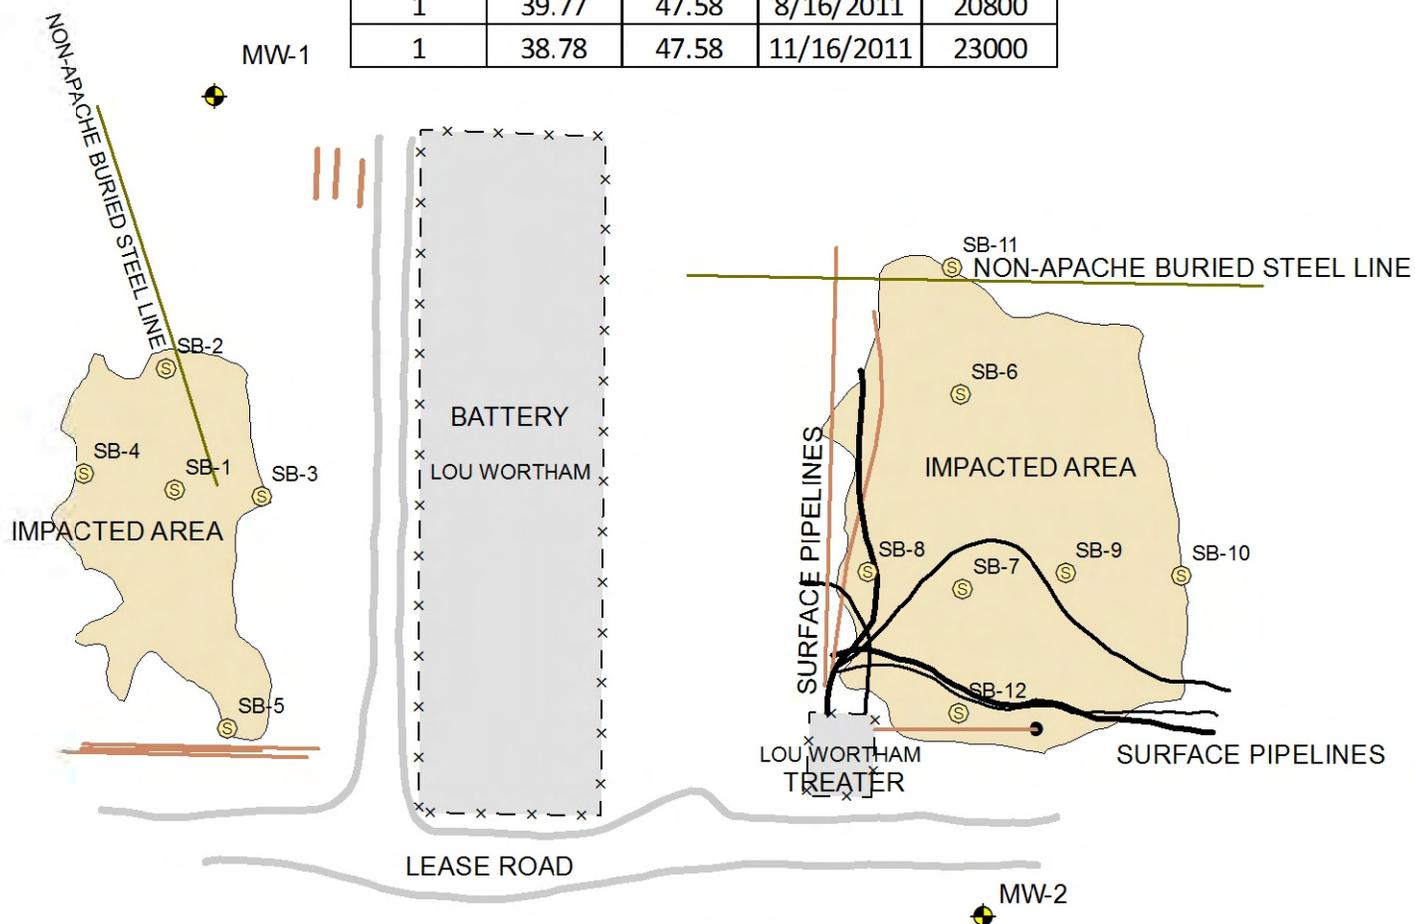
### Figure 2

# Monitor Well Sampling Data

MW	Depth to Water	Total Depth	Sample Date	Cl
1	39.76	47.58	8/7/2011	24000
1	39.77	47.58	8/16/2011	20800
1	38.78	47.58	11/16/2011	23000

MW	Depth to Water	Total Depth	Sample Date	Cl
2	41.64	82.65	8/7/2011	23200
2	41.67	82.65	8/16/2011	22000
2	41.69	82.65	11/16/2011	19200

DGW: 40 ft

Since their installation, the two monitor wells have been sampled three times, most recently on November 16<sup>th</sup>, 2011 (Figure 2). From the monitor well sampling conducted at the site, it is evident that chloride levels coming onto the site are higher than those leaving the site suggesting the site has an up gradient source of contamination (Appendix A). Based on data found in the NMOCD website, there is evidence of an up gradient chloride contamination source which has impacted the surrounding area (Figure 3 and 4). These results indicate that this location and the surrounding area have pre-existing groundwater quality impairment, and that the effects of the Lou Central Battery AD are inconsequential. In addition, the liners installed at the site and the re-vegetation of the surface will inhibit chloride migration through the vadose zone to the aquifer. Since the up gradient monitor well shows higher chloride readings than the source well, and liners have been installed at the site which will inhibit chloride migration, the site will not contribute to the degradation of the aquifer. Therefore, RECS requests that the site be granted 'remediation termination' status of the regulatory file.

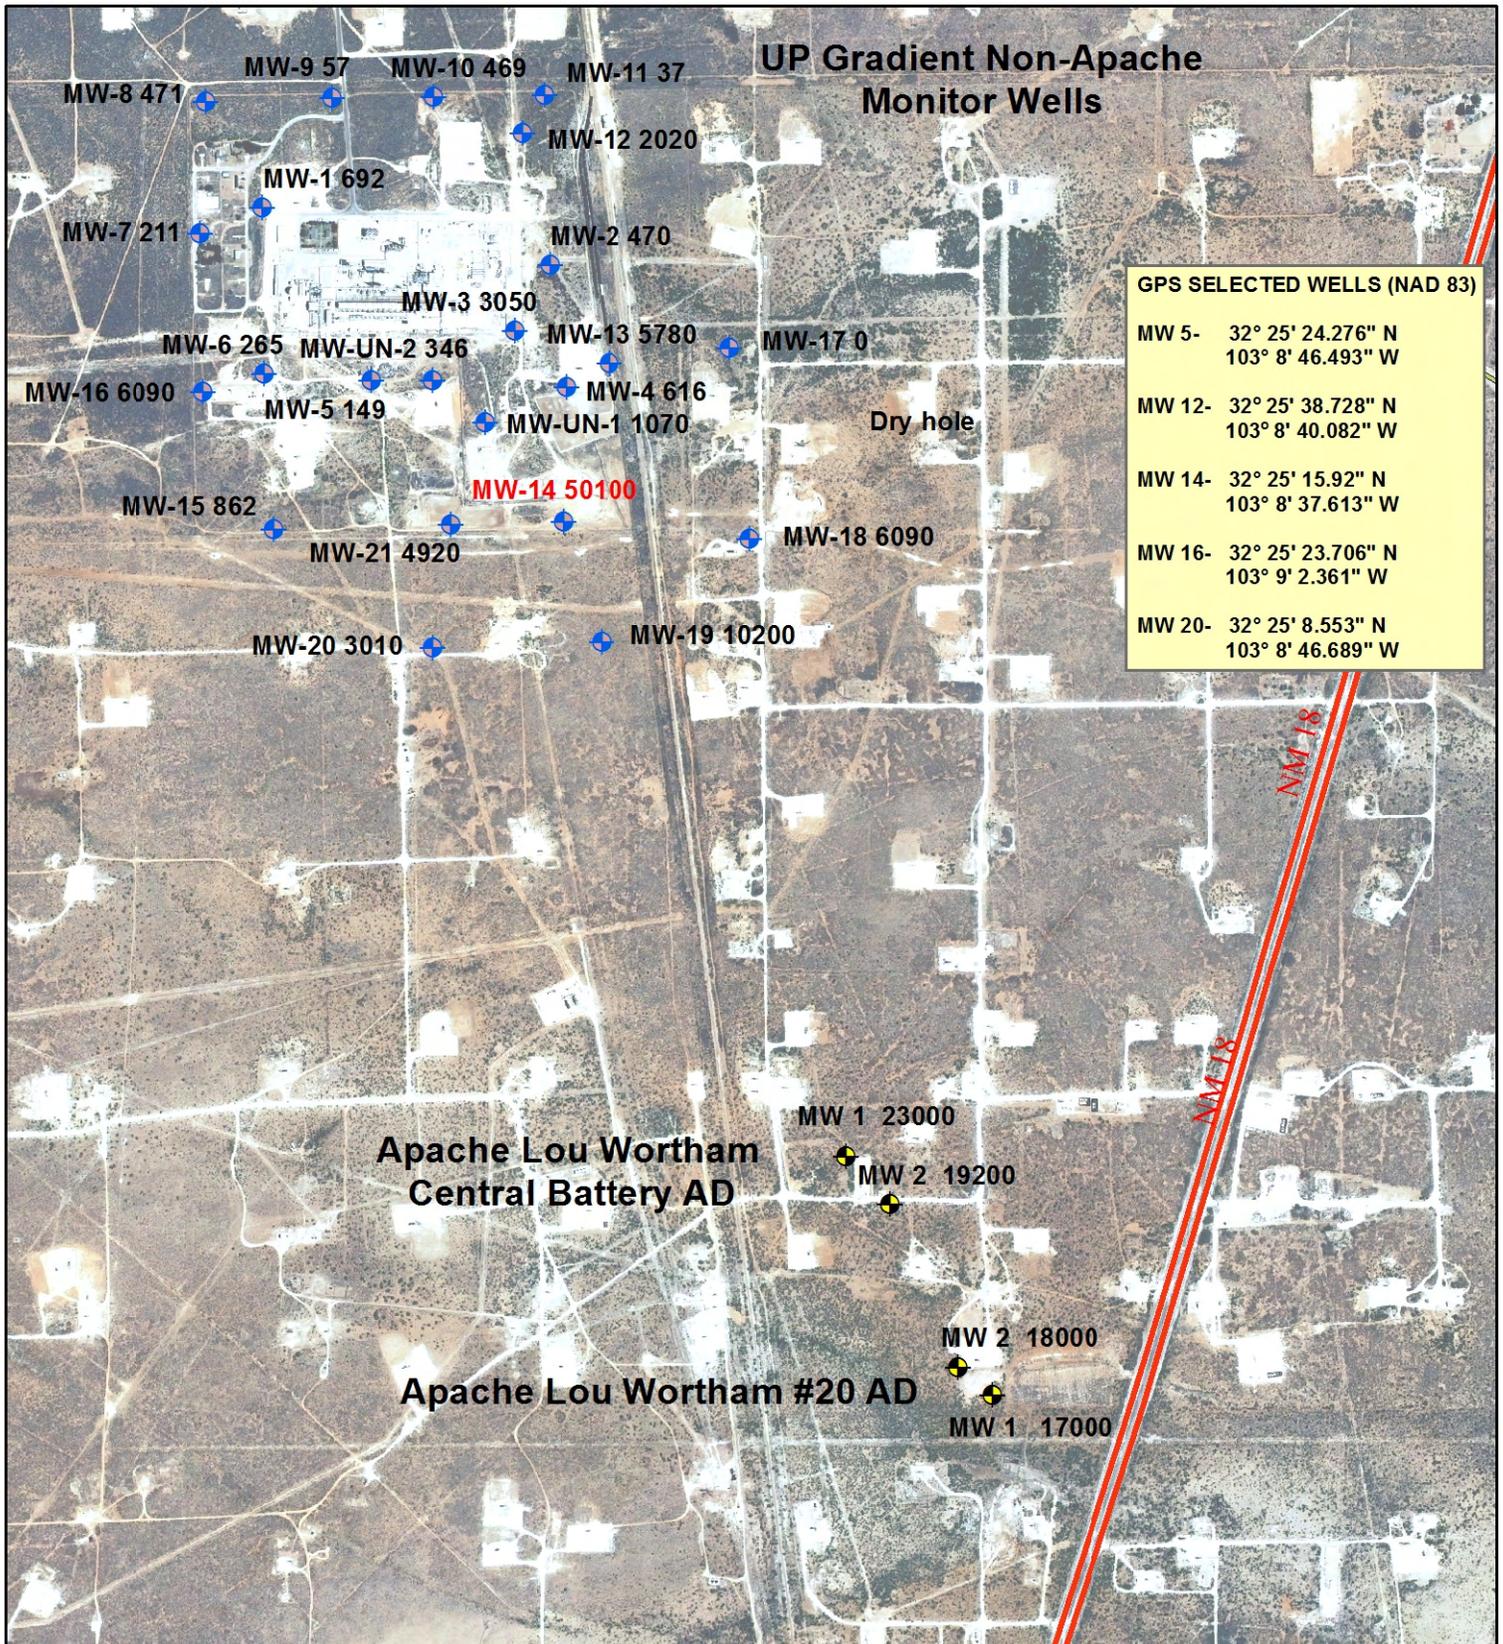
Figure 3

## Regional Chloride Concentrations

LEGALS: sec. 2, 3, 10 & 11  
T22S R37E

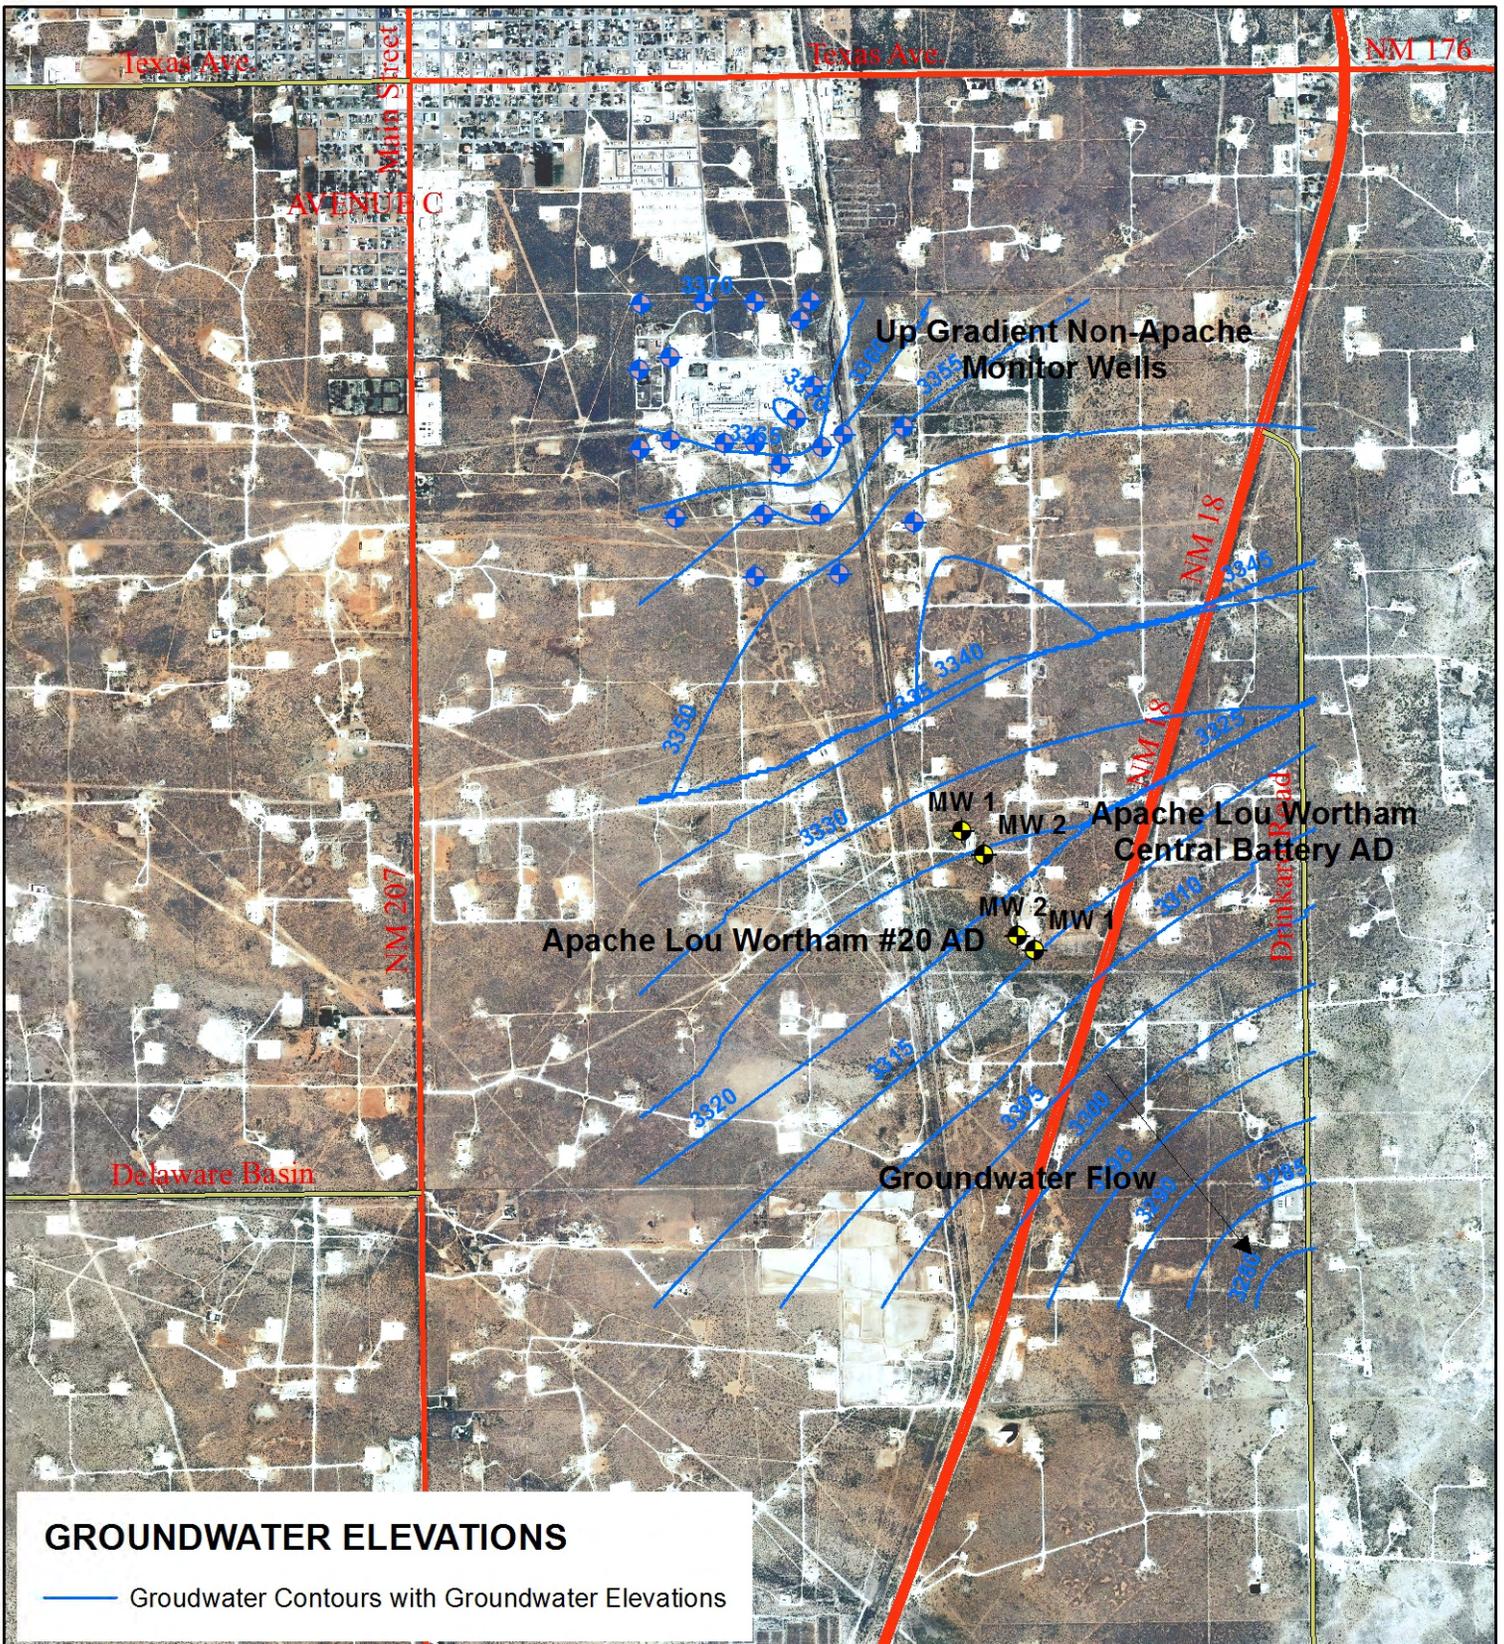
**Figure 4**

**GROUNDWATER ELEVATIONS**

— Groudwater Contours with Groundwater Elevations

**Regional  
Potentiometric  
Map**
