3R – 454

**Q1 2012
GWMR**

**RE: 1st Quarter 2012 Groundwater Monitoring Report
Enterprise Products Company
2D-1LP (Olmer #4) Pipeline August 2011 Release
San Juan County, New Mexico**

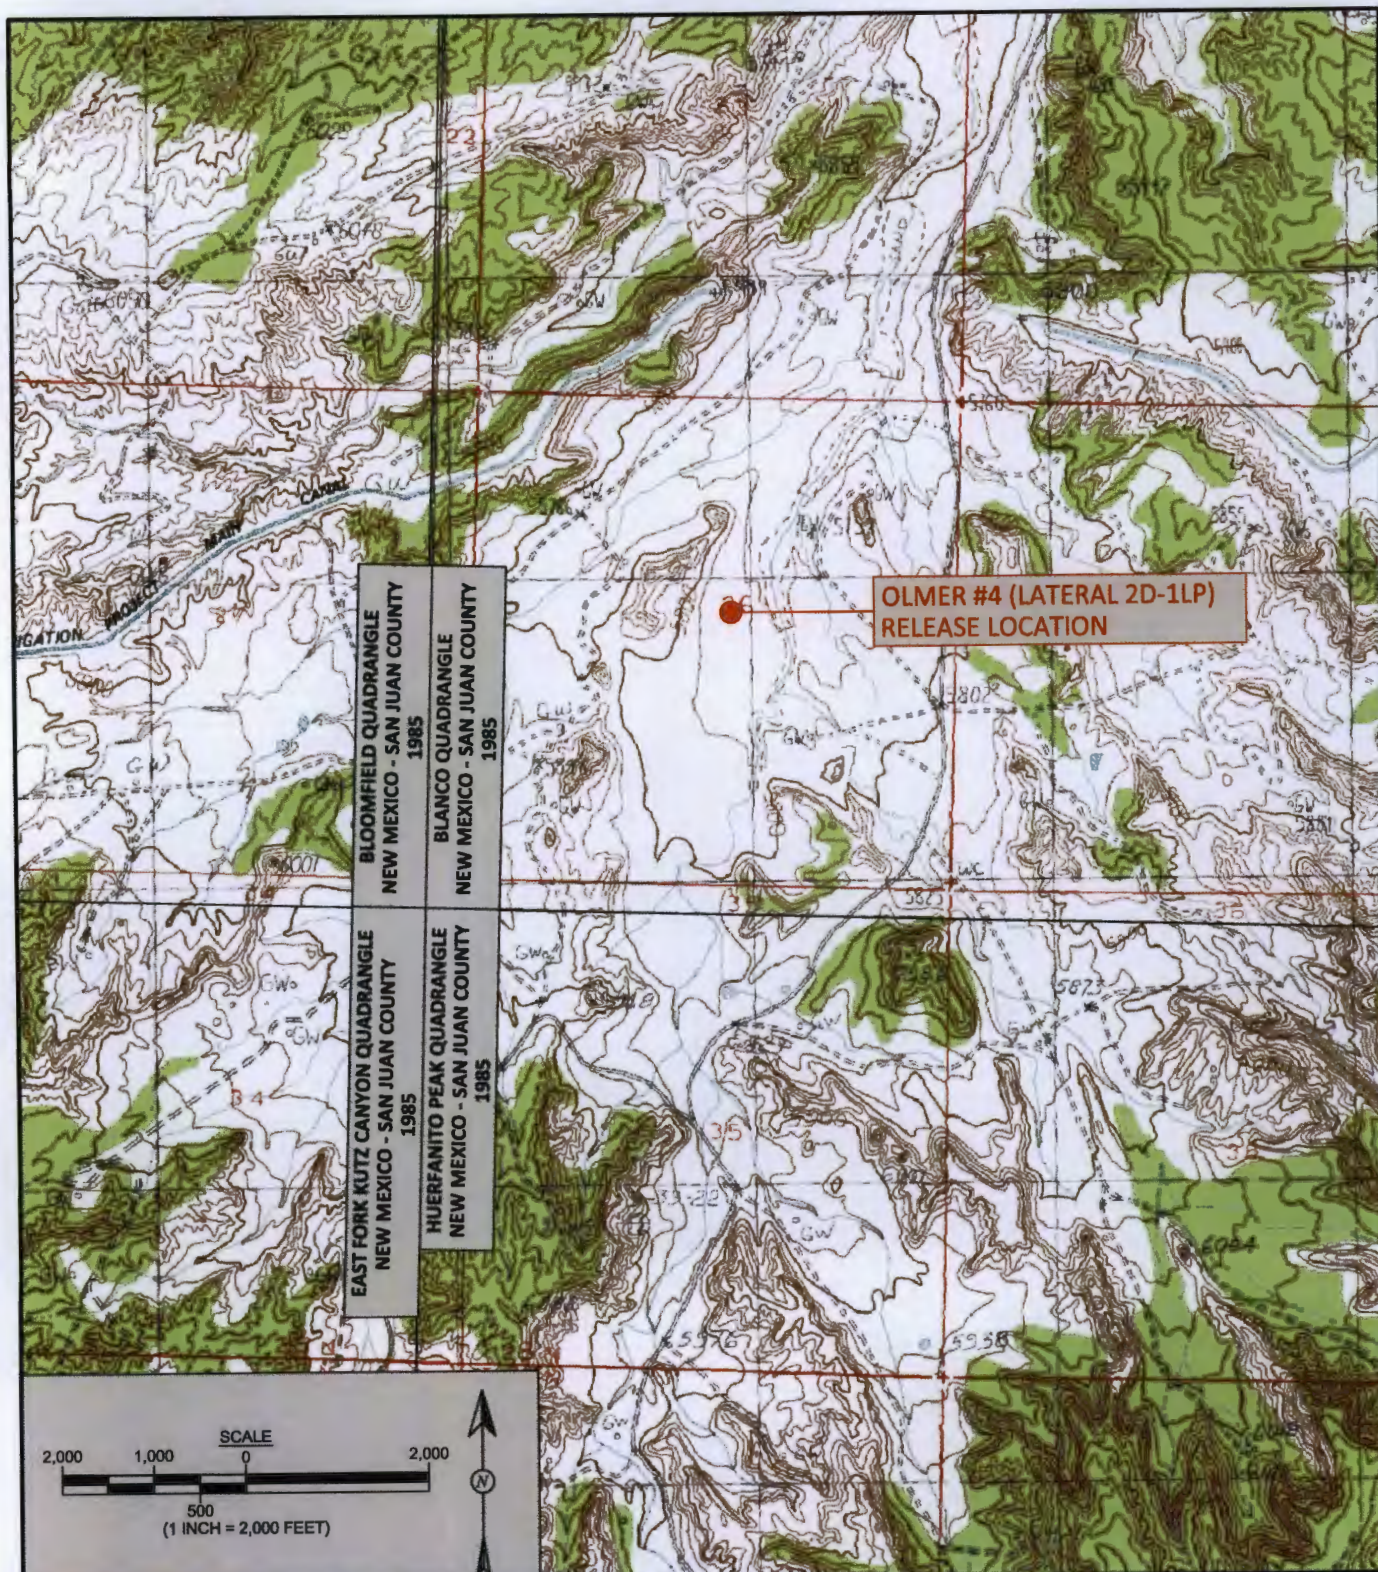
FIGURE 1

TOPOGRAPHIC SITE LOCATION MAP
ENTERPRISE PRODUCTS COMPANY
OLMER #4 (LATERAL 2D-1LP) PIPELINE
SAN JUAN COUNTY, NEW MEXICO
SW¼, NE¼, SEC. 26, T28N, R10W
N 36.63388, W 107.86387

The release is located along the Enterprise Lateral 2D-1LP leading from the Olmer #4 well tie within the SW¼ NE¼, Section 26, T28N, R10W, San Juan County, New Mexico. Latitude and longitude of the release were recorded as N36.63388 by W107.86387, respectively. A topographic site location map is included as Figure 1, and an aerial map with the release location is included as Figure 2.
