3R – 438

RELEASE  
ASSESSMENT  
REPORT

10/28/2011

**RE: Soil and Groundwater Sampling Results for Lateral 6C Release, San Juan County,  
New Mexico**

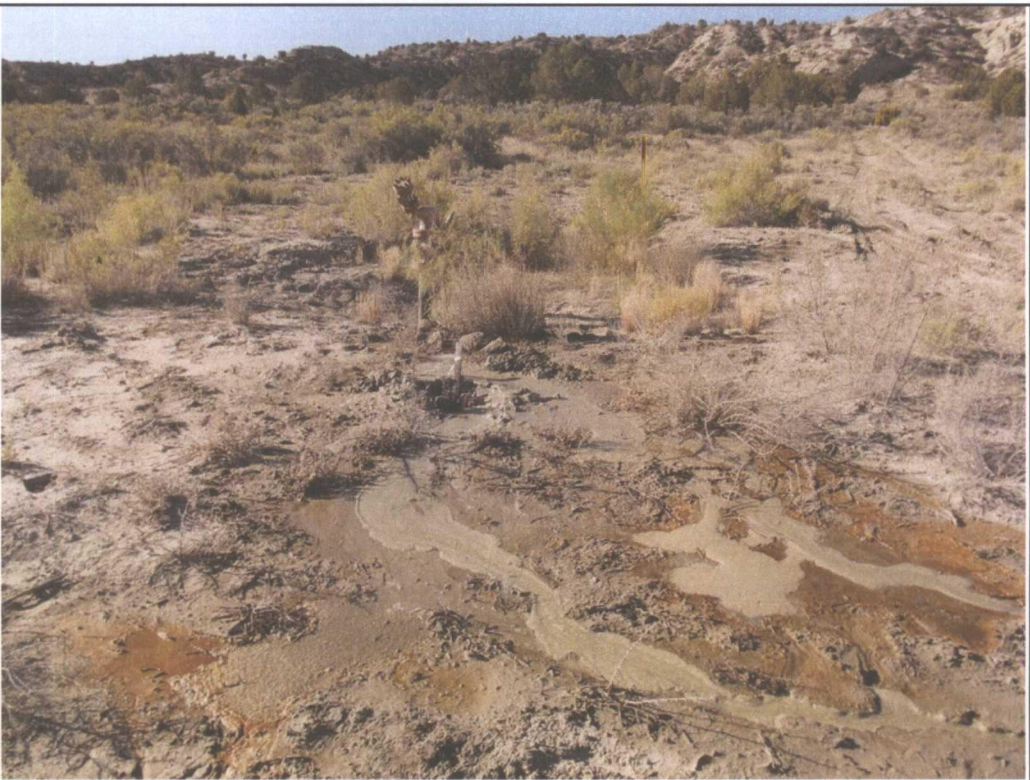
| Photo #1 | |

| AES Project No:<br>110904 | Description: Surface contamination from pipeline release; N 36° 37.921' N; W 107° 58.440. |

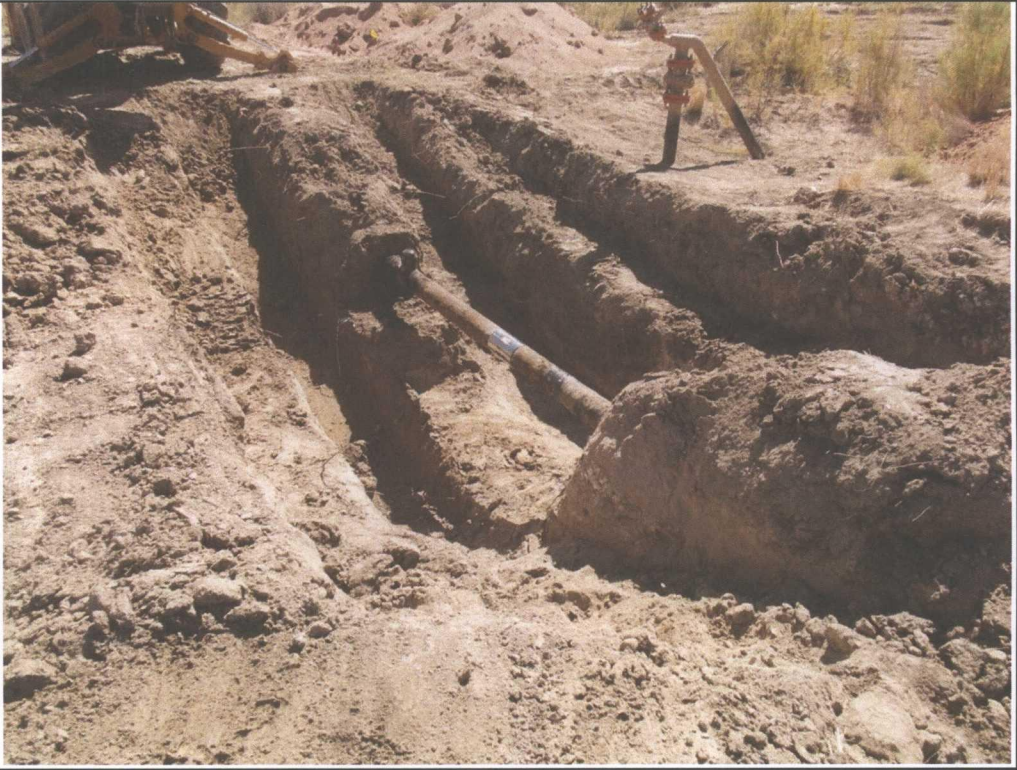
| Photo #3 | |

| AES Project No:<br>110904 | Description: Excavated and repaired pipeline. |

AES was initially contacted by Aaron Dailey of Enterprise on September 21, 2011, and on September 22, 2011, Ross Kennemer and Tami Ross of AES met with Enterprise representatives at the release location. Representatives from Enterprise, AES, and Southwest Field Services were present on-site during the initial site activities. Release excavation and line repair activities were initiated on September 22, 2011, but due to the apparent size of the release, AES suggested that Enterprise conduct the line repair and then contact AES when excavation would continue. The cause of the release was identified as a line leak from a small (1/4-inch) corrosion hole on the underside of the line.

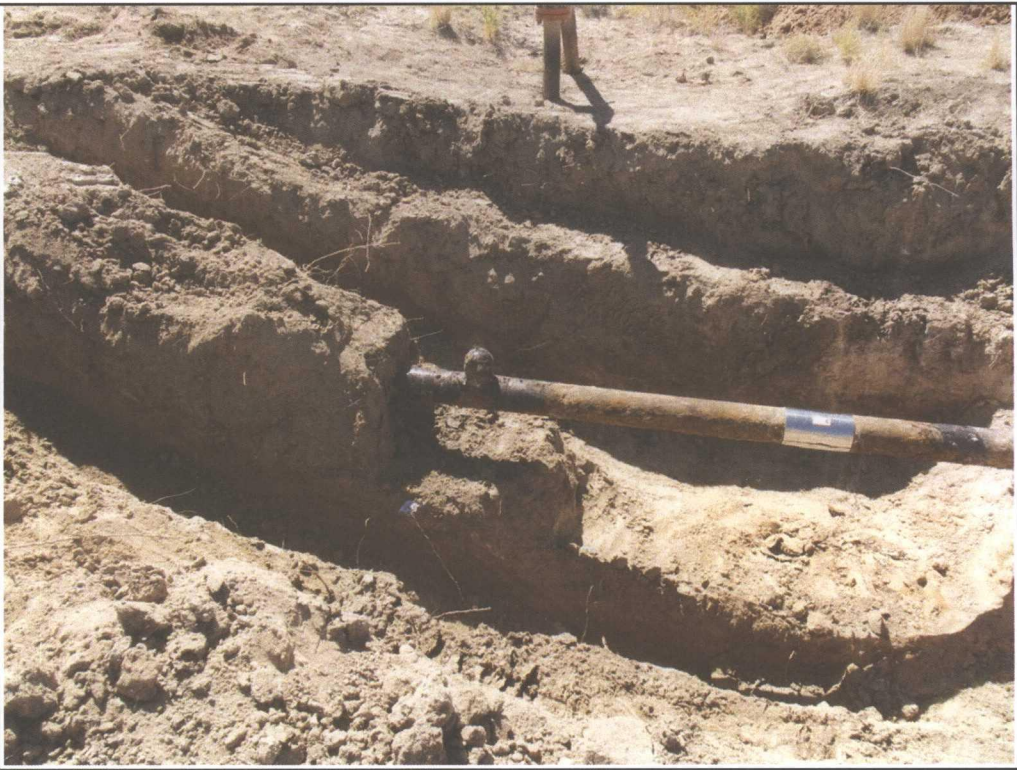
| Photo #4 | |

| AES Project No:<br>110904 | Description: Excavated and repaired pipeline. |

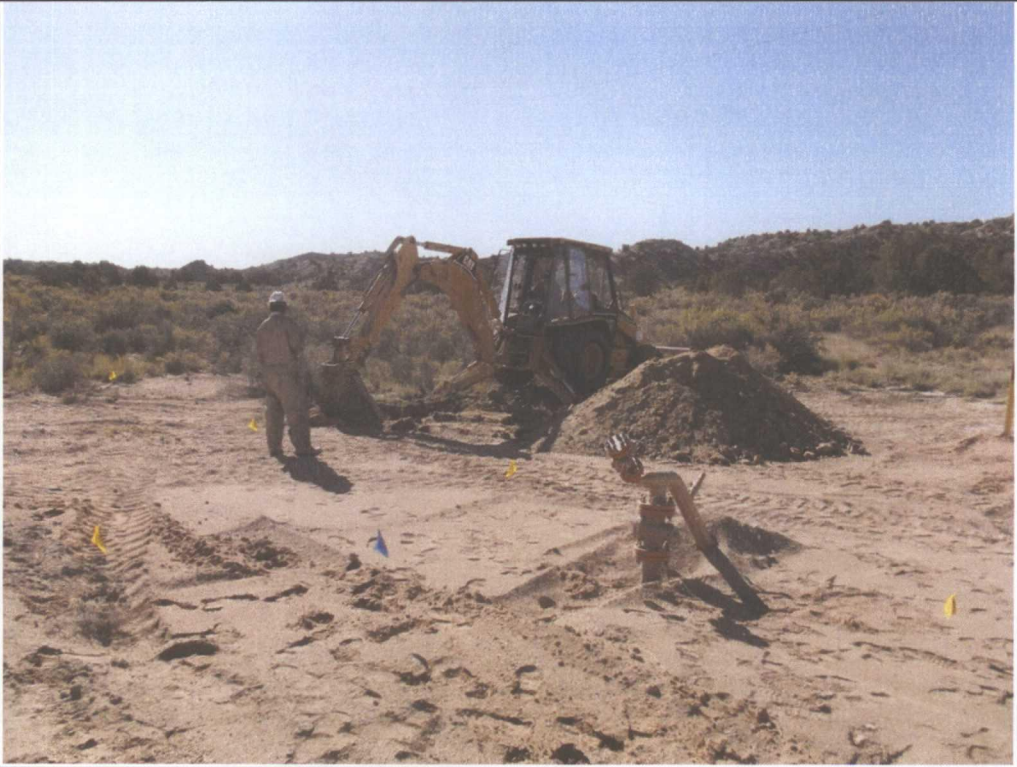
| Photo #5 | |

| AES Project No:<br>110904 | Description: Excavation of Test Pit TP-4, up-gradient of pipeline release point. |

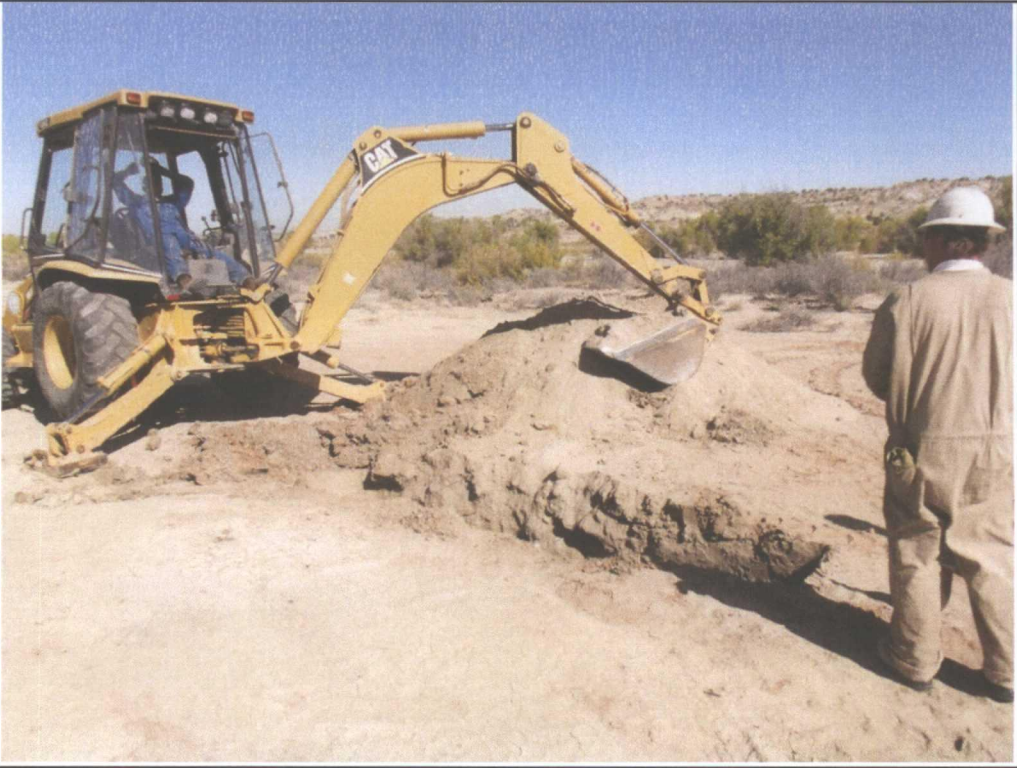
| Photo #6 | |

| AES Project No:<br>110904 | Description: Excavating TP-2, down-gradient of pipeline release point. |

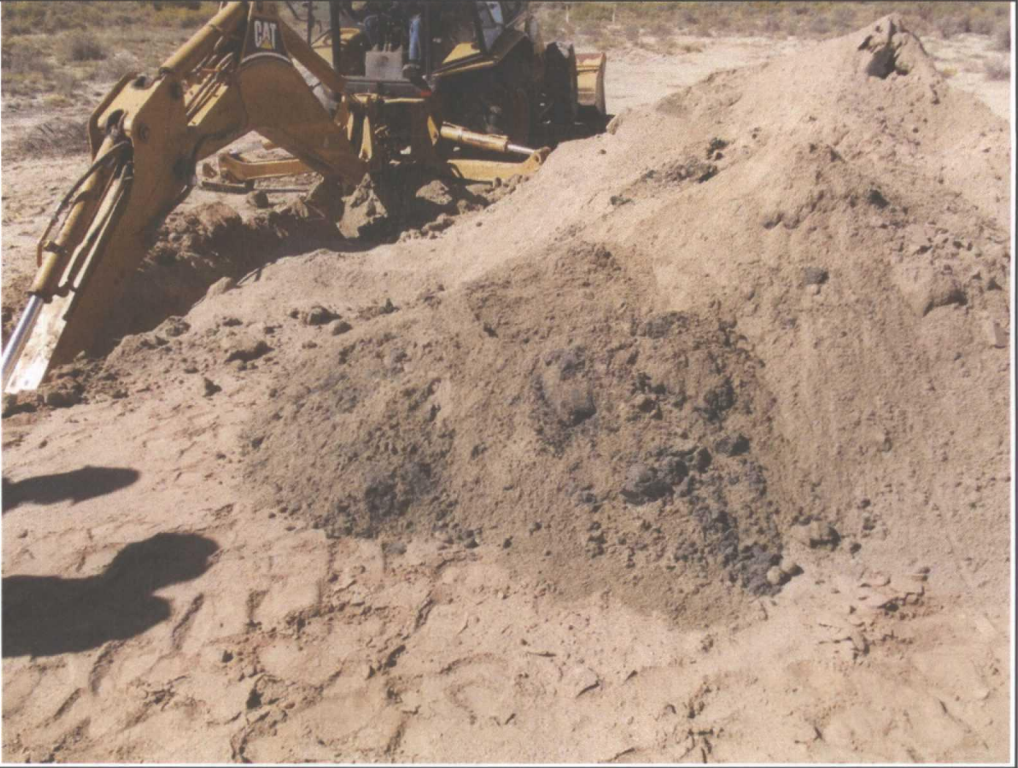
| Photo #7 | |

| AES Project No:<br>110904 | Description: Excavating TP-2, down-gradient of pipeline release point. Note stained soils. |

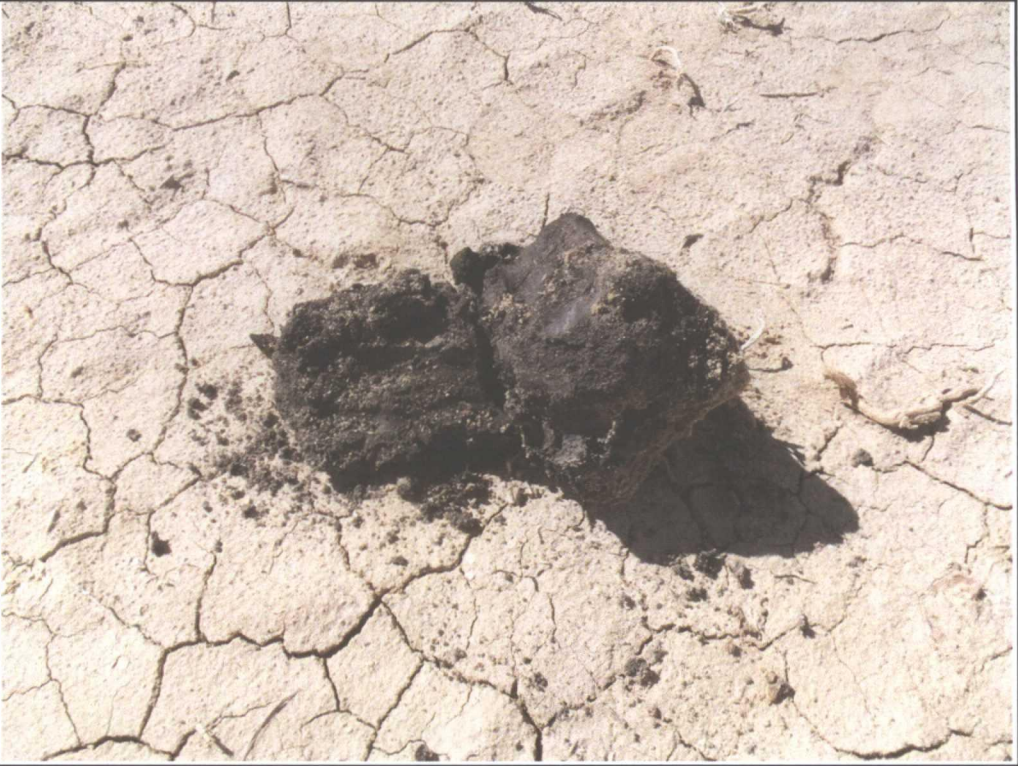
| Photo #8 | |

| AES Project No:<br>110904 | Description: Hydrocarbon contaminated soil excavated from TP-2 at 12 feet below surface. |

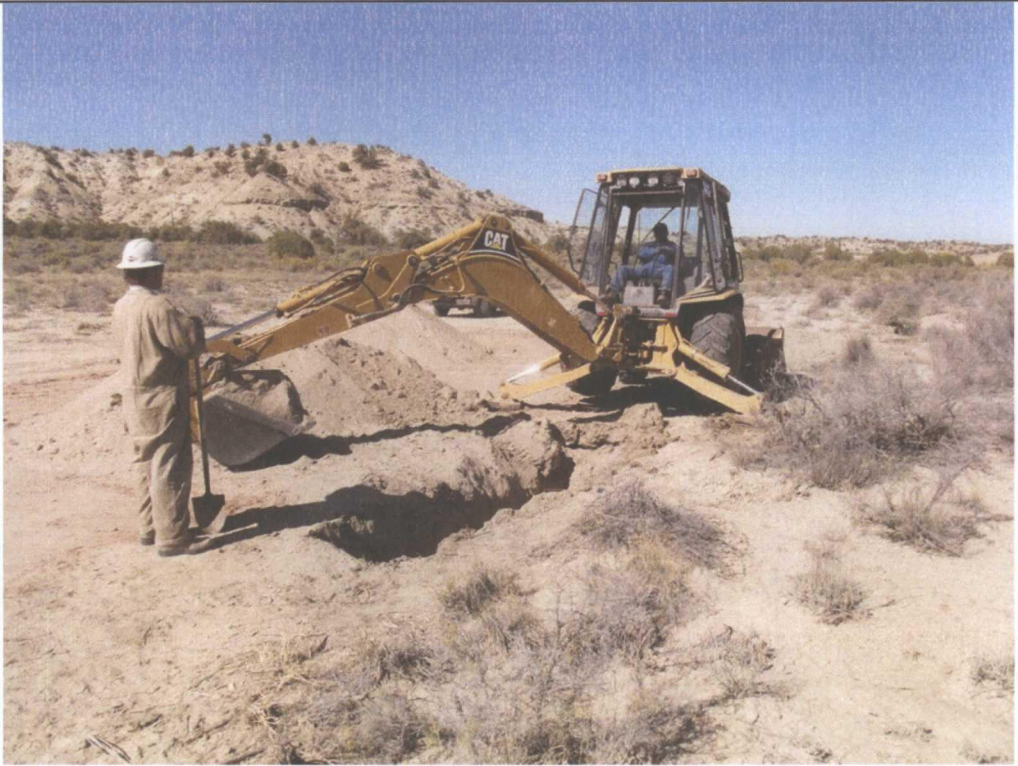
| Photo #9 | |

| AES Project No:<br>110904 | Description: Excavating TP-3, down and cross-gradient of pipeline release point. |

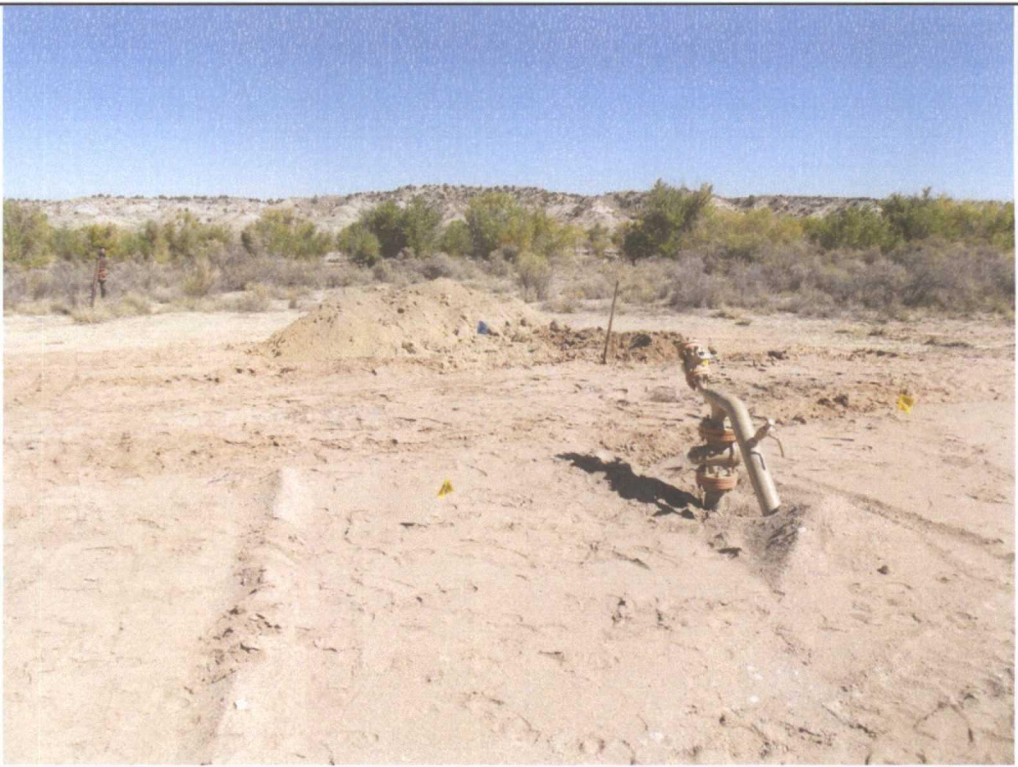
| Photo #10 | |

| AES Project No:<br>110904 | Description: TP-1 at pipeline release point. |
