REMEDIATION SUMMARY & SOIL CLOSURE REQUEST

**REGENCY FIELD SERVICES LLC.
A-14 6" Lateral
Historical Release Site
Lea County, New Mexico
Unit Letter "E", Section 2, Township 24 South, Range 34 East
Latitude 32.24915, Longitude -103.44687
1RP-1062**

February 2015
Apex Project No. 7250715009

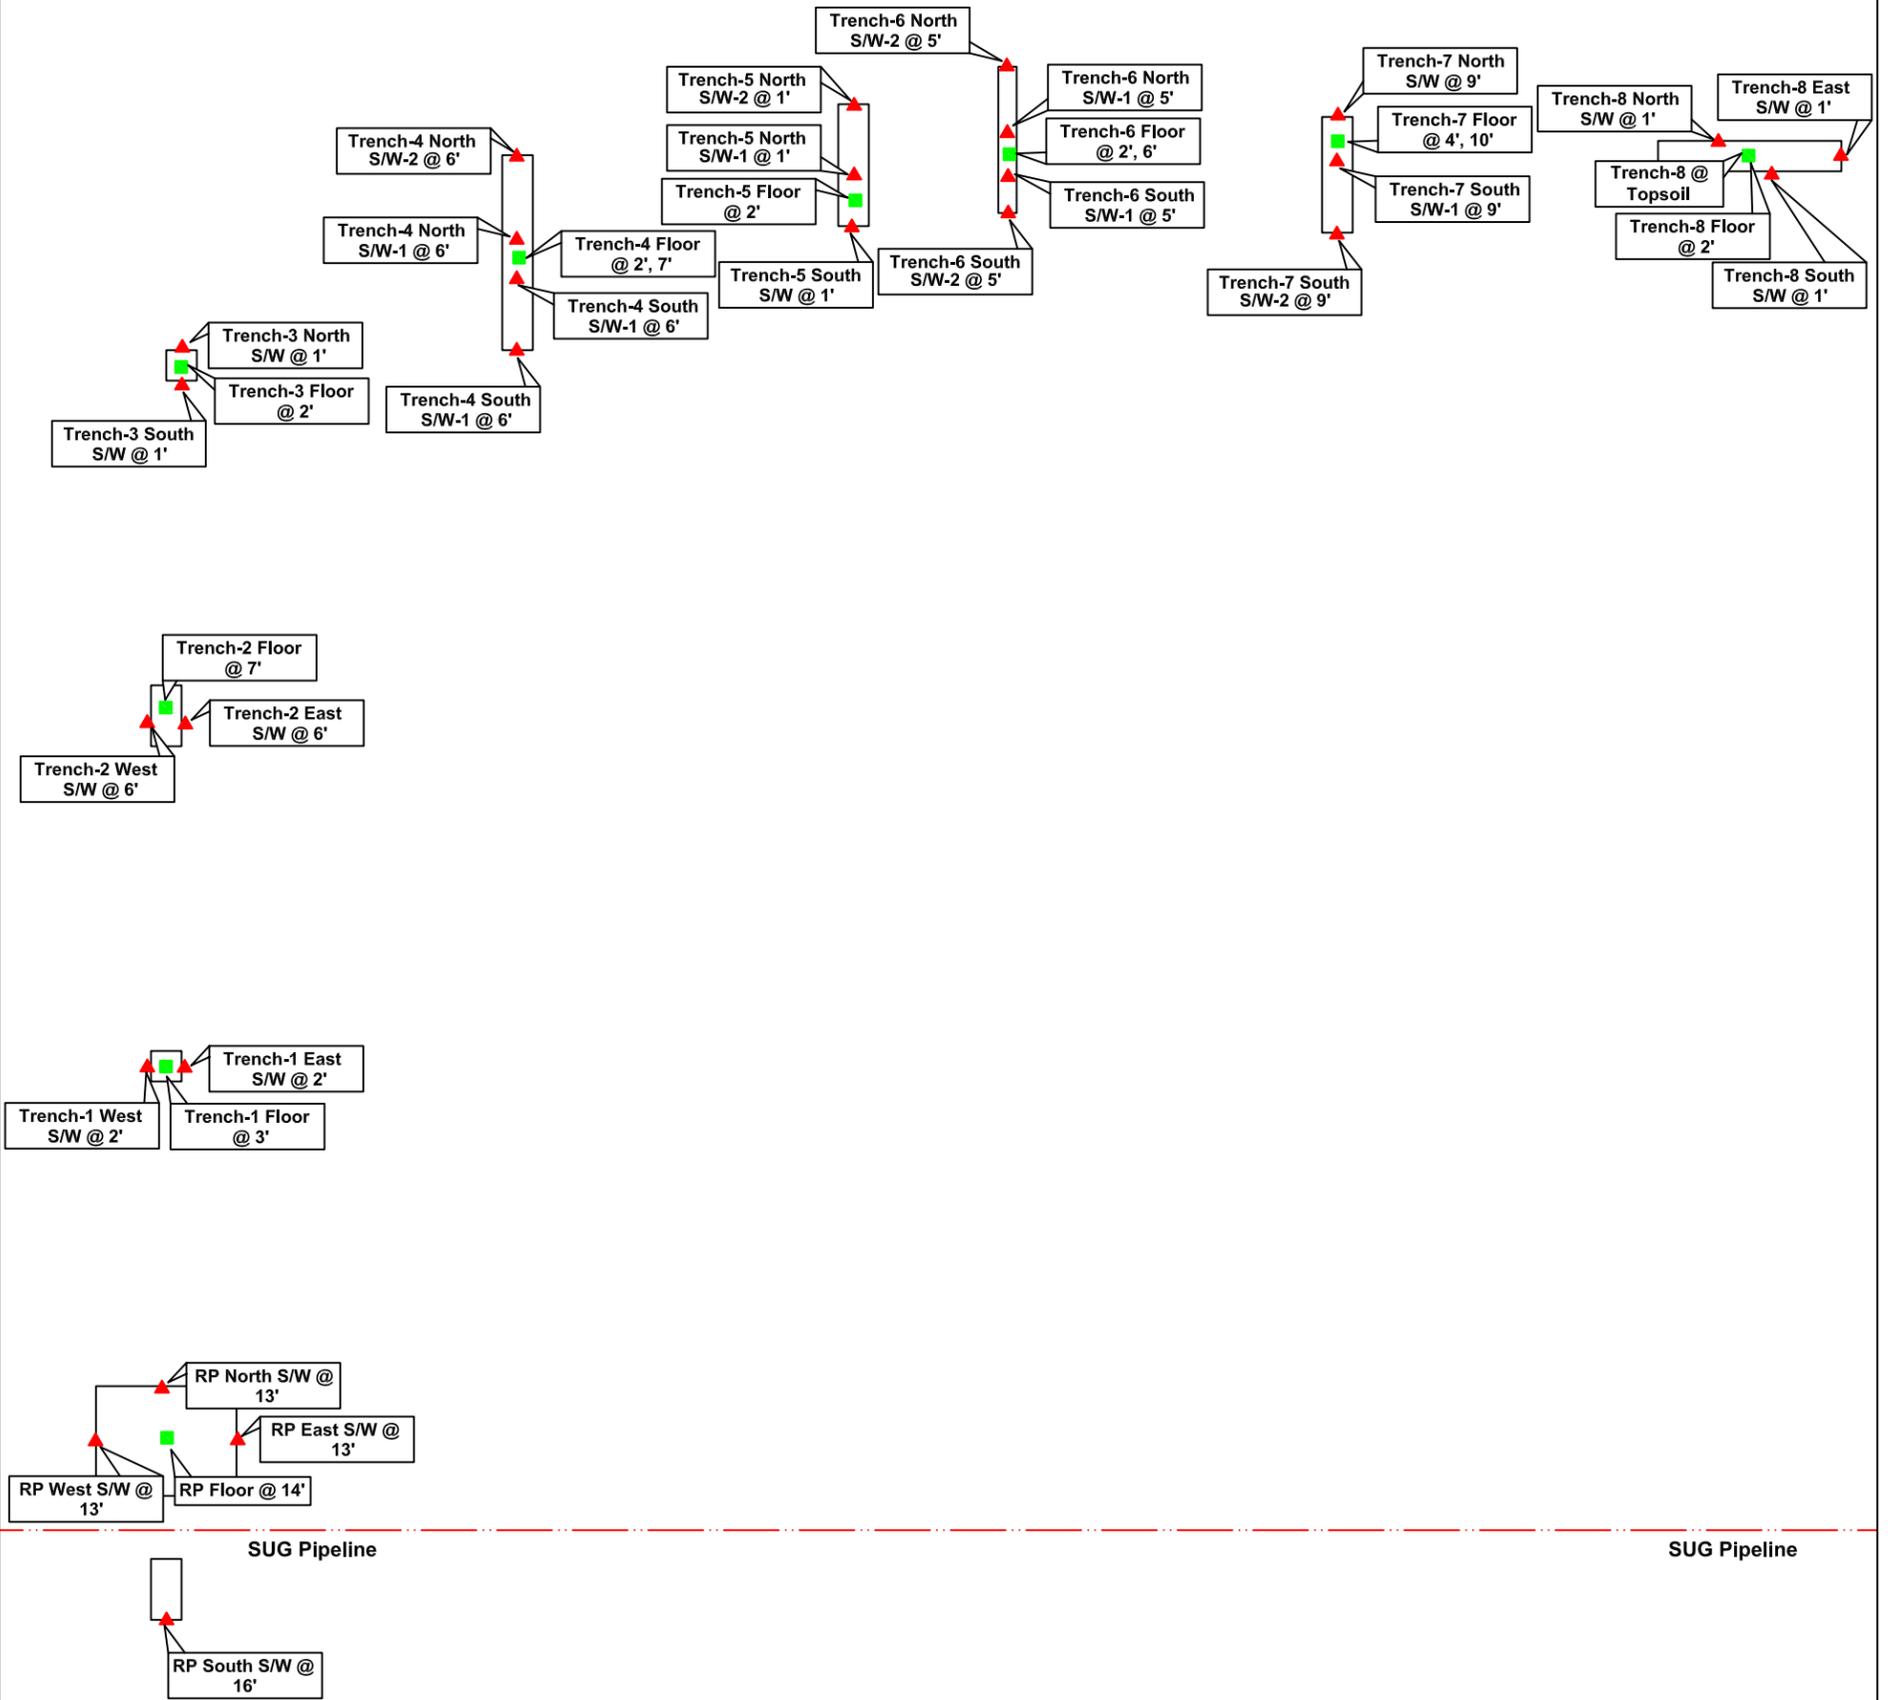
Legend:		<p align="center">Figure 3 Site Details & Soil Samples Location Map Southern Union Gas Service A-14 6 Inch Lateral Lea County, NM 1RP-1062</p>

Soil samples were collected by NOVA personnel and analyzed for BTEX, TPH and chlorides as shown in Appendix B, Table 1. The analytical sample results were below the NMOCD regulatory levels for BTEX and TPH. Elevated chloride concentrations were found in Trench-4, Trench-5, Trench-6 and Trench-7. Trench-4 showed elevated chloride

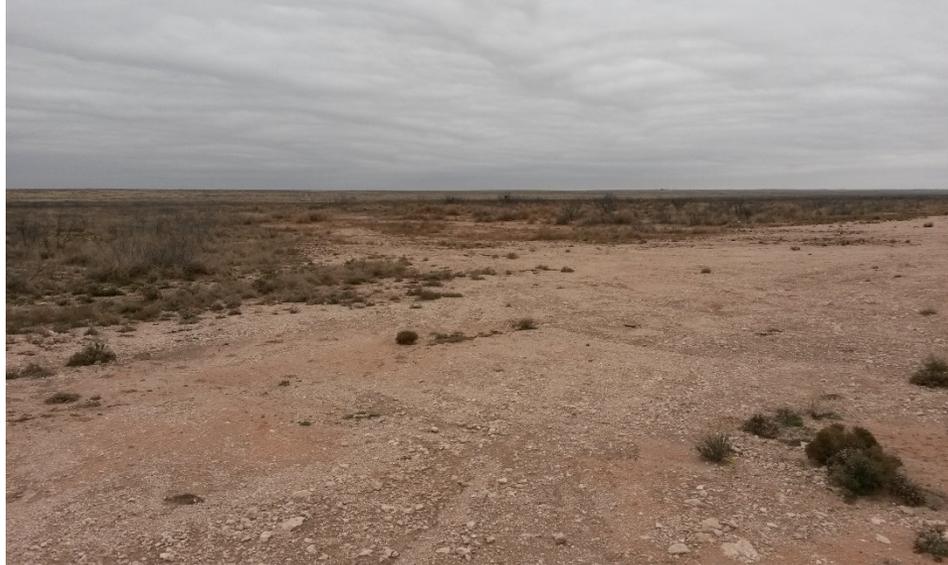
View North – Approximate area of release

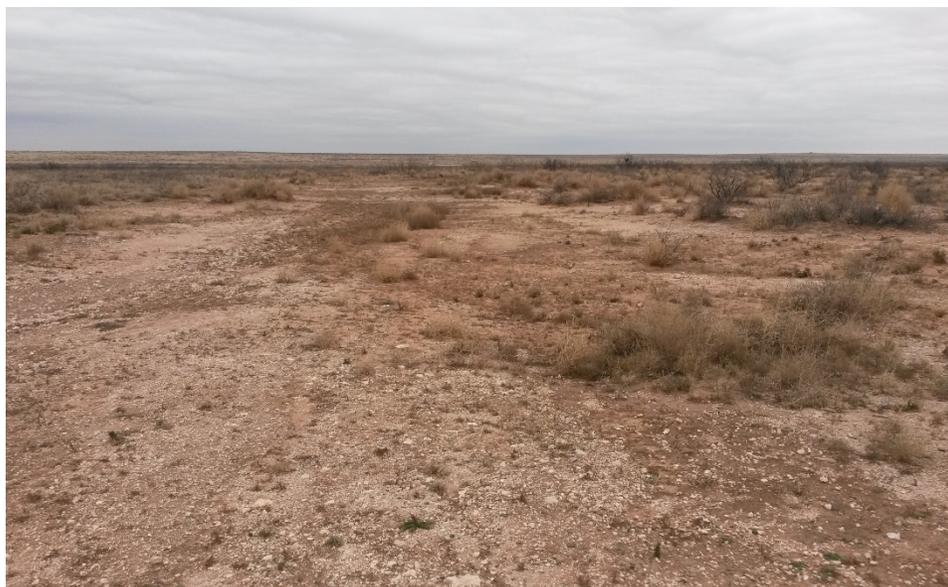
View North – Spill path with new growth
