**OXY USA, Inc.
South Hobbs Unit 29
Delineation Report and Work Plan
3526
Section 5, T19S, R38E
Lea County, New Mexico**

February 23, 2015

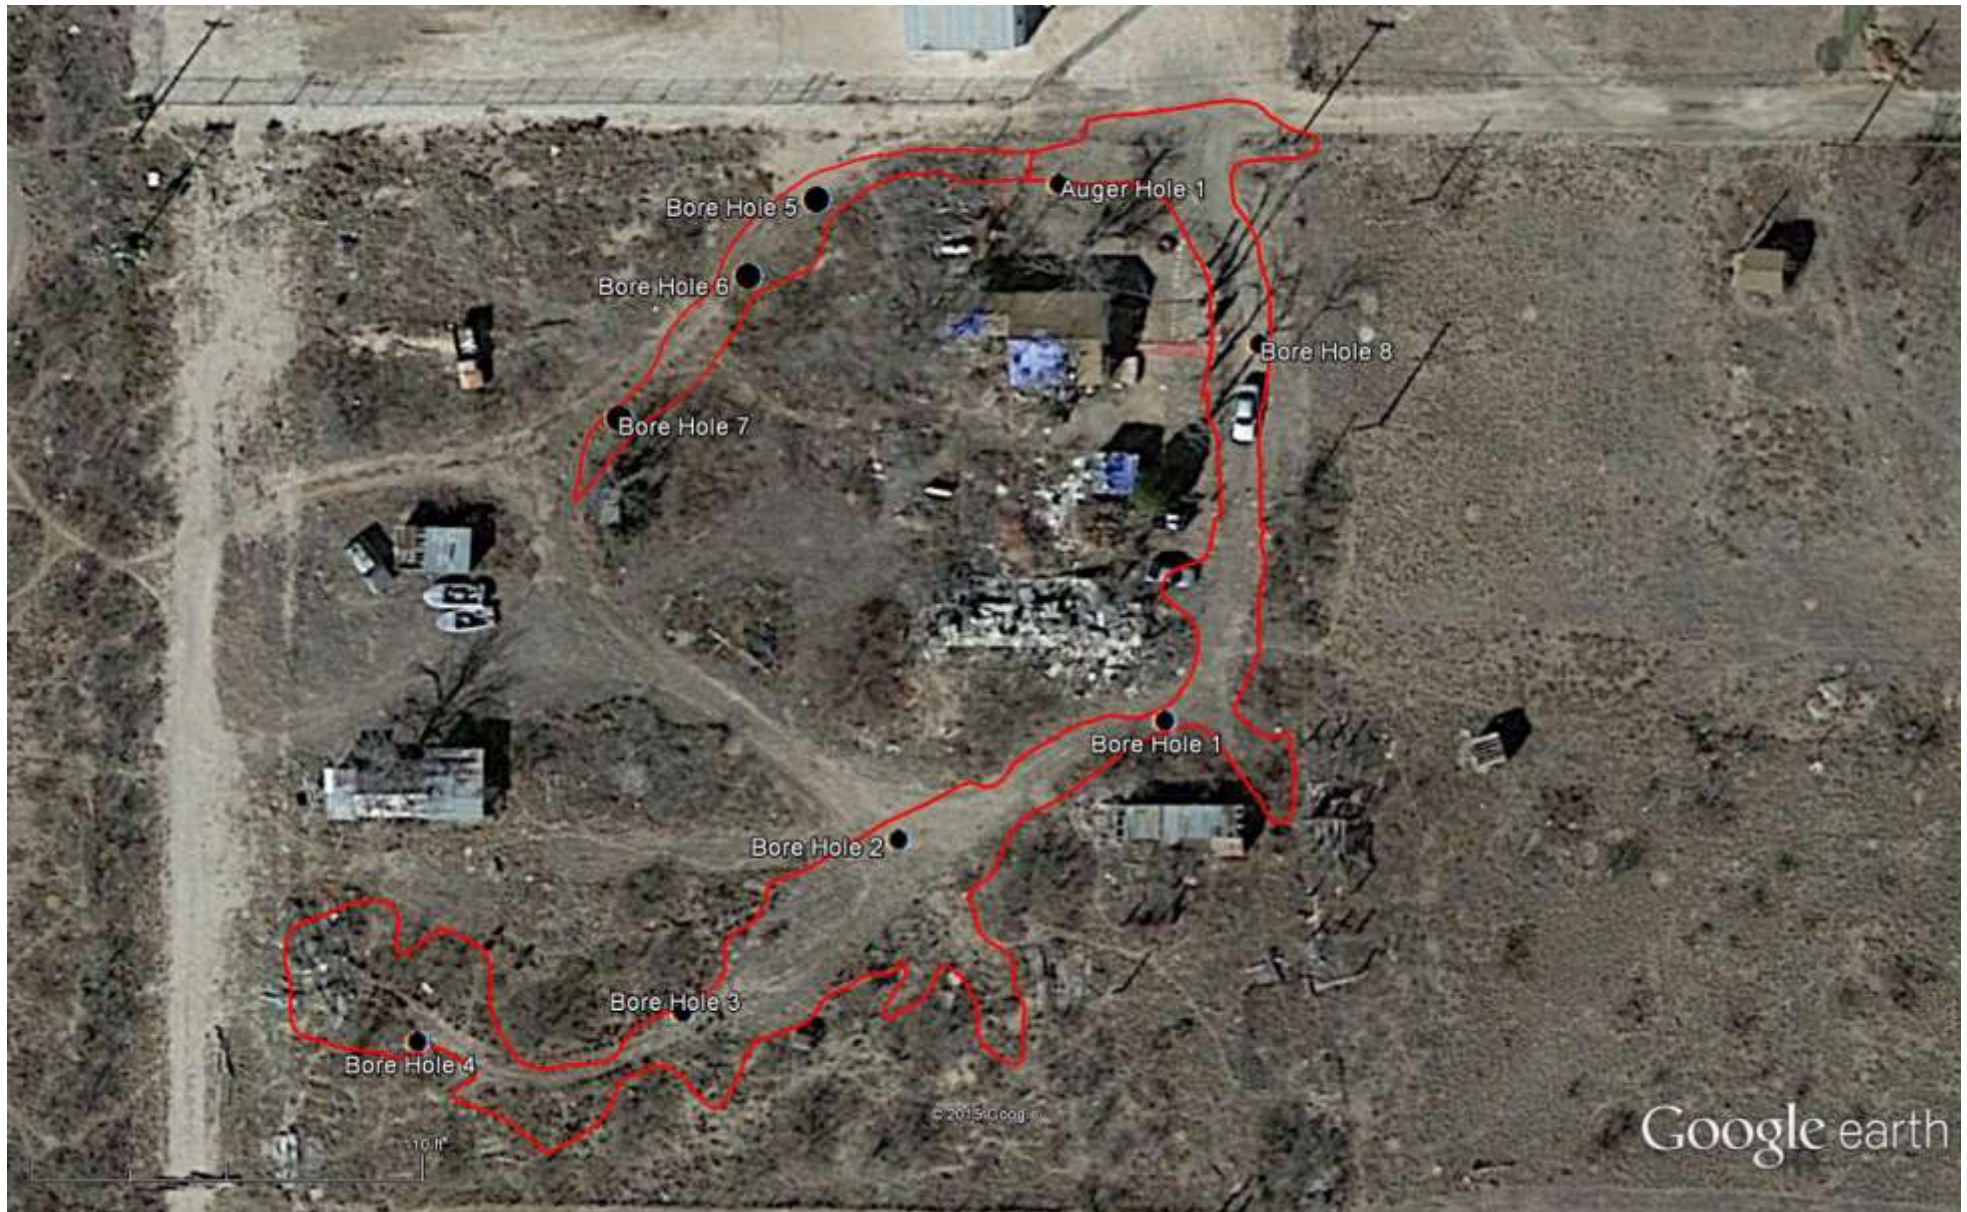
Figure 2

On January 27, 2015, SESI was onsite to determine vertical extent of contamination using boreholes. Samples BH-1 was taken at a depth of 2' ft., 4' ft. and 6.5' ft. Samples BH-2 were taken at 2' ft. and 4 ft. BH-3 were taken at 2' ft. and 4 ft. BH-4 were taken at 2' ft. and 3' ft. BH-5 were taken at 2' ft. and 3.5-3.8' ft. BH-6 were taken at 2' ft. and 3-3.4' ft. BH-7 were taken at 2' ft. and 3-3.8' ft. BH-8 were taken at 2' ft. and 3.5-4' ft. All samples were properly packaged, preserved and transported to the Laboratory, Hobbs

Site Plan

Excavate and remove all Chloride contaminated soil to the depth where the concentration is 250 PPM chlorides and 100 TPH. Contaminated soils will be transported to an approved NMOCD facility for disposal. The excavated area will be backfilled with native soil and returned to natural grade. Composite confirmation samples will be taken from the sides and bottom of the excavation area.
